# ROOFING

846 Elgin Cir, Pickerington, OH August 21, 2014

Report No. 1087, v.3

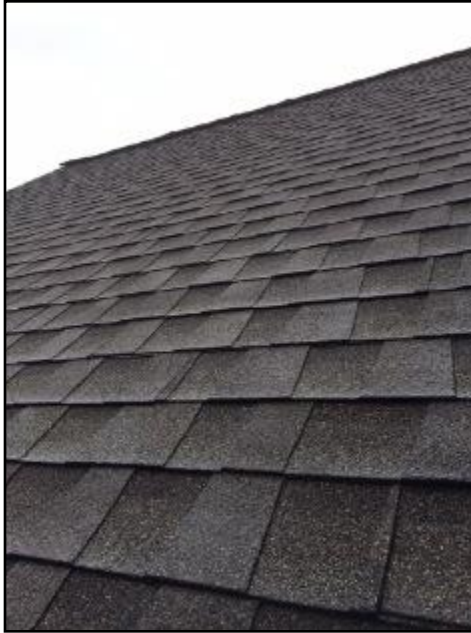
1. *Wet roof surface hides flaws*

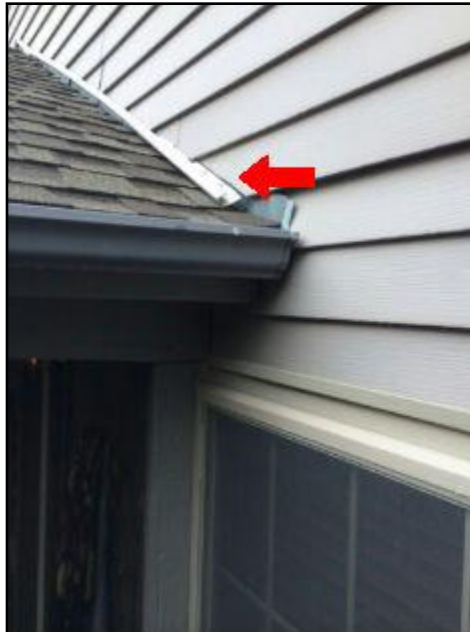
**1. Condition:** • Siding Damage:

Siding has minor damage. Any opening should be sealed to prevent water entry

Loose J-Channel

**Implication(s):** possible water to contents

**Location:** Rear Exterior Wall Upper Level

**Task:** Repair

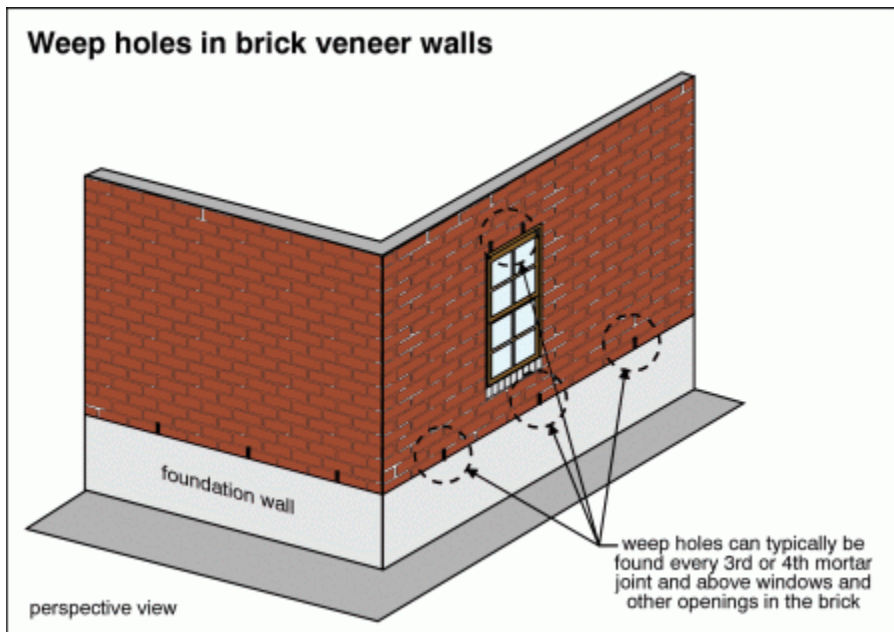
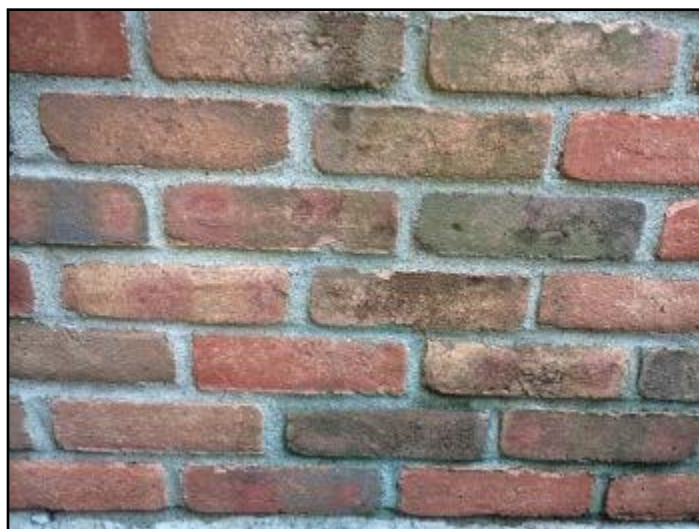
3.

**2. Condition:** • As is, unfortunately typical of installation in this area the brick veneer has been applied without the benefit of certain best practices; one of these is flashing a thin impervious material placed in mortar joints through air spaces in masonry to prevent water penetration and/or provide water drainage. Flashing should extend to the surface of the exterior wall finish above "All" openings and horizontal transitions. Another is weep holes, these are openings placed in mortar joints of facing material at the level of flashing, to permit the escape of moisture. There were no weep holes or flashing visible in the brick veneer above or below the windows. Absent these details, there is an increased risk of water penetration and damage to the building. Water damage can be difficult to detect without the use of invasive or destructive means that are beyond the scope of this inspection. It is recommended by the Brick Industry Association that weep holes and flashing be installed to allow water or moisture to escape.

**Implication(s):** Possible water damage to contents

**Location:** Various Throughout Exterior Wall

**Task:** Improve

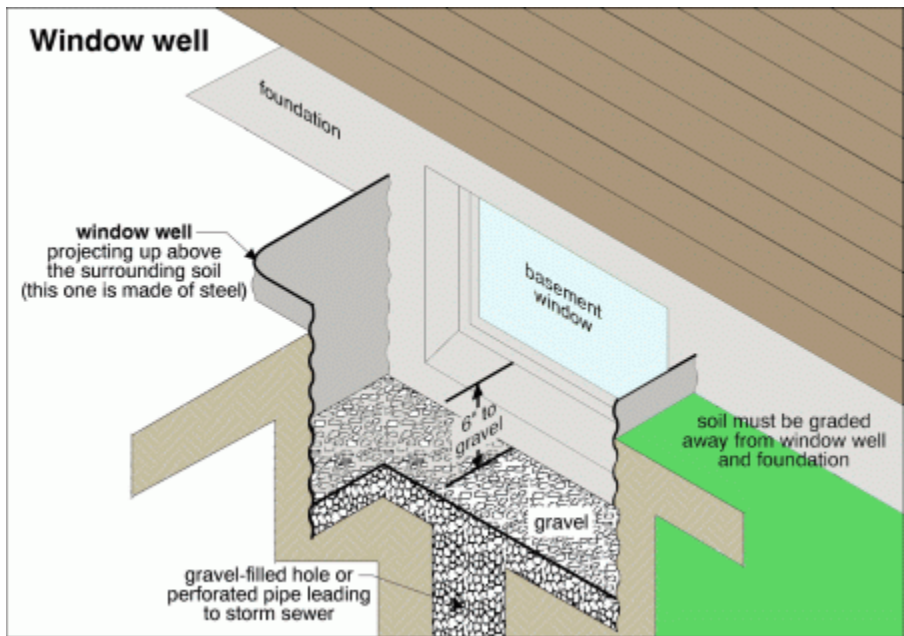
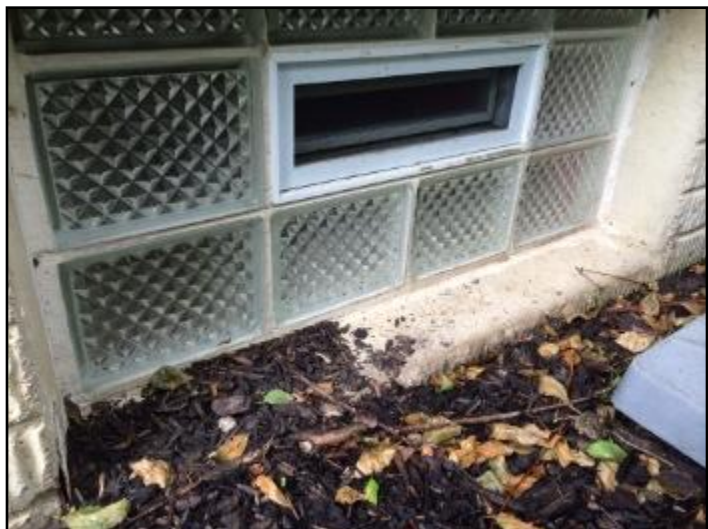
**3. Condition:** • [Missing](#)

Missing window wells throughout exterior improvement needed.

**Implication(s):** Chance of water damage to contents, finishes and/or structure | Material deterioration

**Location:** Various Throughout Exterior

4. Missing

**Task:** Provide

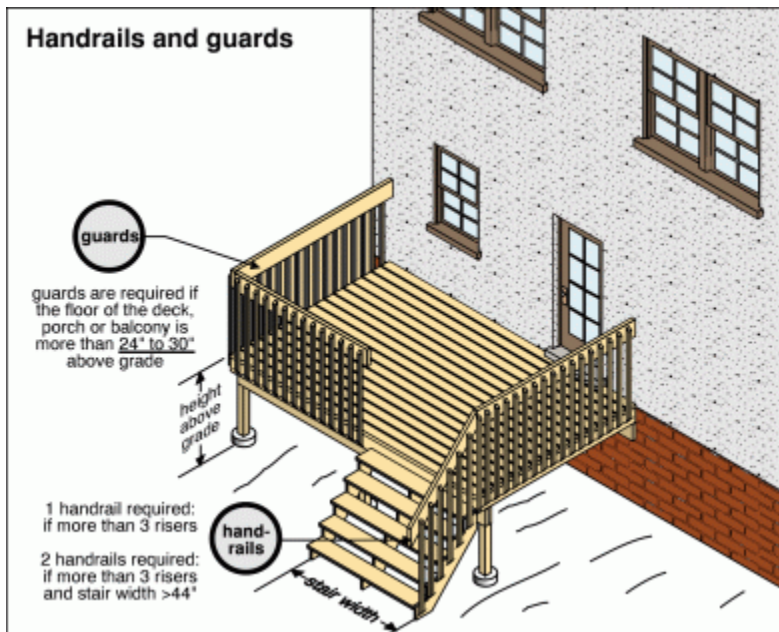
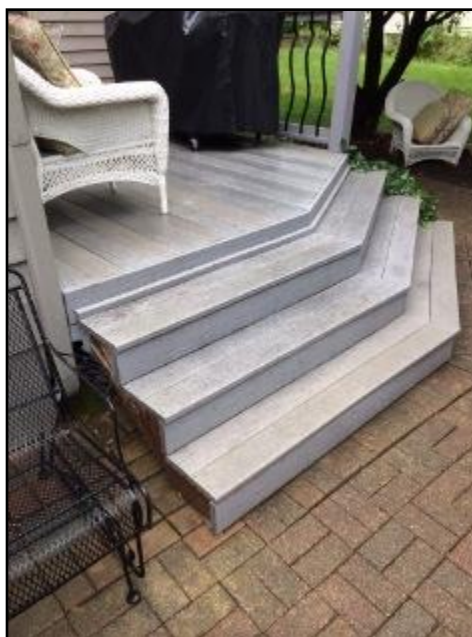
4. Condition: • [Missing](#)

Handrail missing

**Implication(s):** Fall hazard

**Location:** Rear Exterior Staircase Deck

5. Missing

**Task:** Provide

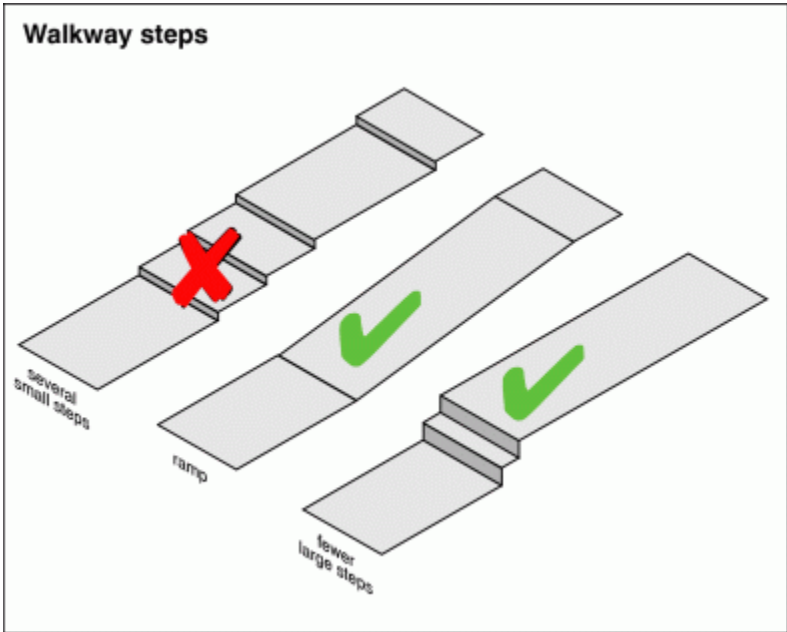
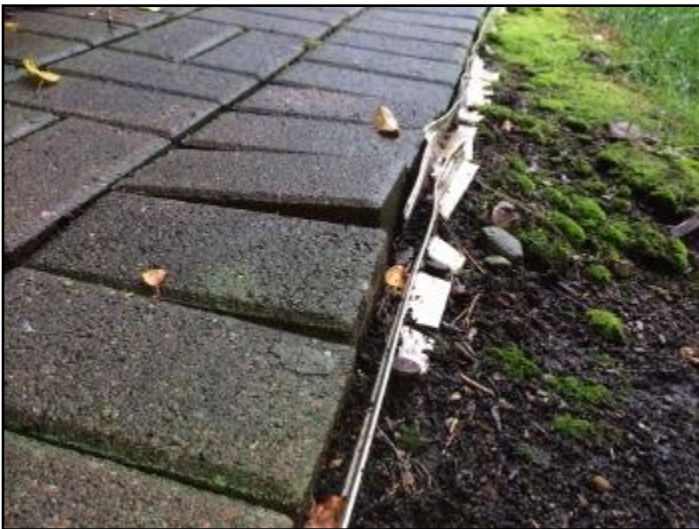
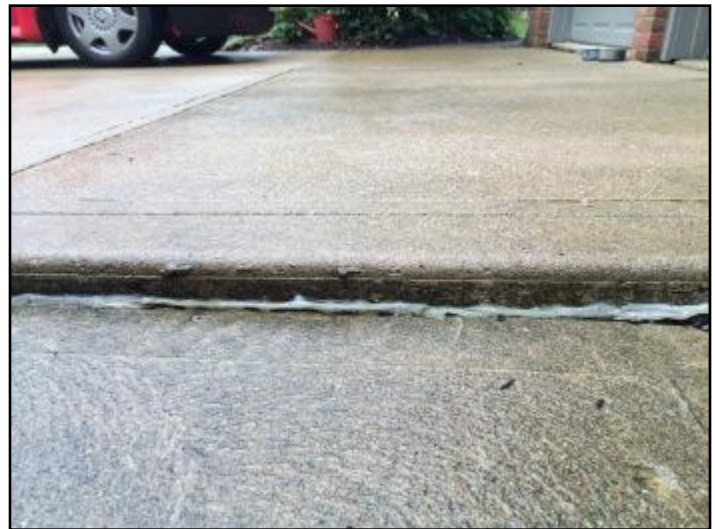
**5. Condition:** • (uneven) The walkways is uneven creating a trip hazard. This condition should be corrected for improved safety.

**Location:** Various Throughout

6. (uneven) The walkways is uneven creating a...

7. (uneven) The walkways is uneven creating a...

**Task:** Improve

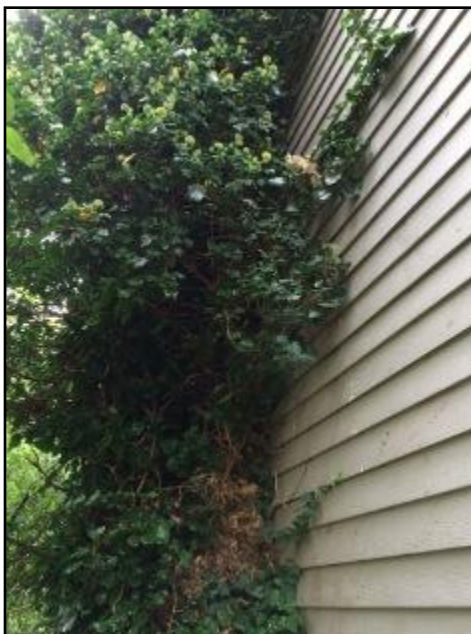
**6. Condition:** • [Vines](#)

Vines growing on exterior walls should be kept trimmed away from siding, window trims and the eaves to reduce risk of insect and water damage.

**Implication(s):** Chance of damage to finishes

**Location:** Right Side Exterior Wall

8. Vines

**Task:** Remove

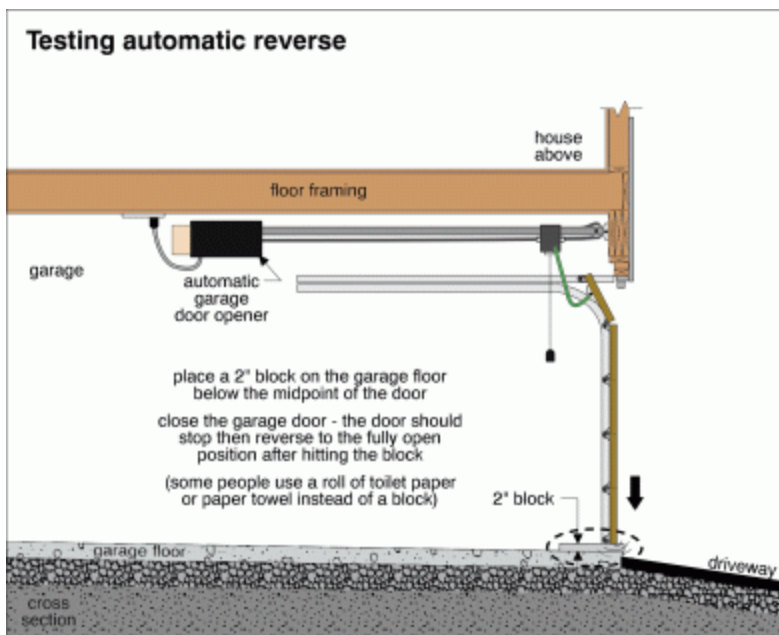
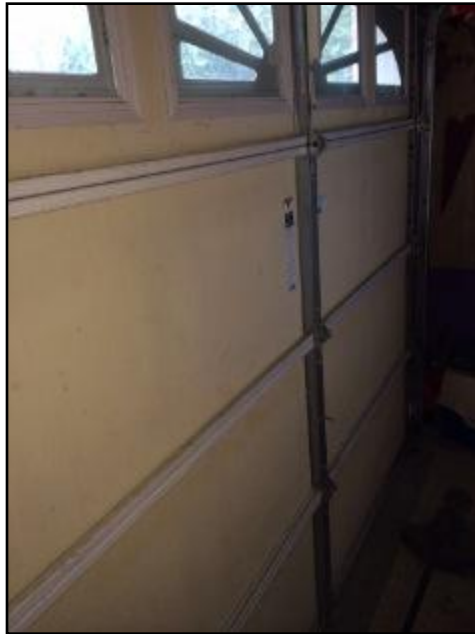
7. Condition: • [Fails to auto reverse](#)

Implication(s): Physical injury

Location: Left Side Garage Door

9. *Fails to auto reverse*

Task: Provide

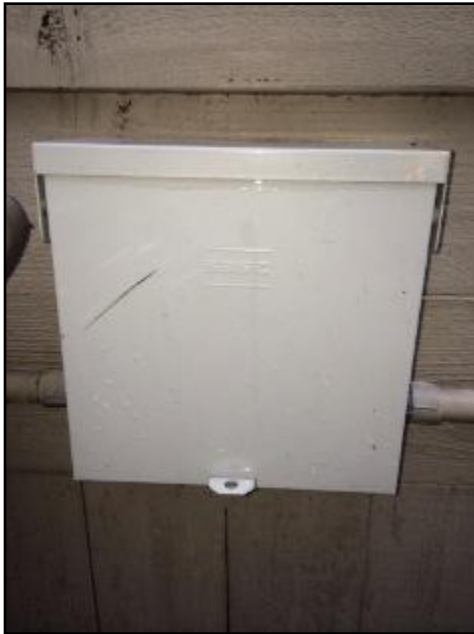
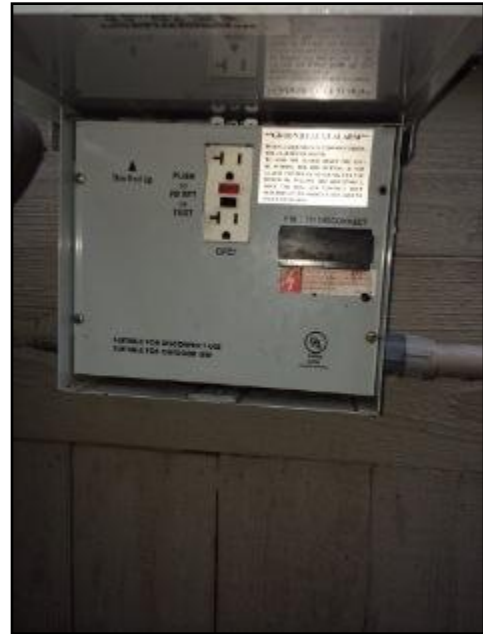
11.

**8. Condition:** • Disconnected Box- The disconnect box for the hot tub is drawing too many amps. This buzzing noise or humming sound is usually an indication that the contactors in the device are wearing. I recommend that a licensed electrician review and make repairs as needed.

**Implication(s):** Fire Hazard

**Location:** Exterior Panel Disconnected

**Task:** Repair or replace

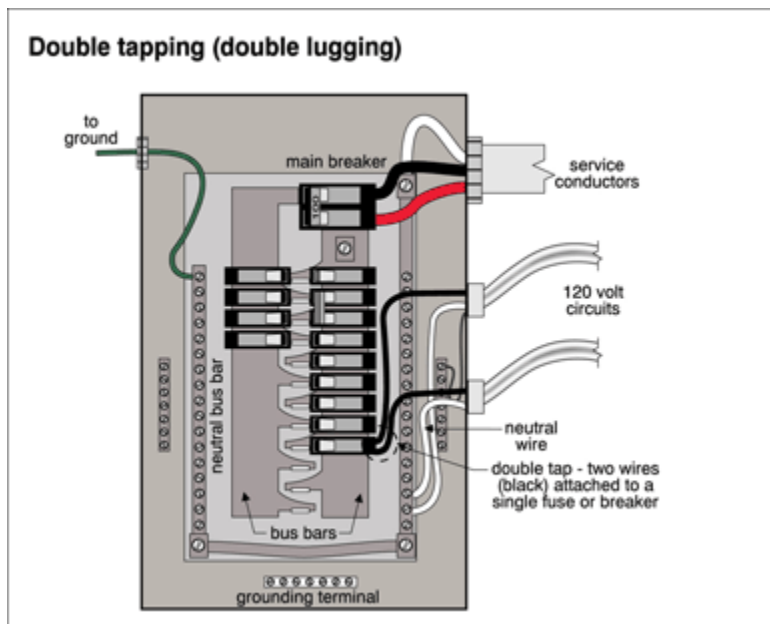
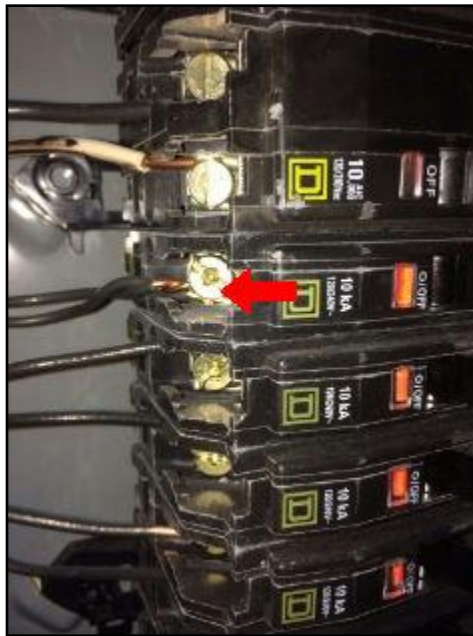
**9. Condition:** • [Double taps](#)

The main breaker is "Double Taped" to hot wires attached to the same breaker. This panel is not made to connect a second circuit to these lugs. The small wires are not large enough to safely carry the maximum amperage provided by this main breaker. Fires could result in overloading the smaller circuit. Correction as needed by a licensed electrician is recommended.

**Implication(s):** Fire hazard

**Location:** Basement Utility Room Panel

13. Double taps

**Task:** Correct

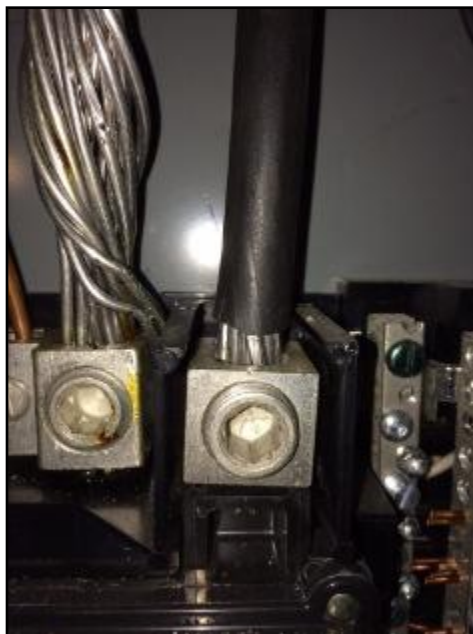
### 10. Condition: • [Loose connections](#)

All strands should be connected inside main lug from service entry cable neutral. I recommend license electrician make repairs as needed.

**Implication(s):** Electric shock | Fire hazard

**Location:** Basement Utility Room

14. Loose connections

**Task:** Correct

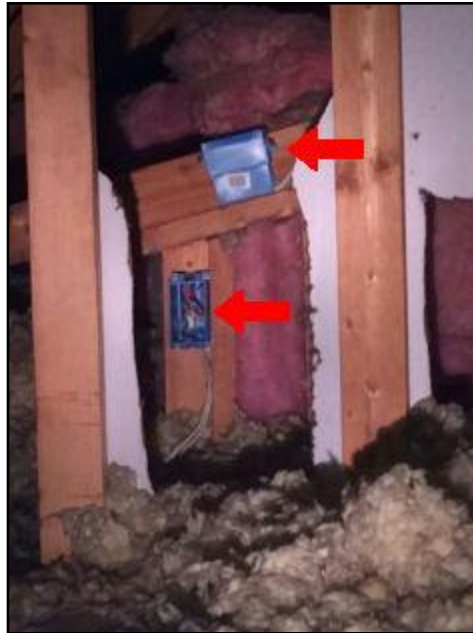
### 11. Condition: • [Cover loose or missing](#)

Missing covers provide

**Implication(s):** Electric shock | Fire hazard

**Location:** Attic

15. Cover loose or missing

**Task:** Improve

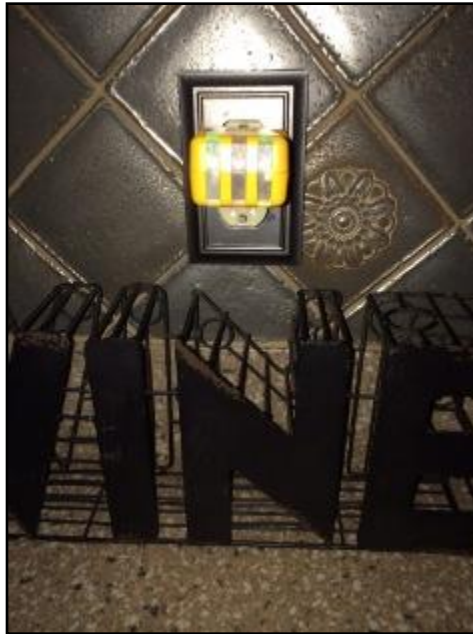
**12. Condition:** • The Installation of ground fault circuit interrupter (GFCI) outlets is advisable in Bathrooms, Kitchens, Exterior, Basements, and Garages. A (GFCI) outlet offers protection from shock or electrocution. The Ground fault circuit interrupter (GFCI) is Inoperative or missing during this inspection. Exterior GFCI's shall be installed with weather proof housing. The receptacle should be repaired or replaced

**Location:** Right Side First Floor Kitchen

16. The Installation of ground fault circuit...

**Task:** Provide

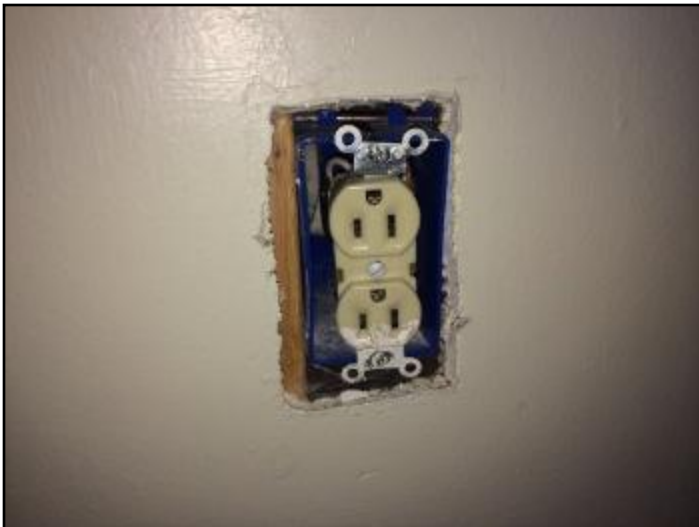
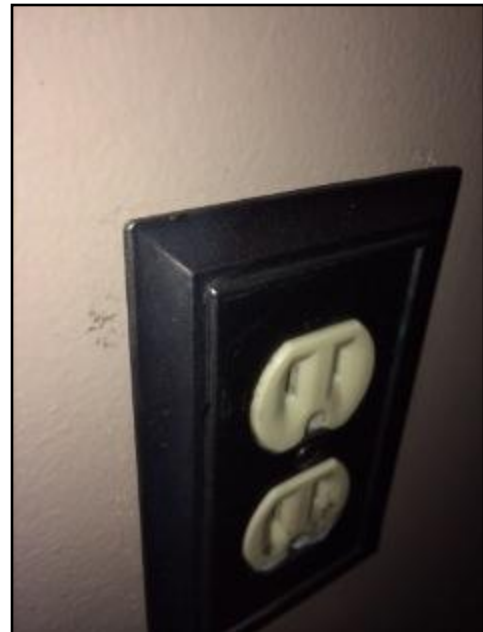
13. Condition: • [Missing](#)

Missing or damaged cover plates

**Implication(s):** Electric shock

**Location:** Various Throughout Interior Residence

17. Missing

18. Missing

**Task:** Improve

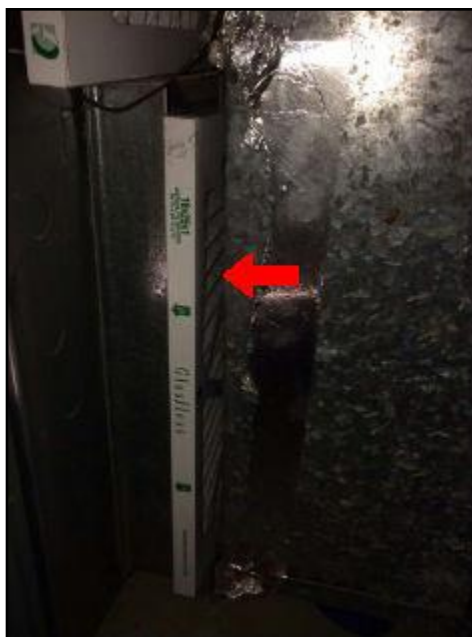
**14. Condition:** • [Leaky joints](#)

The furnace filter has no mechanical door. When pulling in ambient air at this location particulates may enter on the wrong side of the filter. This condition may also inhibit return air side of system to function improperly and cause excessive buildup on evaporator coil. I recommend that a licensed HVAC professional make any and all repairs as needed

**Implication(s):** Increased heating costs | Reduced comfort

**Location:** Basement Utility Room

22. Leaky joints

**Task:** Improve

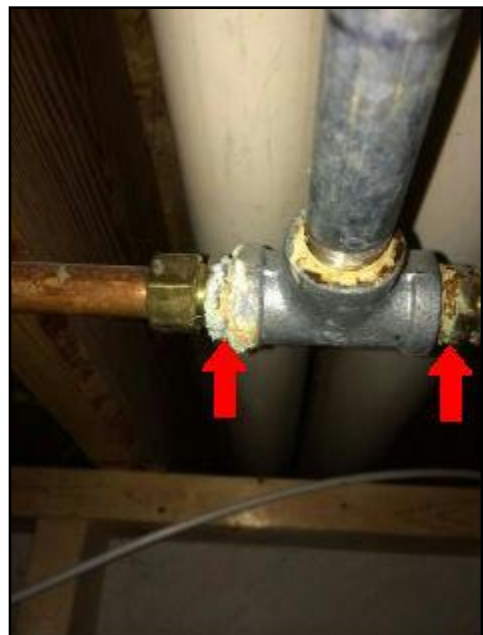
**15. Condition:** • [Rust](#)

Rust from dissimilar metals coupling needed. Its a coupling that acts as an electrical barrier between the two metals. One side is made of copper, the other steel. Between the two sides, there is a non-conducting washer, usually made of plastic. I recommend contacting a licensed plumber to make any and all repairs as needed.

**Implication(s):** Chance of water damage to contents, finishes and/or structure | Leakage | Reduced system life expectancy | Equipment failure

**Location:** Basement Utility Room

29. Rust

**Task:** Correct

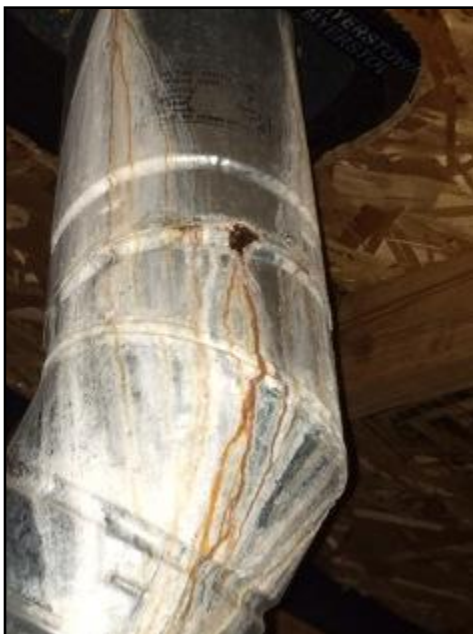
16. Condition: • Rust, dirty, obstructed

Water Heater Fuel leaking at roof collar. There's a chance of water damage to contents if left in this condition there may also be a chance of combustible gases entering the home. I recommend a licensed HVAC professional make any and all repairs as needed.

**Implication(s):** Equipment not operating properly | Hazardous combustion products entering home

**Location:** Attic

30. Rust, dirty, obstructed

**Task:** Repair or replace

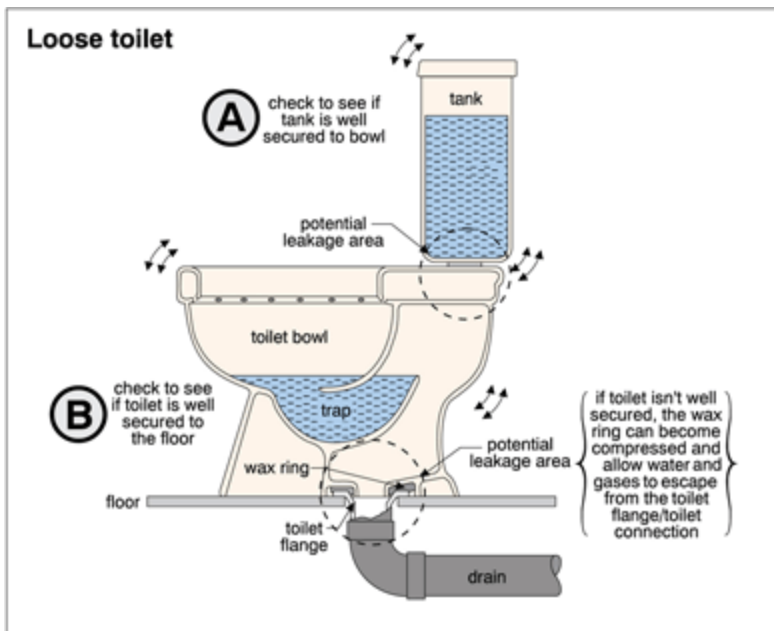
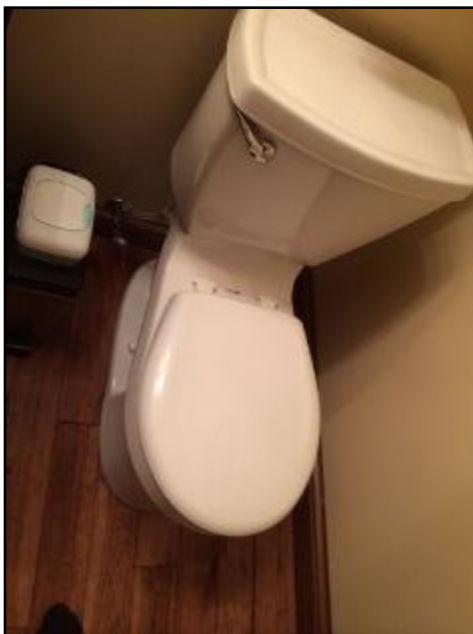
17. Condition: • [Loose](#)

Implication(s): Chance of water damage to contents, finishes and/or structure | Sewage entering the building

Location: First Floor Bathroom Hallway Bathroom

31. Loose

Task: Correct

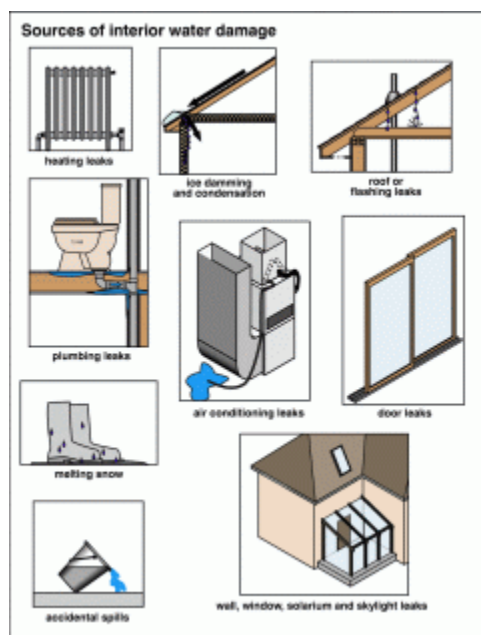
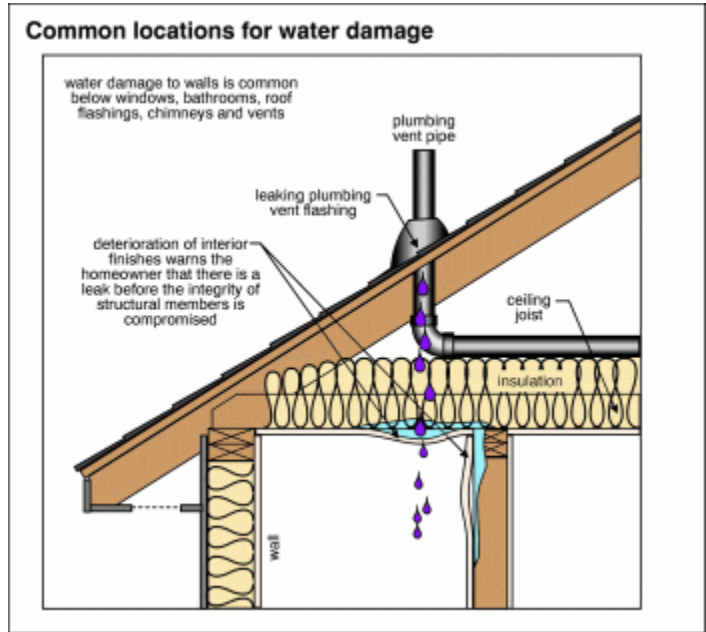
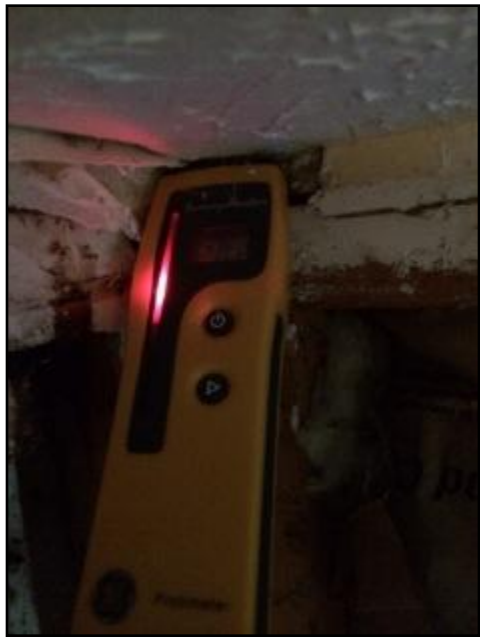
18. Condition: • [Water damage](#)

Water damage on the ceiling was found with a " Protometer " moisture meter. The leak is active this inspection is limited, exhaustive or destructive inspections are excluded. Future leaks may be found should be repaired as needed. I recommend contacting a qualified contractor for further evaluation.

**Implication(s):** Cosmetic defects | Chance of movement

**Location:** Right Side Garage Ceiling

32. Water damage

**Task:** Further evaluation

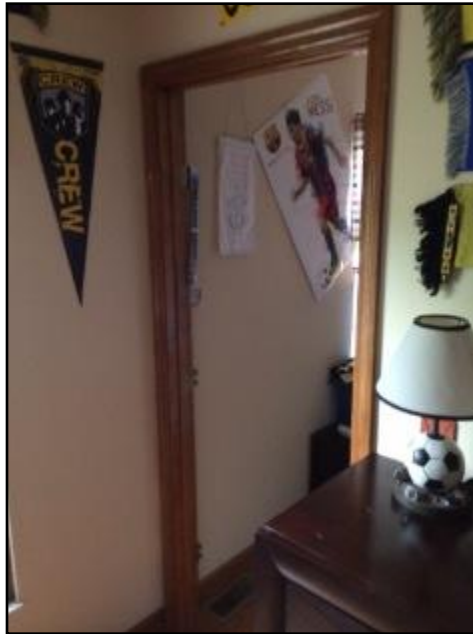
**19. Condition:** • Missing Door Slab & Hardware

**Location:** Front Bedroom Closet Door

33. Missing Door Slab & Hardware

**Task:** Provide

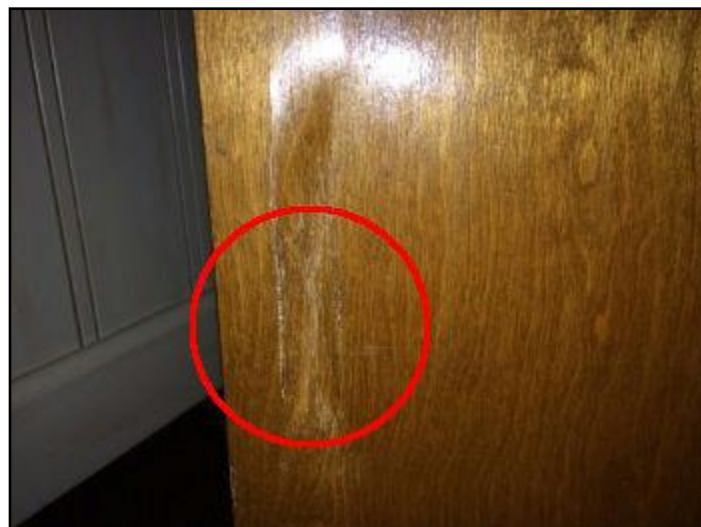
**20. Condition:** • [Damage](#)

Door slab is busted

**Implication(s):** Cosmetic defects

**Location:** Rear Center Hallway Bathroom Bedroom Door

34. Damage

**Task:** Repair or replace

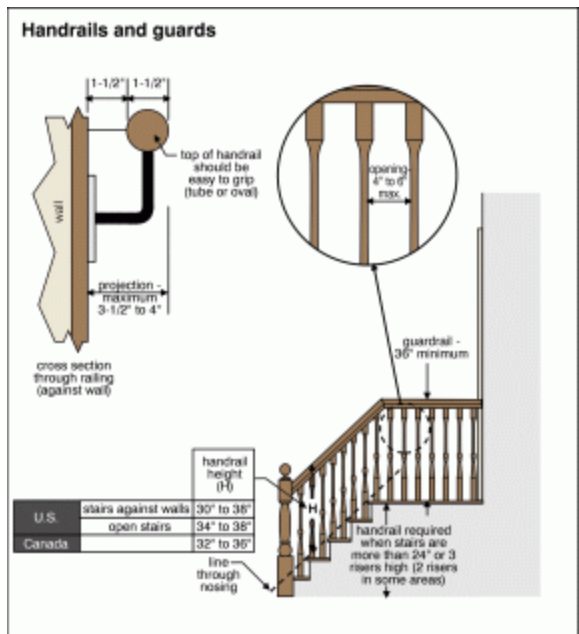
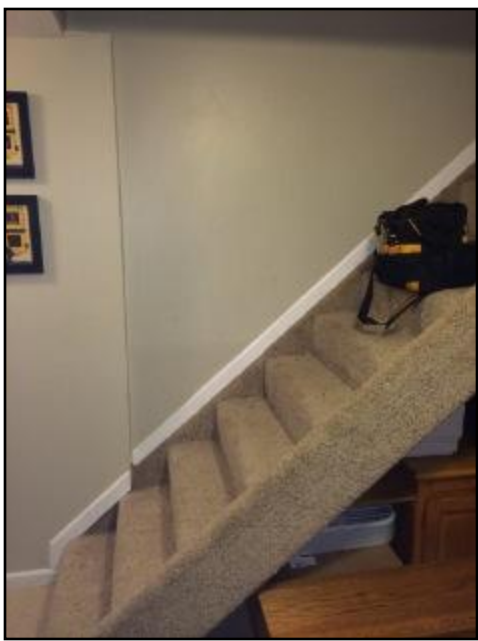
**21. Condition:** • [Missing](#)

No handrail improve safety

**Implication(s):** Fall hazard

**Location:** Basement Staircase

35. Missing

**Task:** Provide

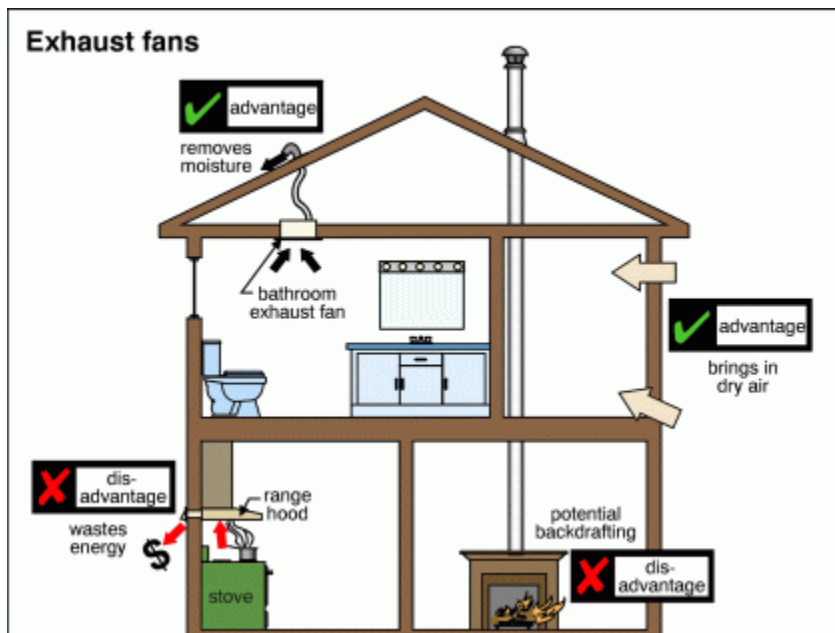
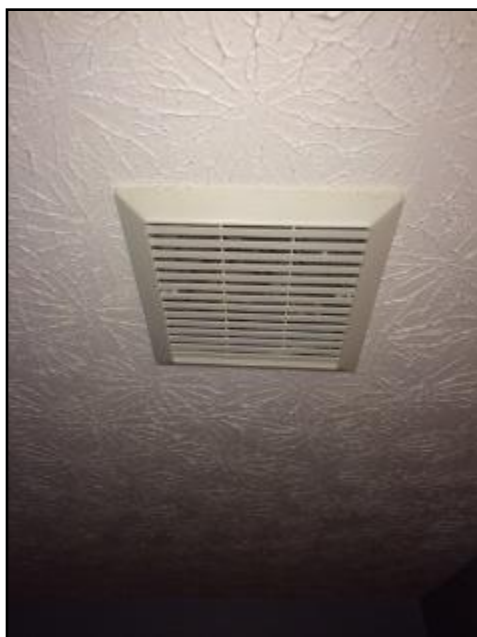
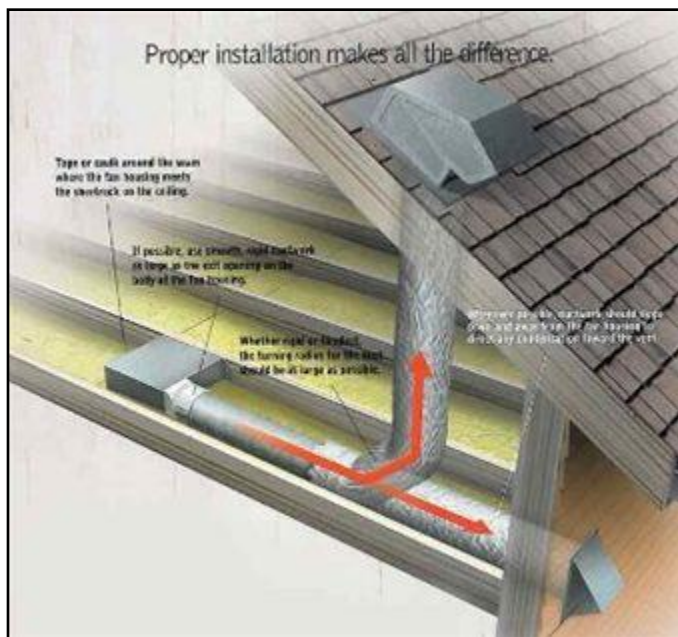
**22. Condition:** • Not Vent to Exterior- The bathroom fan vent is open into the attic. 2000 Mechanical Code; 501.3 Outdoor discharge; The air removed by every mechanical exhaust system shall be discharged outdoors at a point where it will not cause a nuisance and which it cannot again be drawn in by a ventilating system. Air shall not be exhausted into an attic or crawl space.

**Location:** Various Throughout Bathroom

36. Not Vent to Exterior- The bathroom fan vent...

37. Not Vent to Exterior- The bathroom fan vent...

**Task:** Further evaluation Request disclosure

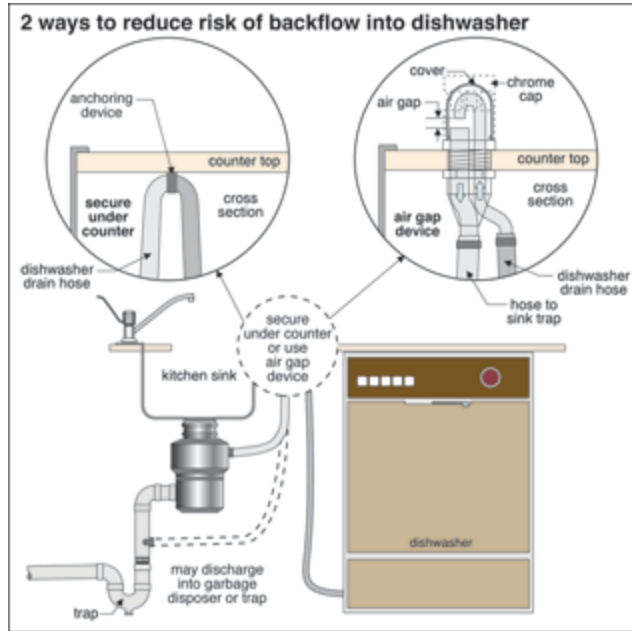
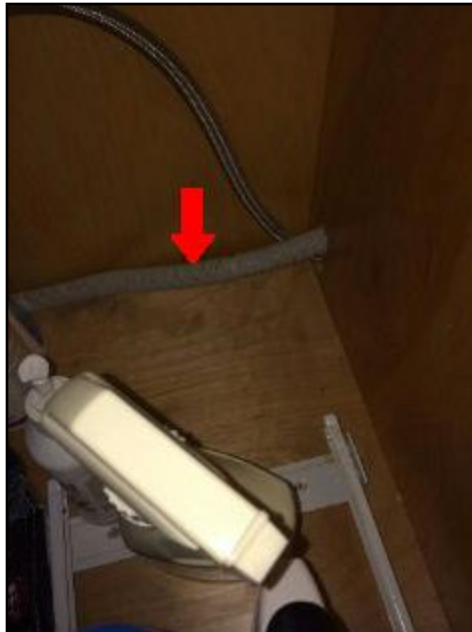
**23. Condition:** • Backflow prevention missing

**Implication(s):** Contaminated drinking water

**Location:** First Floor Kitchen

**38. Backflow prevention missing**

**Task:** Provide
