Your Inspection Report

10717 Honeysuckle Way
Plain City, OH 43064

RE: Report No. 4534, v.2
10717 Honeysuckle Way
Plain City, OH
43064

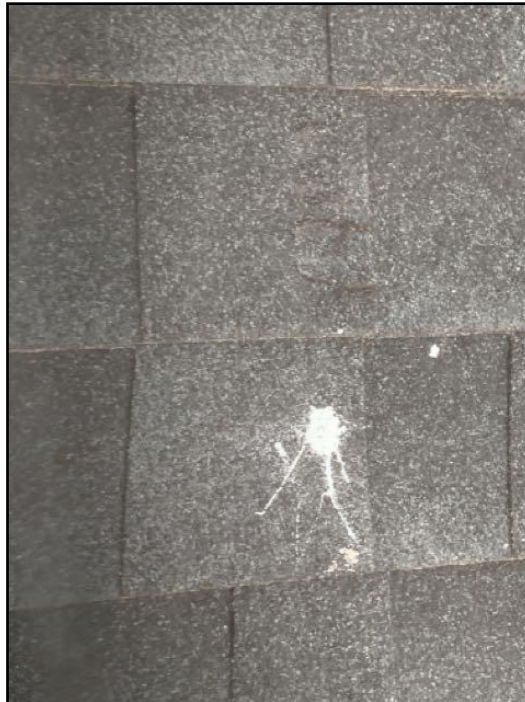
1. Damage

1. Condition: • Damage

The roof has various areas of damage from high traffic during construction. I recommend roof be evaluated by a qualified roofing contractor and repairs made as necessary.

Implication(s): Chance of water damage to structure, finishes and contents

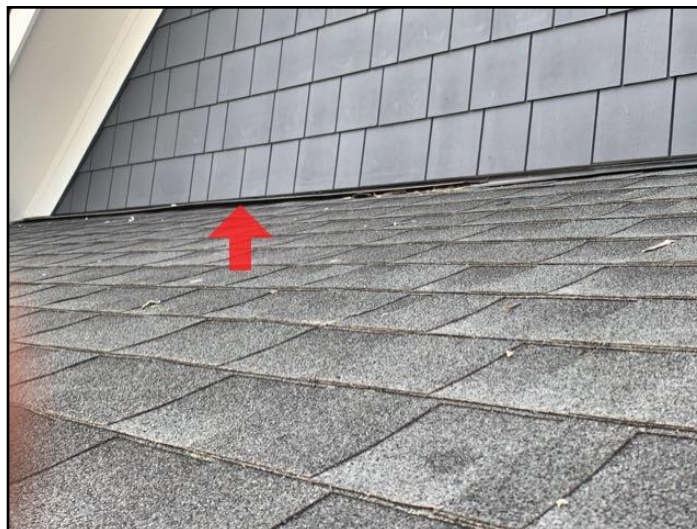
2. Damage, loose, open seams, patched

2. Condition: • Loose, damaged, patched, open seams

The roof flashing has damaged, loose or open seam. The flashing is designed to divert water from entering the structure. When the flashing is past it's life expectancy it will fail, caulking and taring these area is a temporary fix. I recommend contact a qualified roofer to make any and all repairs as necessary.

Implication(s): Chance of water damage to structure, finishes and contents

Location: Front Exterior Porch

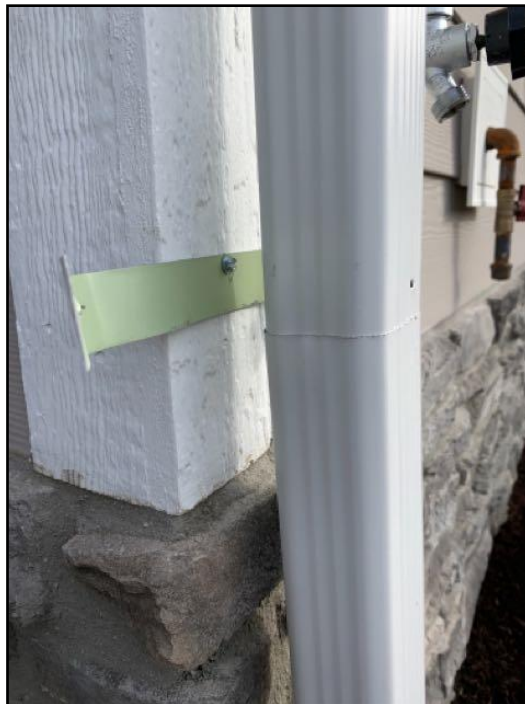
3. Connections loose

3. Condition: • Connections loose

Loose connection can cause water damage to the structure. I recommend this to be repaired to prevent water damage.

Implication(s): Leakage

Location: Rear Exterior Down Spout

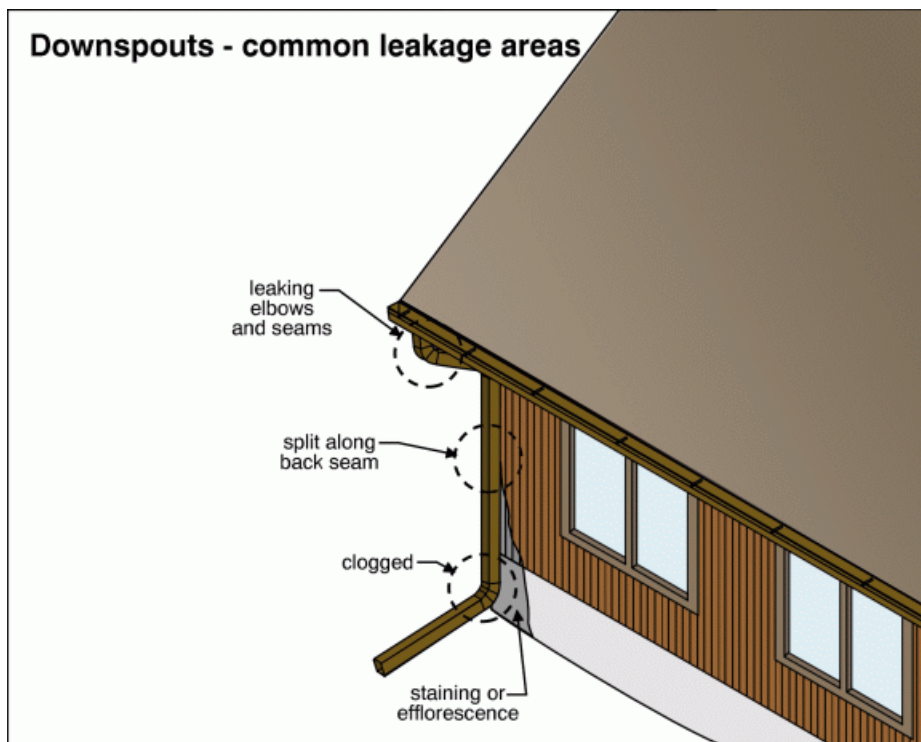
4. *Damage*

4. Condition: • Damage

PVC is damaged, I recommend the perimeter drain be repaired to prevent water damage to the structure.

Implication(s): Chance of water damage to structure, finishes and contents

Location: South Elevation Storm Drain

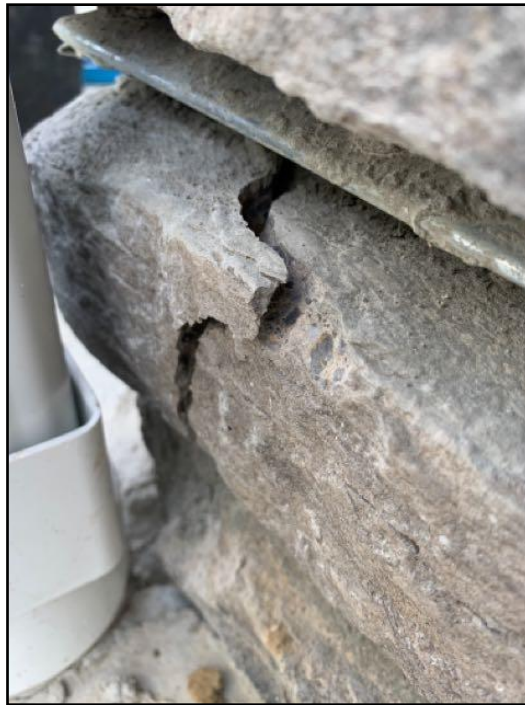
10. Cracked

9. Condition: • Cracked

The masonry is cracked and appears to be in needed of repair. I recommend contacting a qualified professional to make any and all repairs as needed.

Location: Single Garage

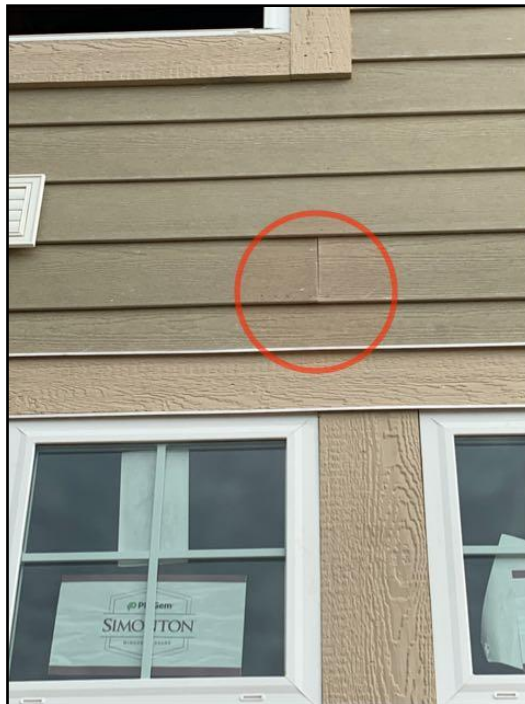
12. Mechanical damage

11. Condition: • Mechanical damage

The fiber cement siding is damaged from handle during construction. I recommend contacting a certified contractors to make any and all repairs.

Implication(s): Chance of water damage to structure, finishes and contents

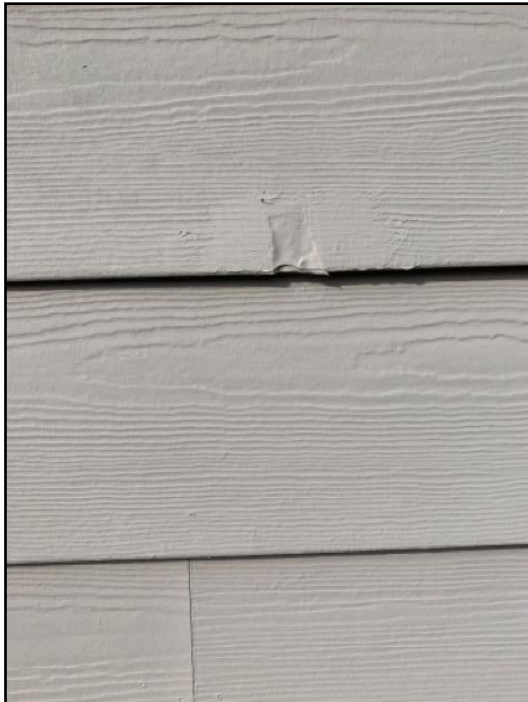
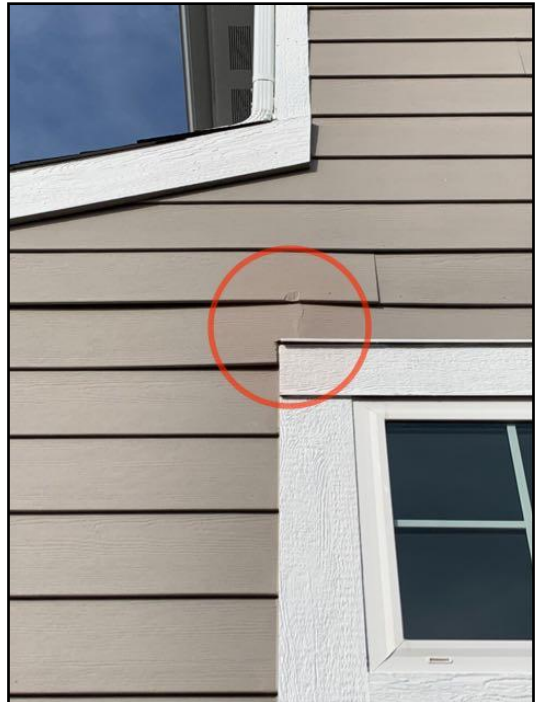
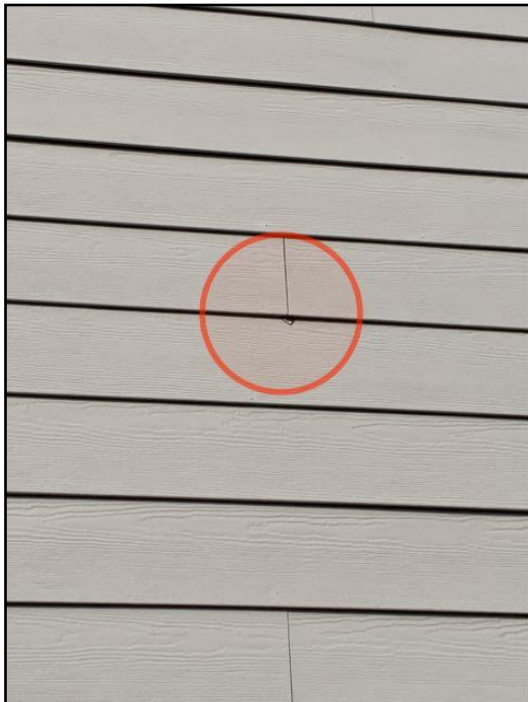
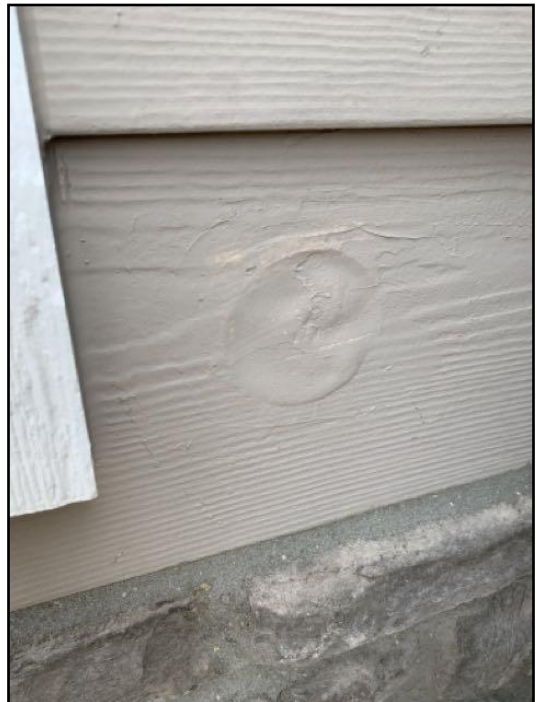
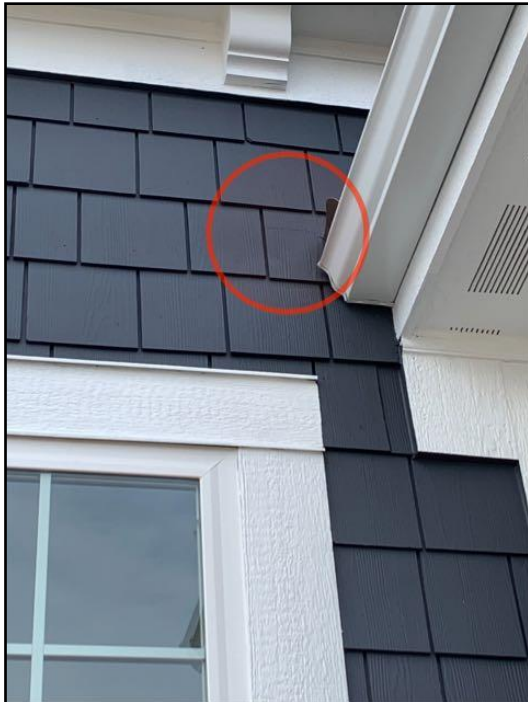
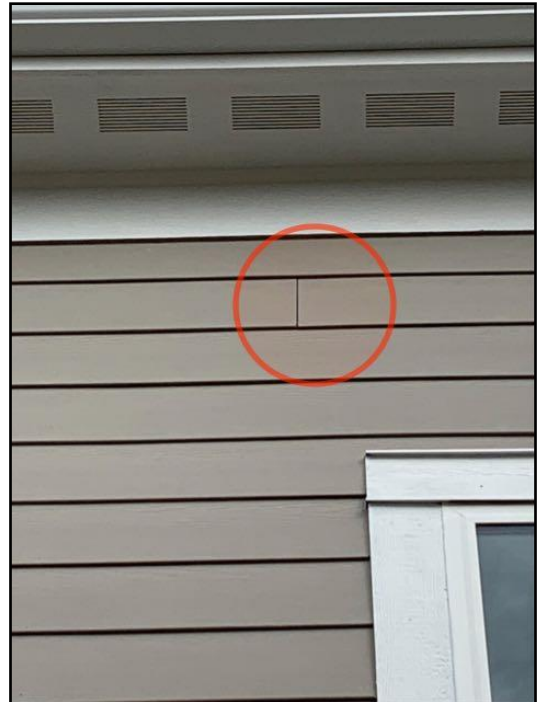
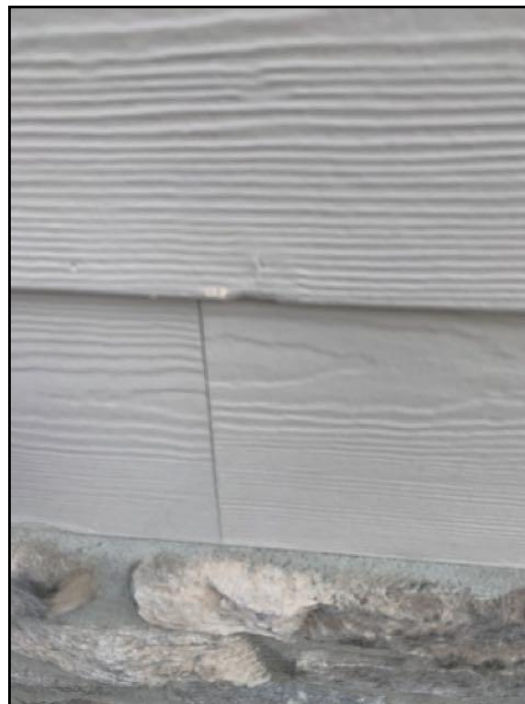
12. Condition: • Mechanical damage

The fiber cement siding is damaged from handle during construction. I recommend contacting a certified contractors to make any and all repairs.

Implication(s): Chance of water damage to structure, finishes and contents

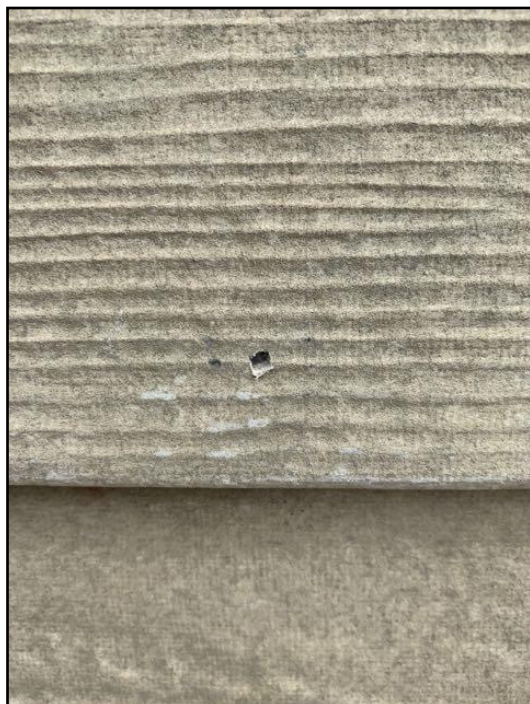
20. Nailing problems

13. Condition: • Fiber Cement lap siding is great product, but it only performs as well as its installed. James Hardie siding is a fiber-cement product that comes with a 30 or 50 year warranty, but any warranty will be void if the product is improperly installed.

Listed below are a few of the most common installation defects that I find. The funny thing about these installation defects is that the installation instructions are very clear and very specific.

Location: Siding Various Locations

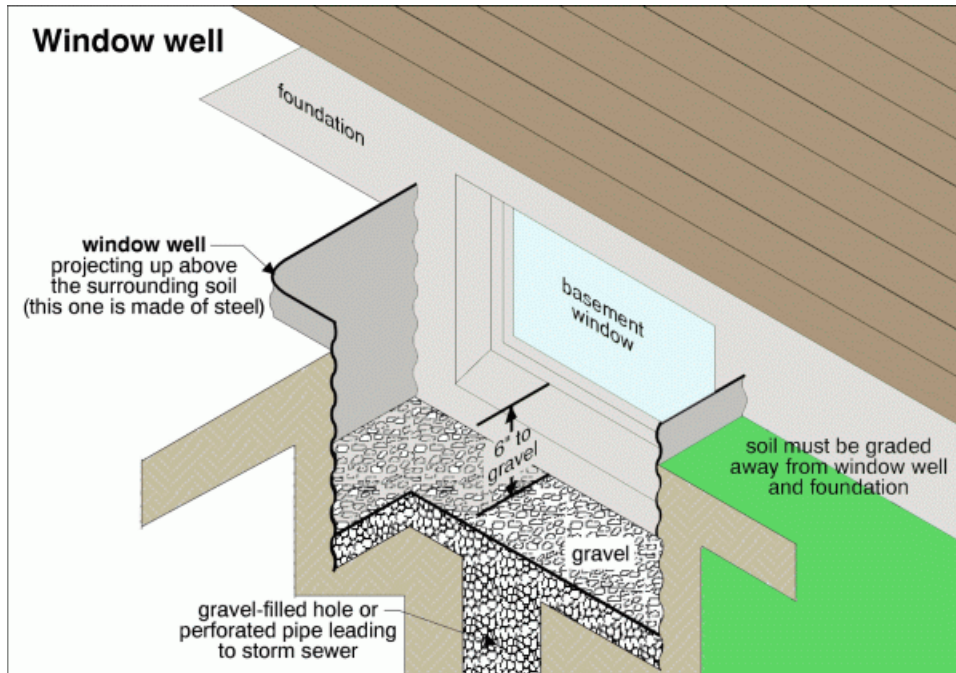
14. Condition: • Missing

Missing window wells throughout exterior improvement needed. These wells are known to prevent precipitation from entering the structure. I recommend these wells to be added to prevent such occurrences. A quality window that will not allow the elements to enter the home should be added at these locations, to prevent water damage to the structure.

Implication(s): Material deterioration | Chance of water damage to structure, finishes and contents

Location: Exterior Wells

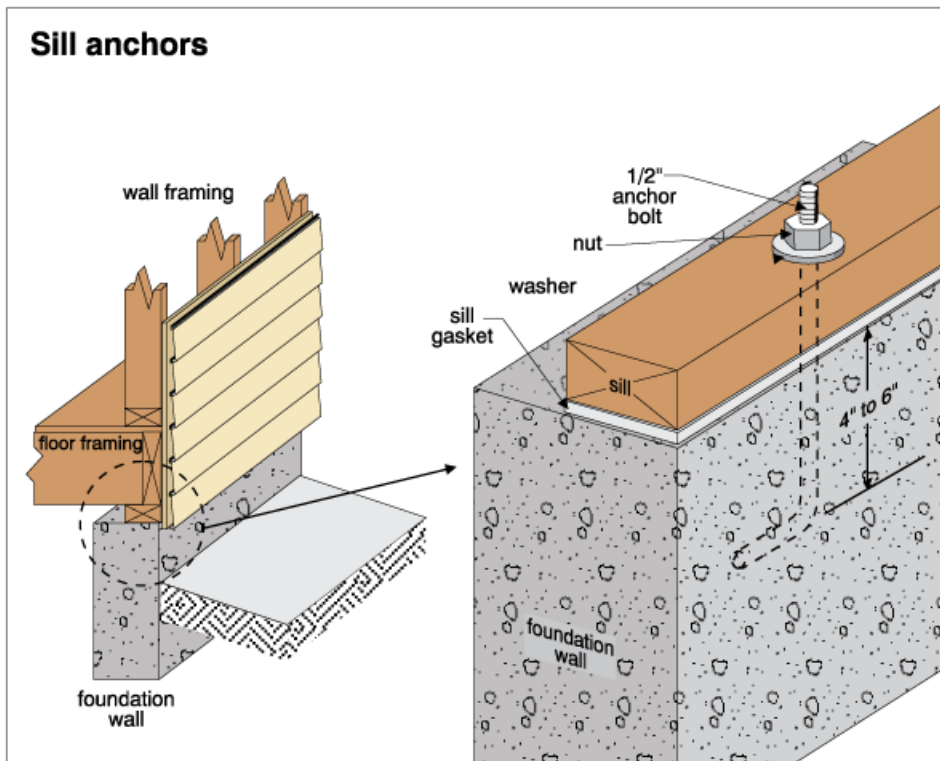
29. Missing

17. Condition: • Anchor bolts missing

R403.1.6 Foundation anchorage. Sill plates and walls supported directly on continuous foundations shall be anchored to the foundation in accordance with this section.

Wood sole plates at all exterior walls on monolithic slabs, wood sole plates of braced wall panels at building interiors on monolithic slabs and all wood sill plates shall be anchored to the foundation with anchor bolts spaced a maximum of 6 feet (1829 mm) on center. Bolts shall be at least 1/2 inch (12.7 mm) in diameter and shall extend a minimum of 7 inches (178 mm) into concrete or grouted cells of concrete masonry units. A nut and washer shall be tightened on each anchor bolt. There shall be a minimum of two bolts per plate section with one bolt located not more than 12 inches (305 mm) or less than seven bolt diameters from each end of the plate section. Interior bearing wall sole plates on monolithic slab foundation that are not part of a braced wall panel shall be positively anchored with approved fasteners. Sill plates and sole plates shall be protected against decay and termites where required by Sections R317 and R318. Cold-formed steel framing systems shall be fastened to wood sill plates or anchored directly to the foundation as required in Section R505.3.1 or R603.3.1.

Location: Rec Room

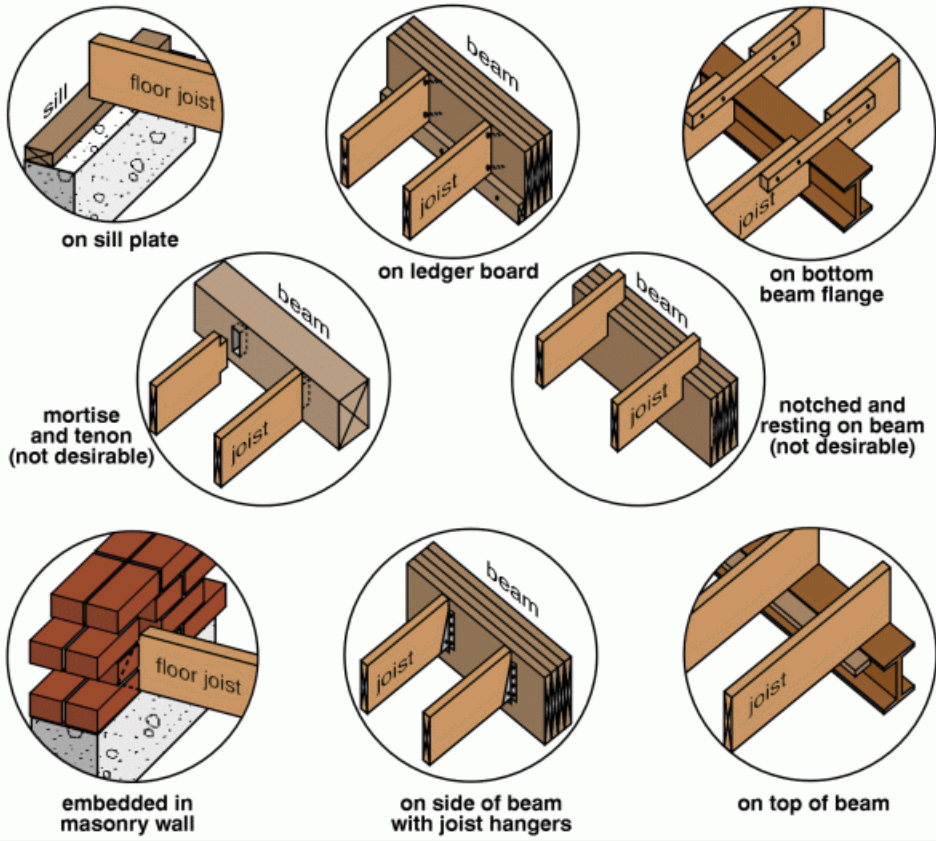
30. Missing

18. **Condition:** • Poor end bearing, joist hanger connections

Joist hangers will provide assurance that the floor will not eventually move causing serious structural damage. I

recommend you contact the general contractor to make any and all repairs as needed.

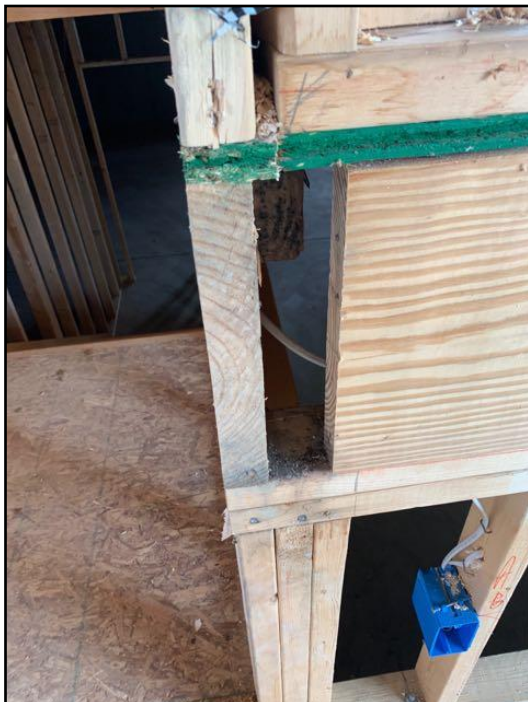
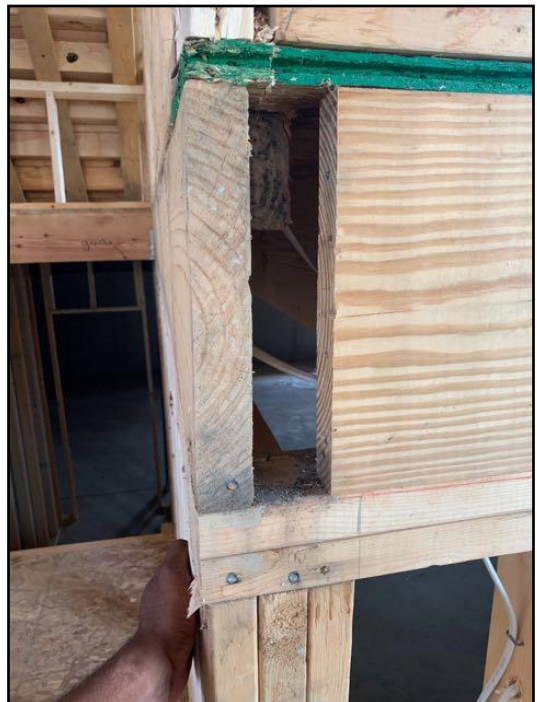
21. Condition: • A section of the rim joist is missing. I recommend contacting the qualified contractors to make the necessary repairs.

Location: Rec room

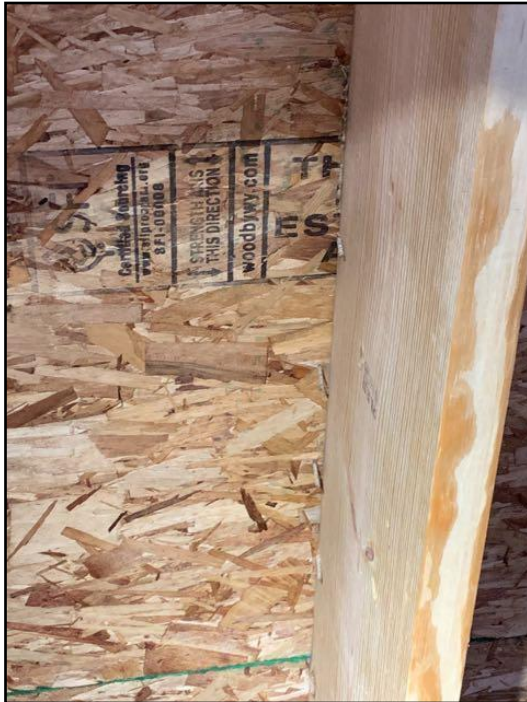
22. Condition: • Improper nail pattern. I recommend verifying with the contractor the fasteners secure the framing members properly.

Location: Floor Joist Various Locations

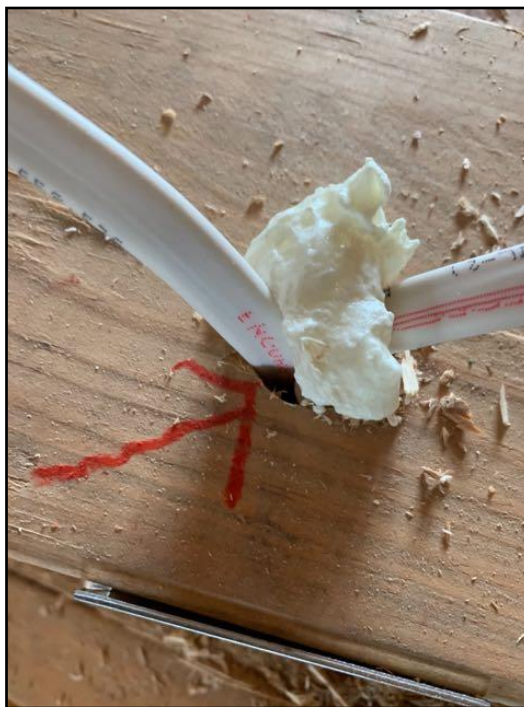
40. *Firestopping missing*

25. Condition: • Firestopping missing

Fireblocks conform to innumerable configurations, depending on the dimensions and location of the concealed space. Section 717 of the IBC is a dedicated section that provides the description of concealed spaces and fireblocking. Section 717.2.1 identifies the materials that are acceptable for use as fireblocks. Fireblocks can be constructed of materials such as 2 inch nominal lumber, structural wood panels, gypsum board, cement fiber board for larger fireblock, and batts or blankets of mineral wool or glass fiber, loose fill insulation, and caulks, sealants, and putties for smaller fireblocks. Similar text appears in the IRC.

Location: Bathroom 2

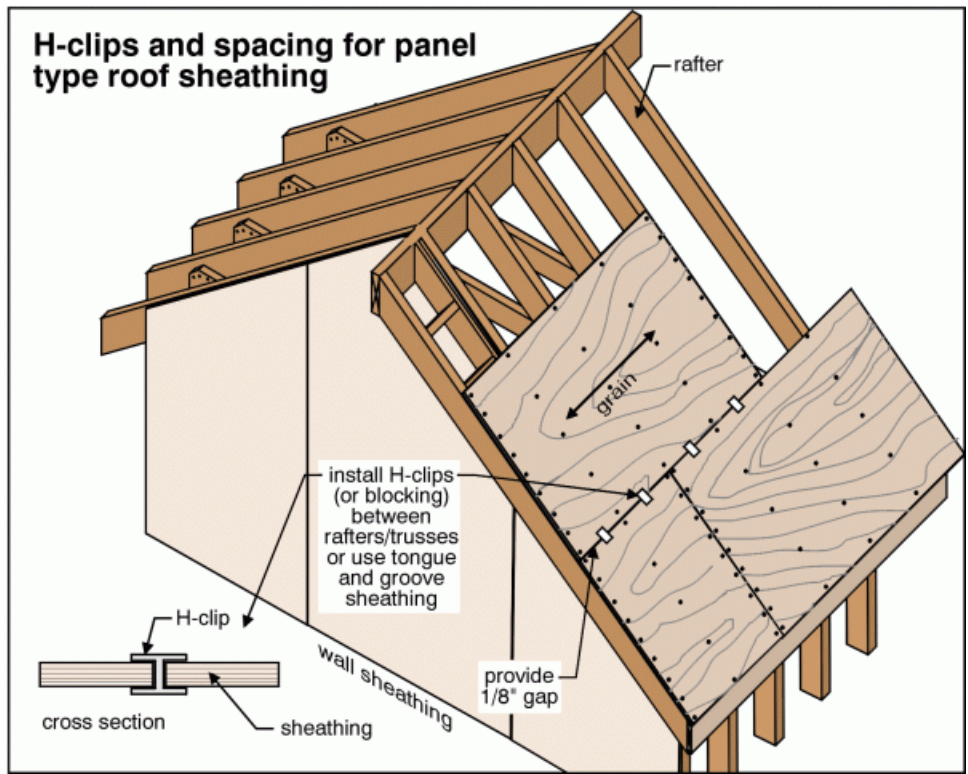
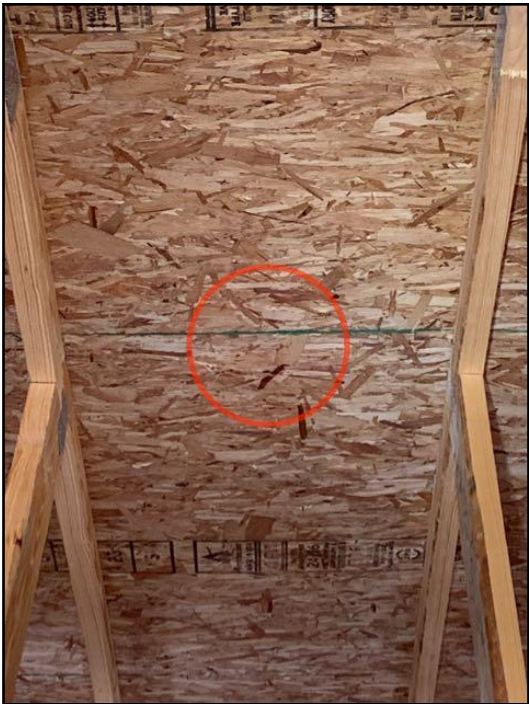
61. H-clips missing

34. Condition: • H-clips missing

Location: Master bedroom

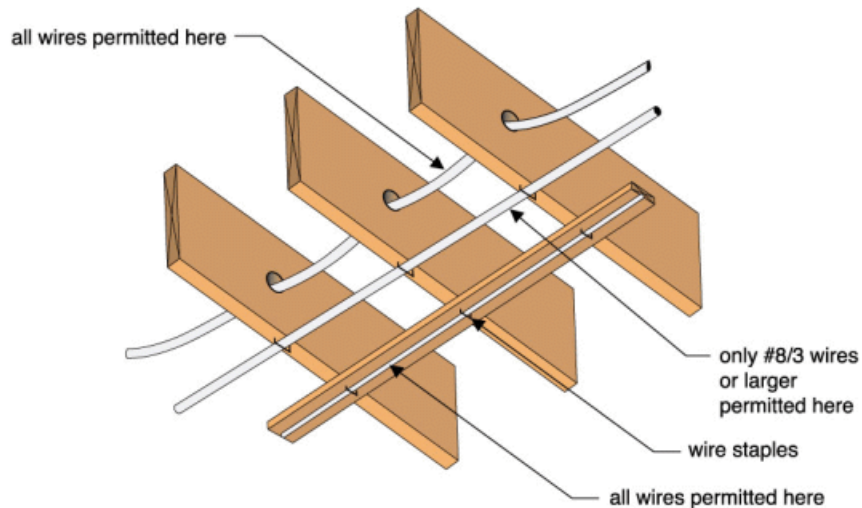
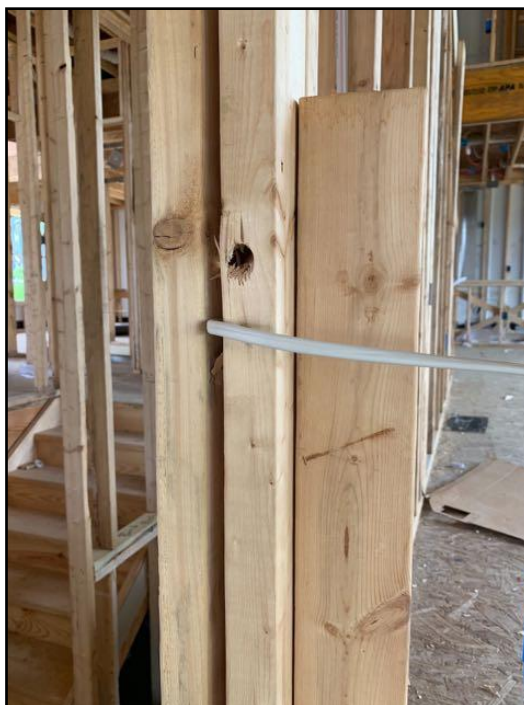
68. Exposed on walls or ceilings

37. Condition: • Exposed on walls or ceilings

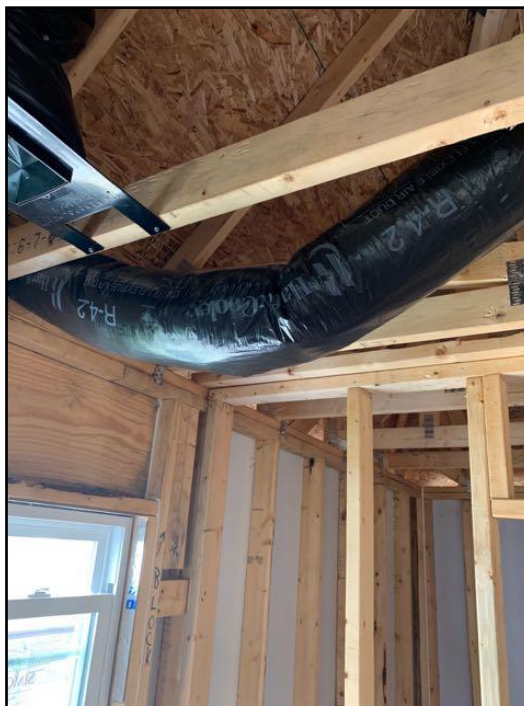
81. The support strap appear to be missing,...

44. Condition: • The support strap appear to be missing, sagging or loose duct runs will cause reduced comfort and restrict airflow if not repaired. I recommend contacting a qualified HVAC contractor to make any and all repairs.

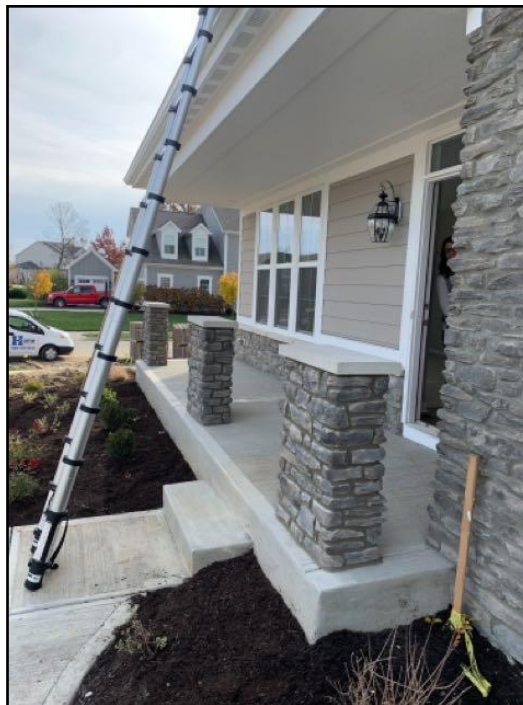
102. *Some areas in the home were under...*

53. Condition: • Some areas in the home were under renovation. Uncompleted or exposed electrical, mechanical, plumbing and/or building materials fixtures and finishes can be a hazard to the occupant. The attached photos show some examples of these areas, I recommend contacting a qualified contractor to get the necessary quotes to finish this project.

Location: Exterior & Interior

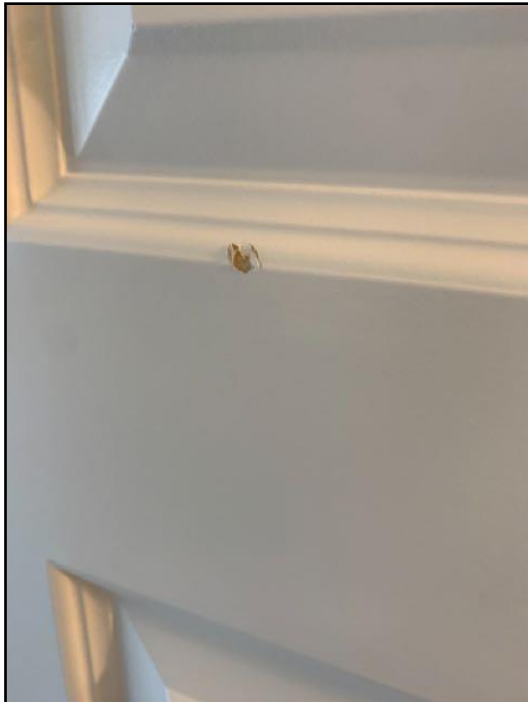
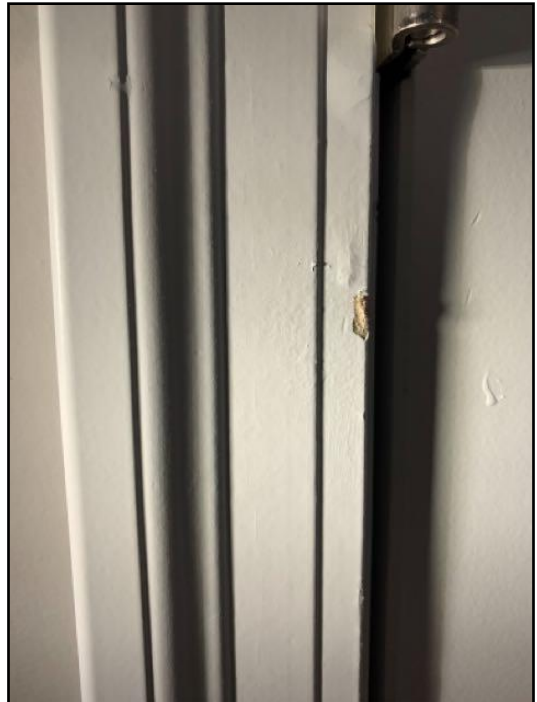
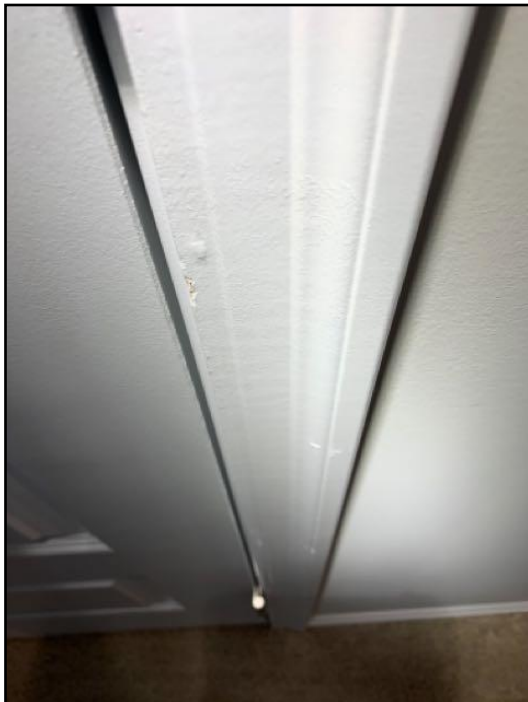
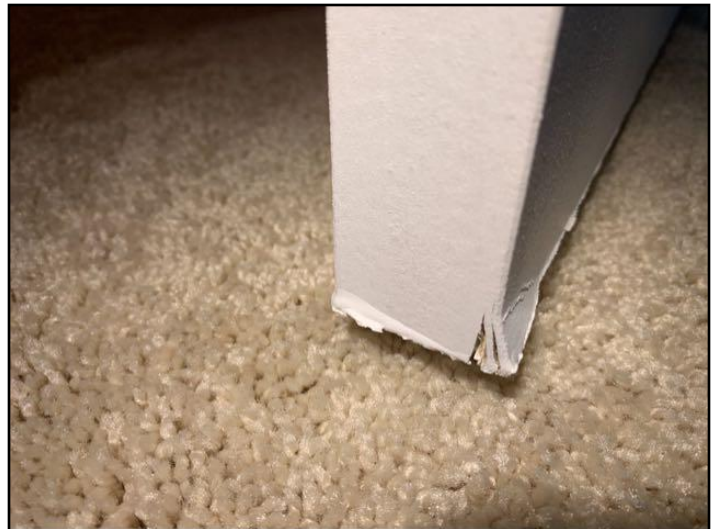
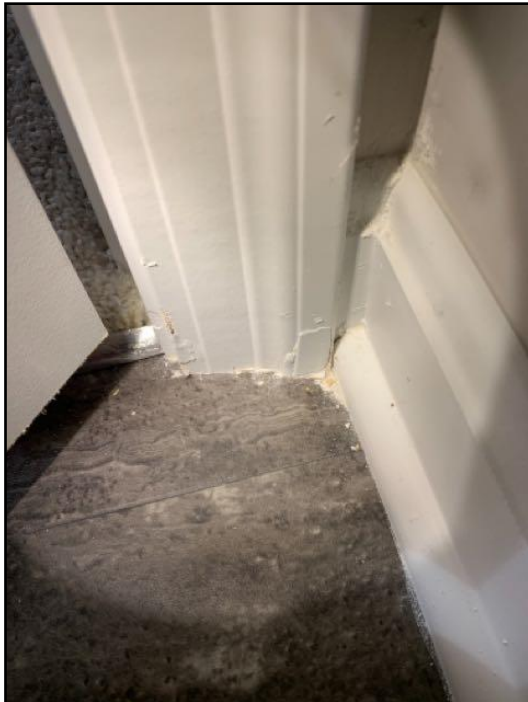
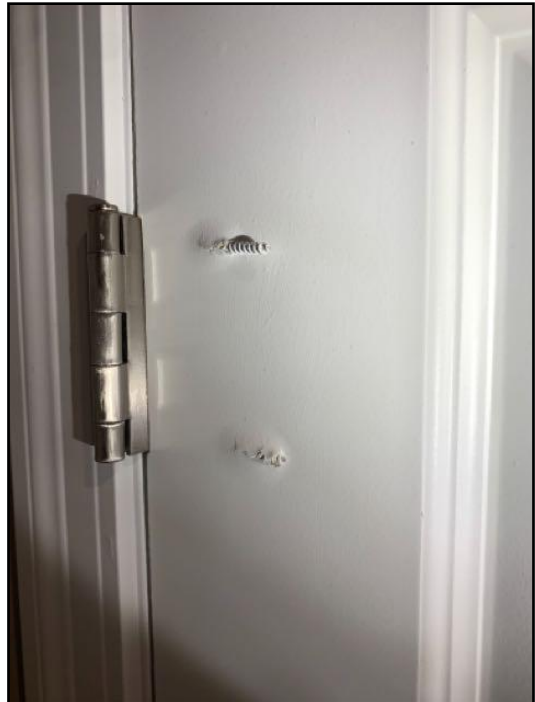
60. Condition: • The door slab has cosmetic defects in the finish, I recommend consulting the current owner to find a remedy for these blemishes.

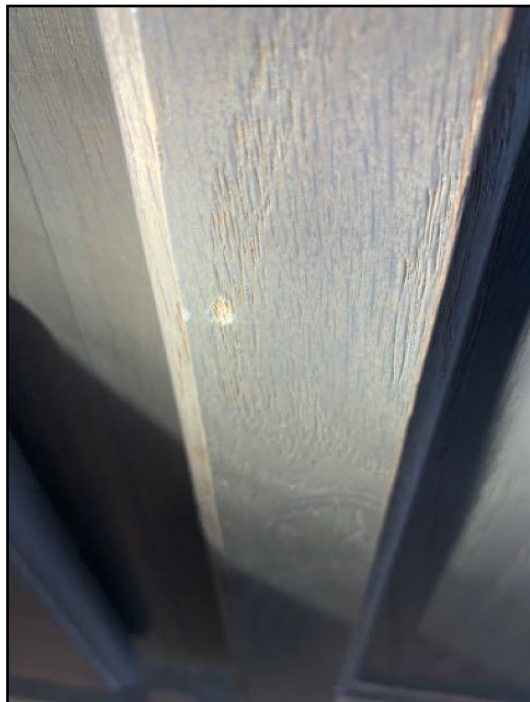
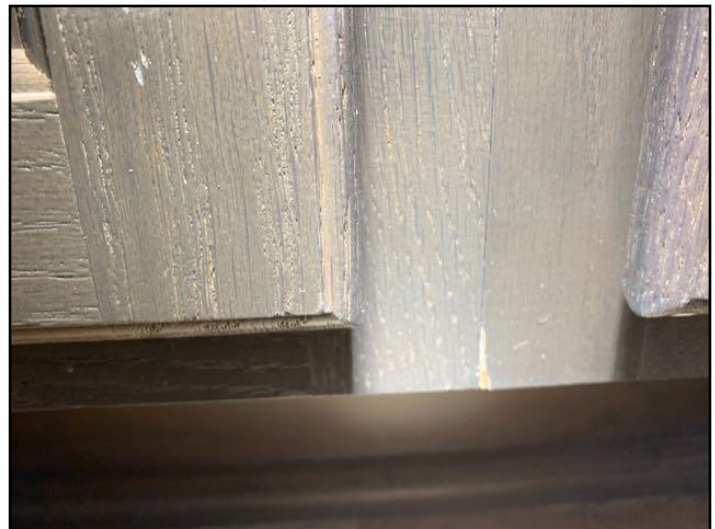
63. Condition: • The cabinets have cosmetic defects in the finish, I recommend consulting the current owner to find a remedy for these blemishes.

Location: Kitchen cabinet

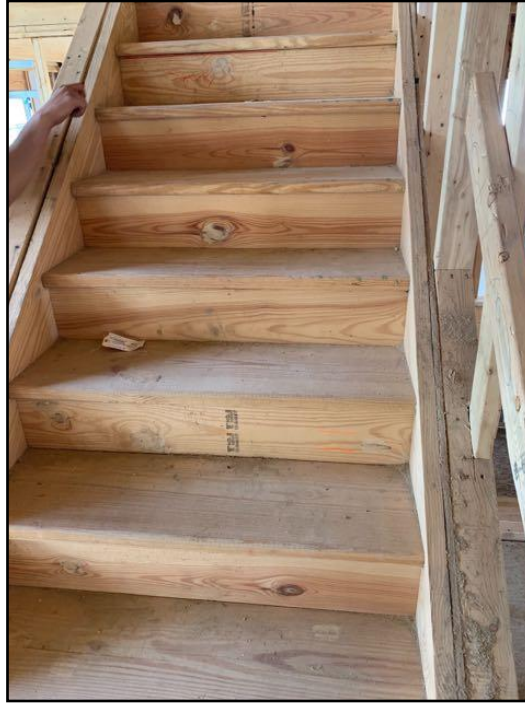
120.

64. Condition: • Tread squeaking is a common issue. There are various industry practices that can remedy this issue, consult your builder for further evaluation

Location: Strairwell
