FINAL ASBESTOS REPORT

SCIOTO VALLEY CTC 951 VERN RIFFE DRIVE
LUCASVILLE, OHIO 45648

ASBESTOS MATERIAL SURVEY

AT Scioto County CTC Taylor Building

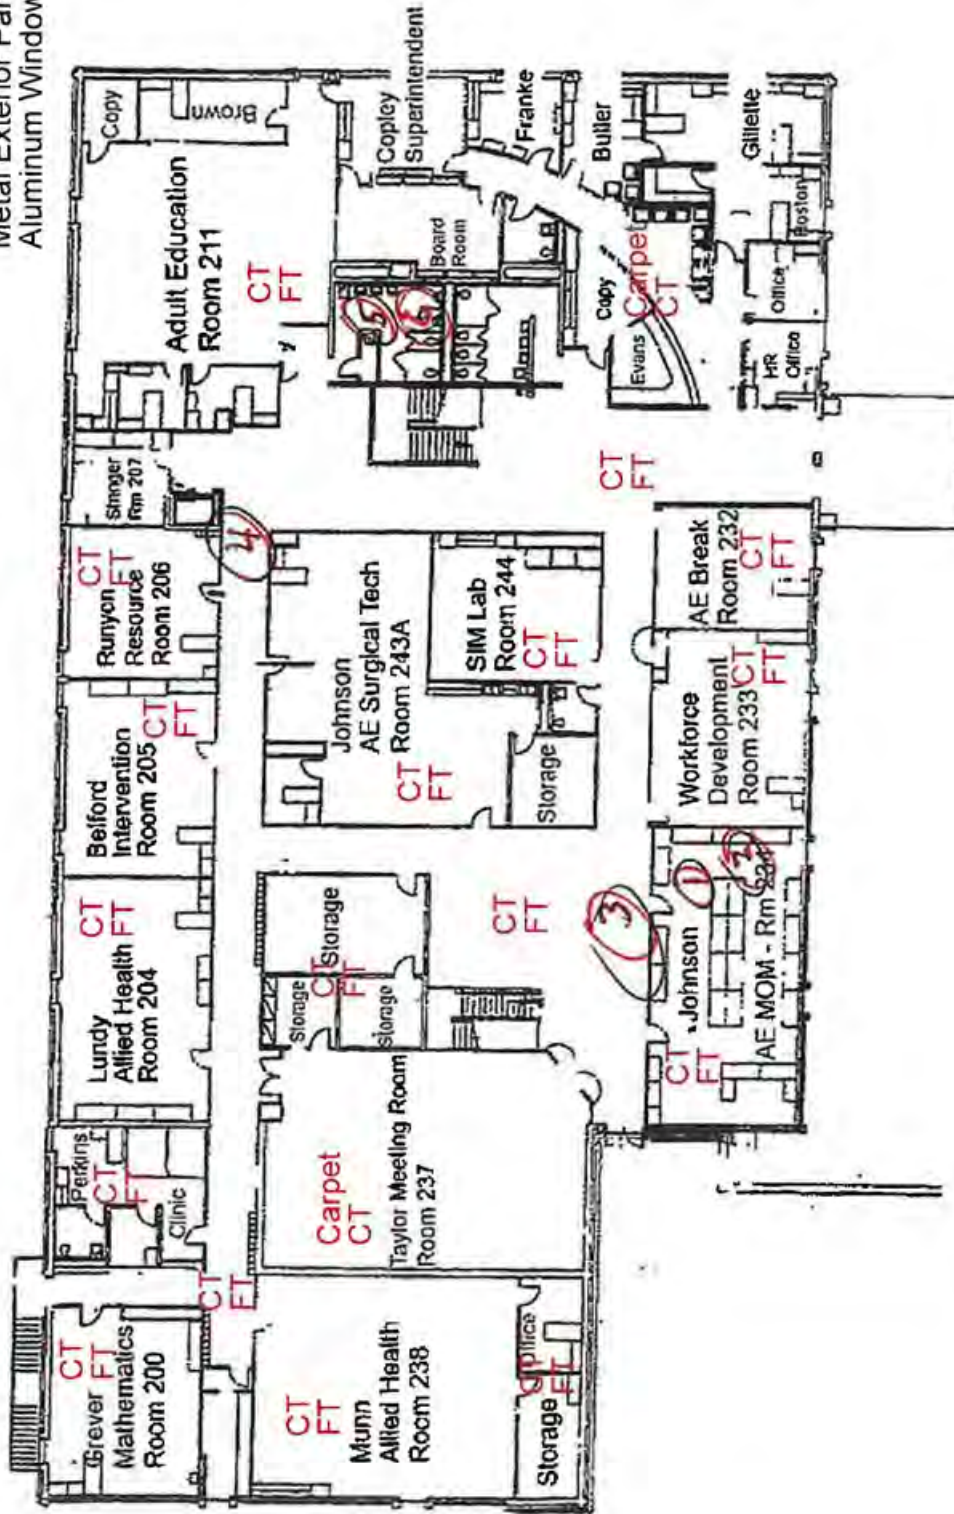
TAYLOR BUILDING UPPER LEVEL

(CT) Ceiling Tiles - Throughout
(FT) Floor Tiles - Throughout
Metal Exterior Panels
Aluminum Windows

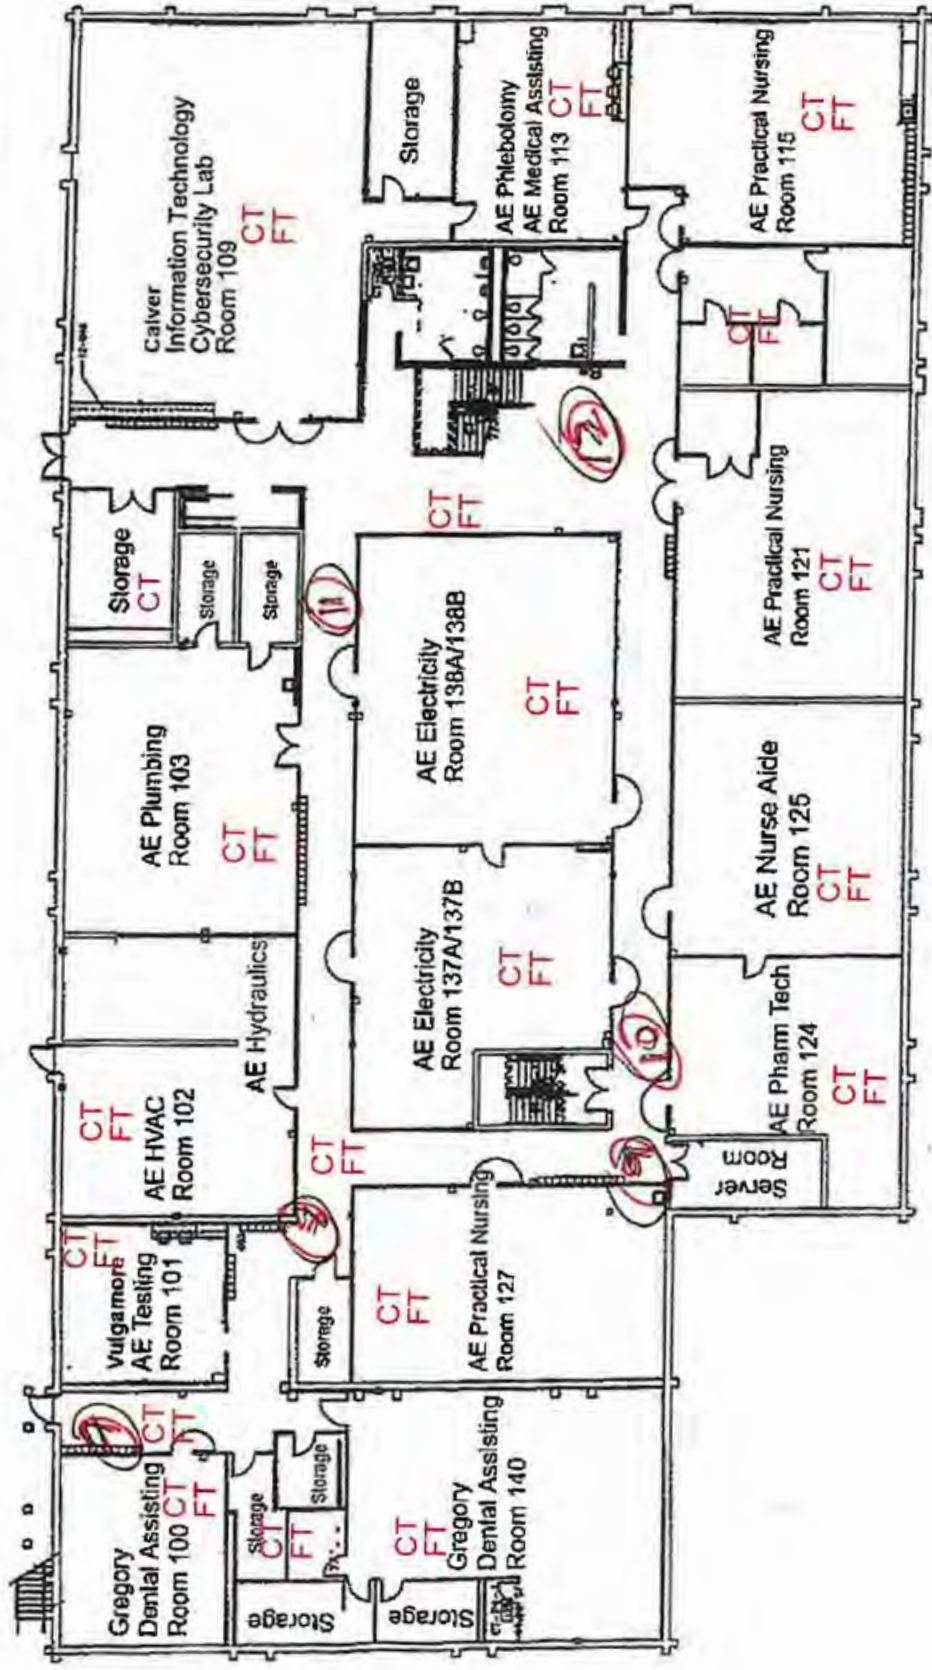
TAYLOR BUILDING LOWER LEVEL FURNITURE PLAN

(CT) Ceiling Tiles - Throughout
(FT) Floor Tiles - Throughout

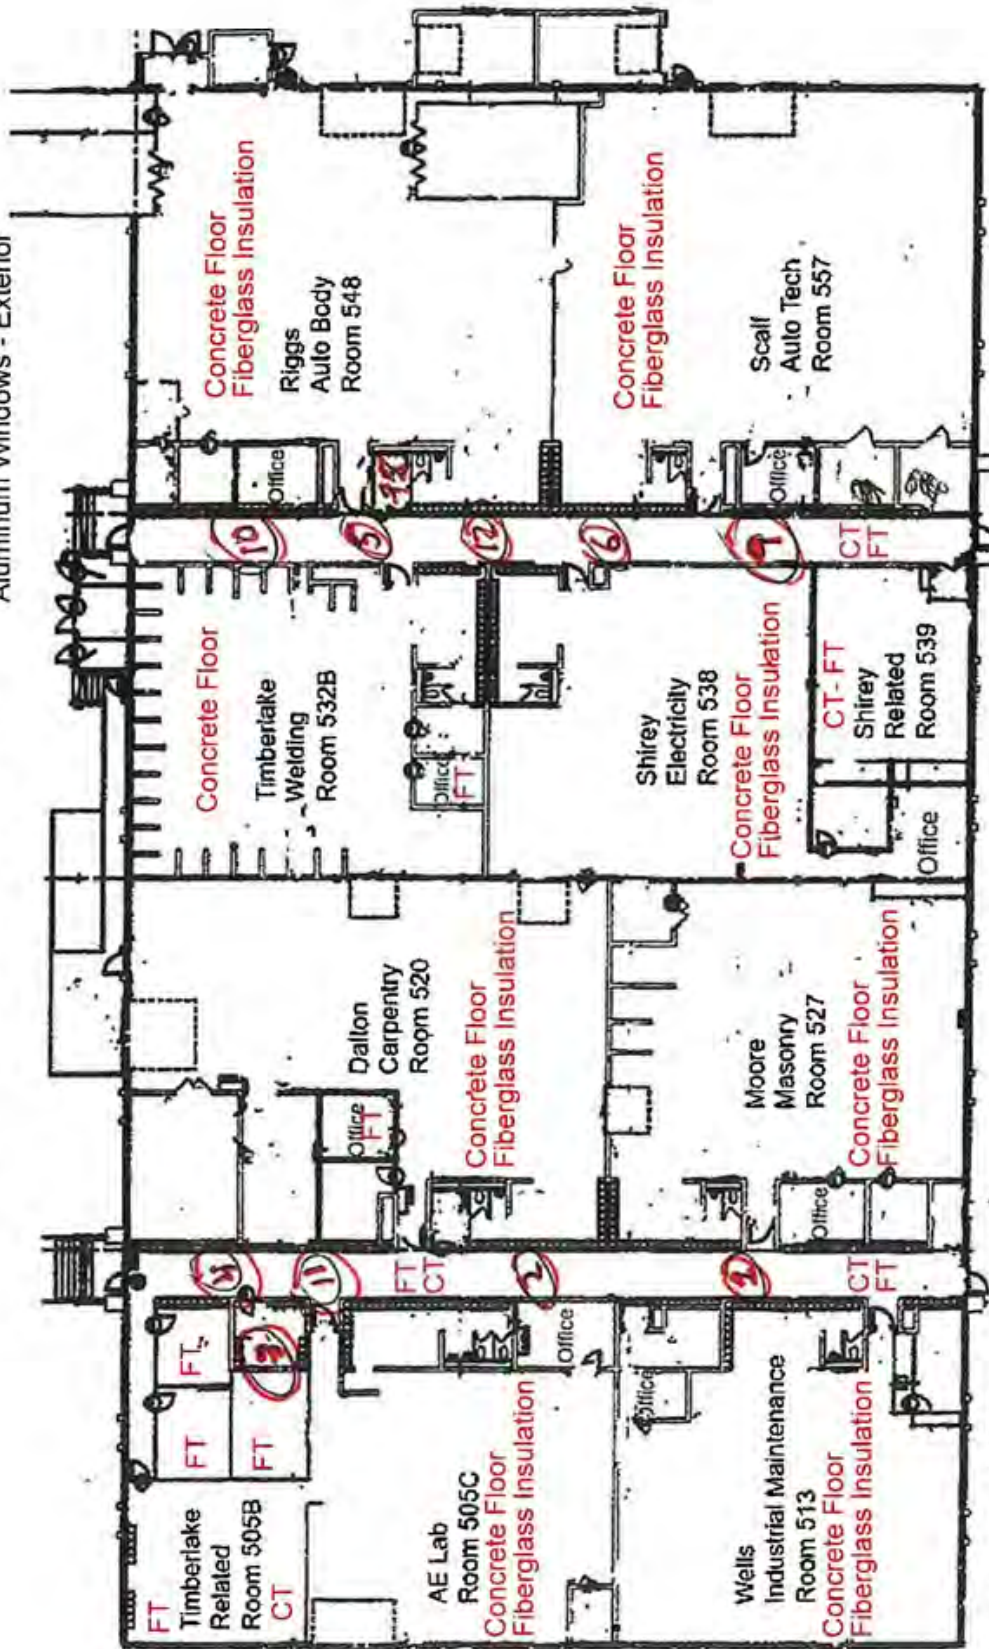
T & I BUILDING

(CT) Ceiling Tiles - Throughout
(FT) Floor Tiles - Throughout
Metal Exterior Panels
Aluminum Windows - Exterior
