Your Inspection Report

6865 Bryne Court
Dublin, OH 43017

Thursday, November 17, 2016

Master Inspector James Jones

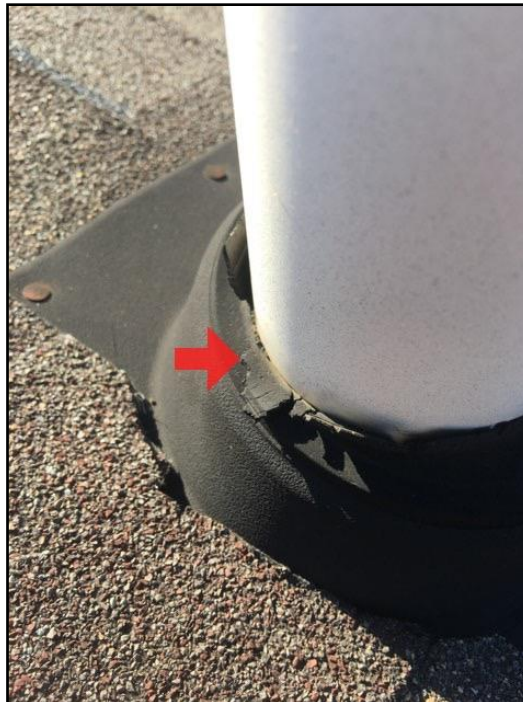
1. *Damage*

Condition: • [Damage](#)

The pipe jack is damaged leaving a opportunity for water damage to enter the structure. I recommend contacting a qualified contractor for any and all repairs.

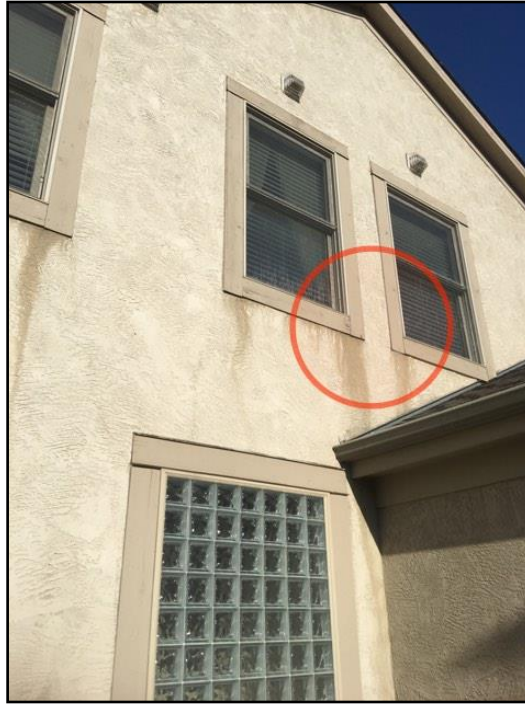
2. Rot

Condition: • Rot

The trim is suffering from a lack of maintenance, cedar does not hold up very well when not maintained regularly. A qualified contractor is recommended to evaluate and estimate repairs.

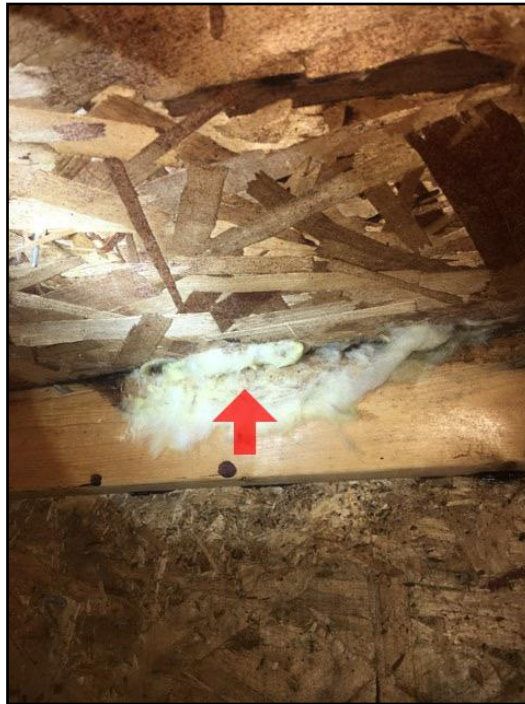
3. Rot

Condition: • [Rot](#)

Moisture has caused damage to the structure. I recommend a qualified contractor be consulted and any and all repairs made as necessary.

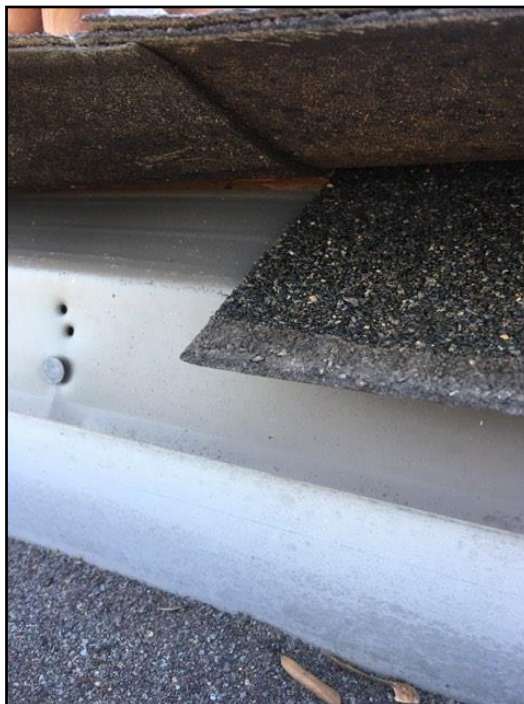
5. Ice and Water shield is a critical componen...

1. Condition: • Ice and Water shield is a critical component to any new roofing system especially in cold weather climates. Many local building codes require Ice and Water shield and The National Building Code states Ice and water shield must start at the roof eave edge and extend 2 ft inside heated wall space of a structure. As the name implies the product is to protect your roof deck in cold and wet situations. When Ice forms and rain or ice melts it can get inside most vulnerable areas where we need to keep it out.

Ice and Water shield is a peel and stick product that adheres directly to the roof deck. It forms a water-proof barrier where ice most often builds up on the eaves edge. It is also commonly applied in the valleys of a house as well as around any roof protrusions including; chimneys, pipe boots, roof vents and skylights. Essentially all the weakest or most prone to leaking areas of a roof should be coated with Ice and Water Shield before installing shingles or any other roofing

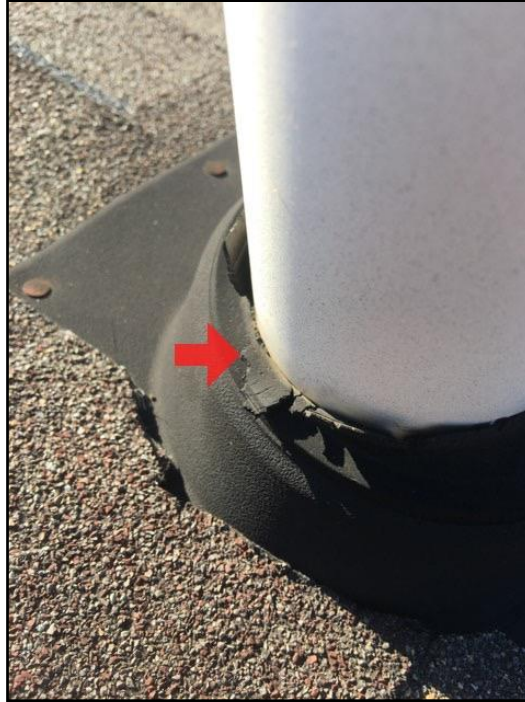
6. *Damage*

2. Condition: • [Damage](#)

The pipe jack is damaged leaving a opportunity for water damage to enter the structure. I recommend contacting a qualified contractor for any and all repairs.

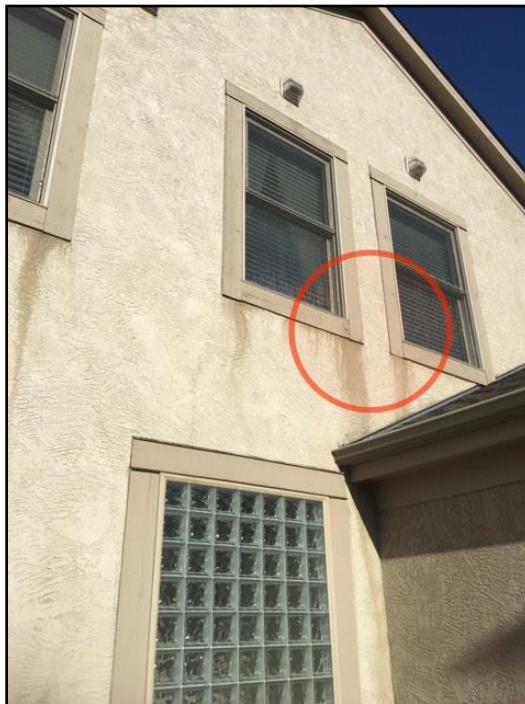
7. Rot

3. Condition: • Rot

The trim is suffering from a lack of maintenance, cedar does not hold up very well when not maintained regularly. A qualified contractor is recommended to evaluate and estimate repairs.

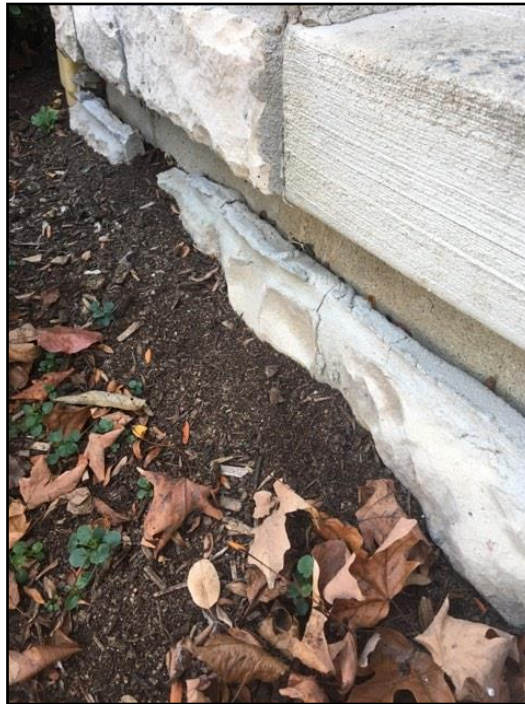
8. *Masonry deterioration*

5. Condition: • [Masonry deterioration](#)

All loose masonry should be repaired, loose masonry allows the chance of water damage to the structure and/or contents. I recommend contacting a qualified professional for further evaluation.

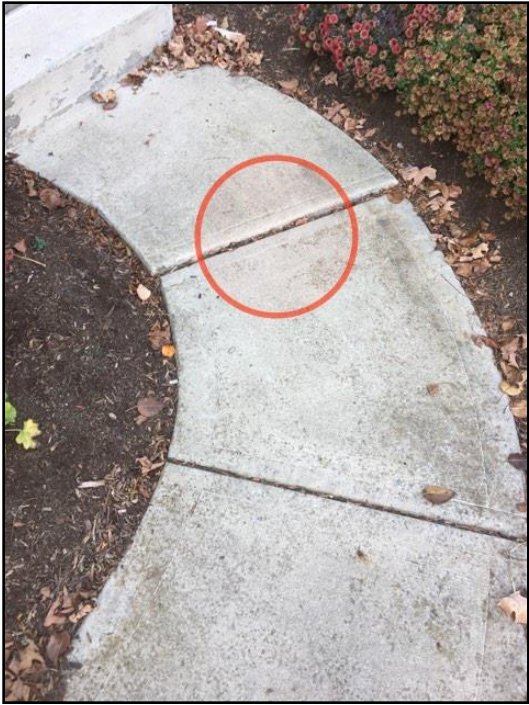
9. Uneven (trip hazard)

6. Condition: • [Uneven \(trip hazard\)](#)

The concrete slab is heaving or settlement causing the slab to drop. Some common causes are the base has failed or washed out, I recommend contacting a qualified contractor to make any and all repairs.

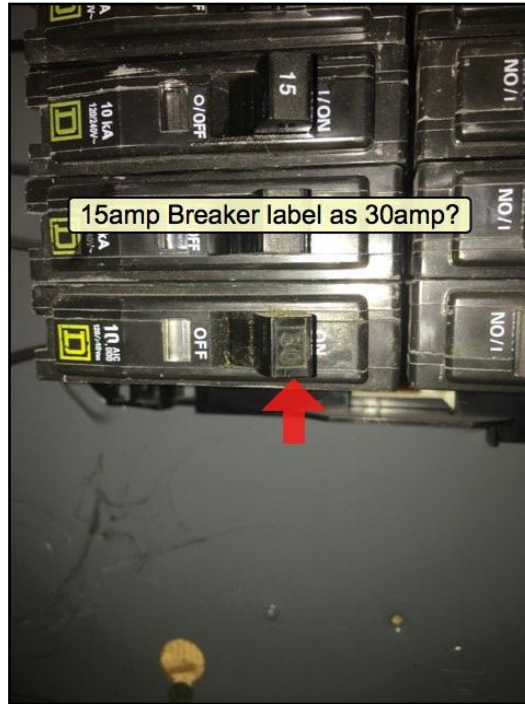
10. Wrong size fuses or breakers for subpanel...

7. Condition: • [Wrong size fuses or breakers for subpanel and feeder](#)

When feeding a device, subpanel or Appliance it it's important to follow the local building codes or the manufacture specifications on the equipment. The breaker/fuse should match the breaker/fuse on the equipment being fed. The wire should be sized accordingly accounting for the distance of the run. The attached URL will provide you with the necessary information to size the wire & breaker properly. <http://www.ci.east-palo-alto.ca.us/ArchiveCenter/ViewFile/Item/168>When

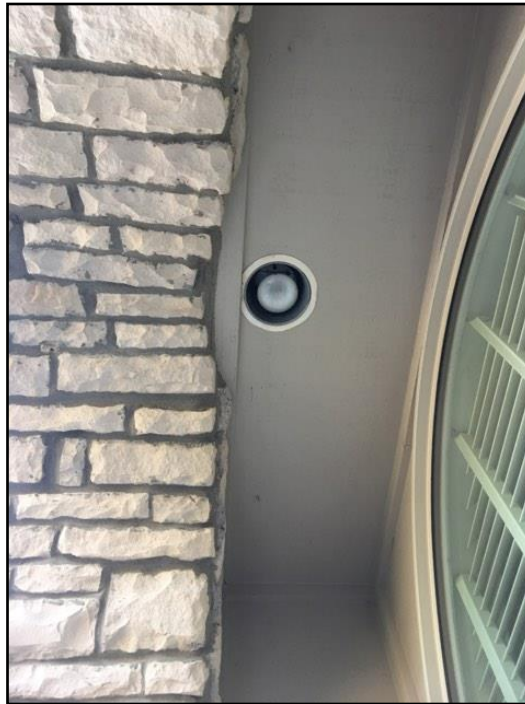
11. *Inoperative*

8. Condition: • [Inoperative](#)

Bulbs maybe blown or the fixture is Inoperative further evaluation needed requests disclosure.

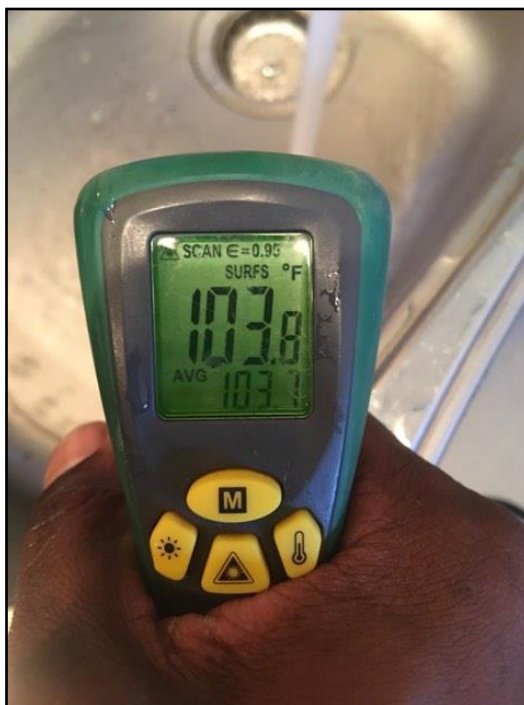
23. Water Temp

- Water heater approximate age:** • 16 years
- Typical life expectancy:** • 8 to 12 years
- Water heater failure probability:**
 - [Low](#)
- Water Temperature lower than average may need adjustment at the tank.

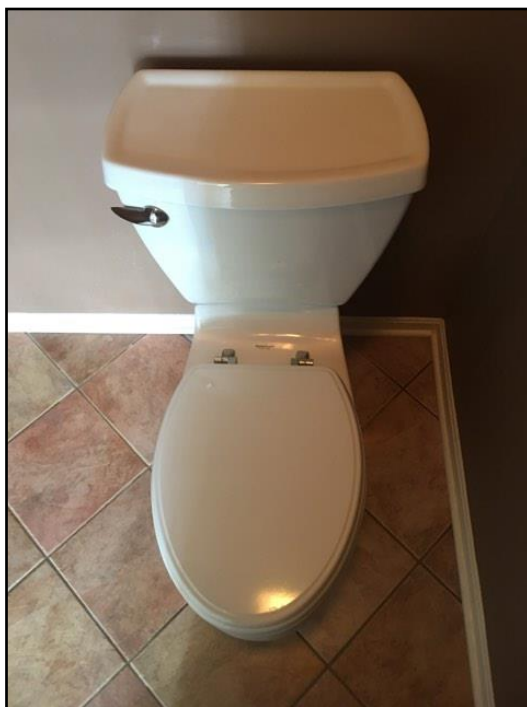
24. Loose

9. Condition: • Loose

The loose toilet needs reset there were no water stains found. If this problem is left unattended it could cause damage to the structure. I recommend a qualified professional make repairs as necessary.

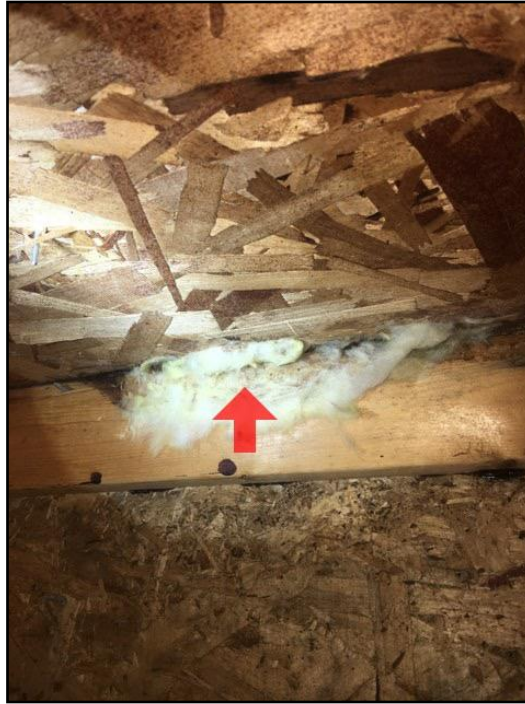
25. Rot

10. Condition: • [Rot](#)

Moisture has caused damage to the structure. I recommend a qualified contractor be consulted and any and all repairs made as necessary.

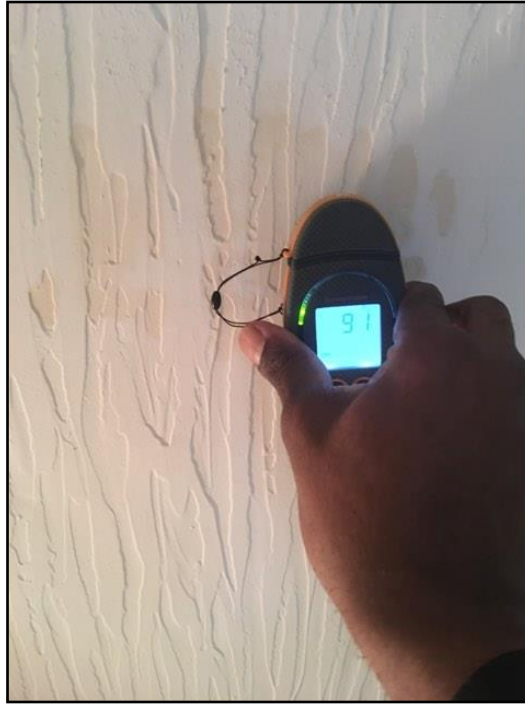
26. (Water Stains OK) Water stains were...

11. Condition: • (Water Stains OK)

Water stains were present. The spot was checked with the " Protometer" Moisture Meter. Although there was no leaking or elevated moisture content found at this time, inspections are limited and exhaustive or destructive inspections are excluded. Future leaks may be found and should be repaired as needed. Verify that this is not a problem with the current owner.

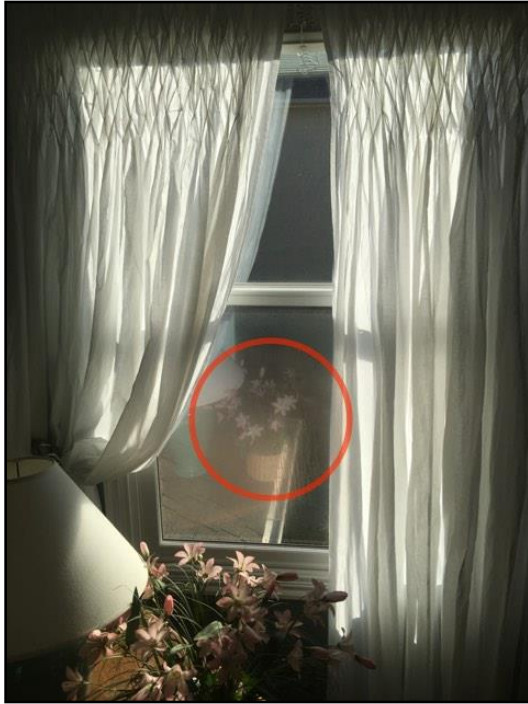
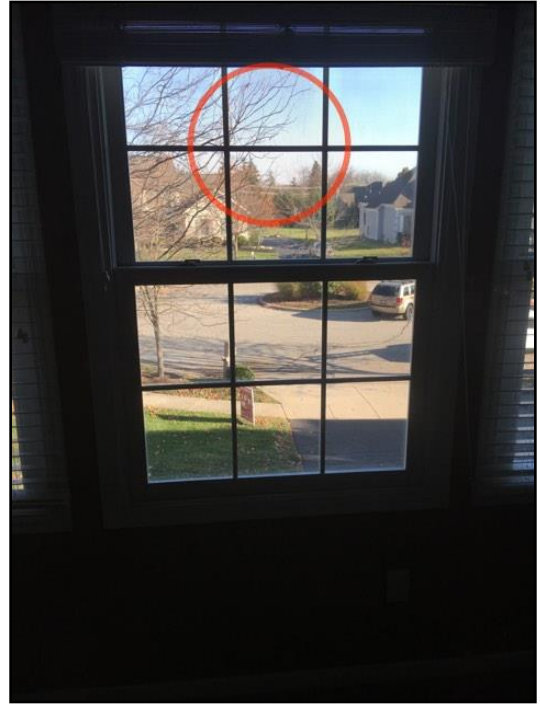
12. Condition: • Fogging or other moisture between the panes of glass which indicates a broken seal was found. Repairs are recommended. Signs of lost seals in the thermal pane windows may appear and disappear as temperature and humidity changes. Some windows with lost seals may not have been evident at time of this inspection. The windows were checked for obvious fogging. I recommended all windows be inspected by a window contractor for further lost seals.

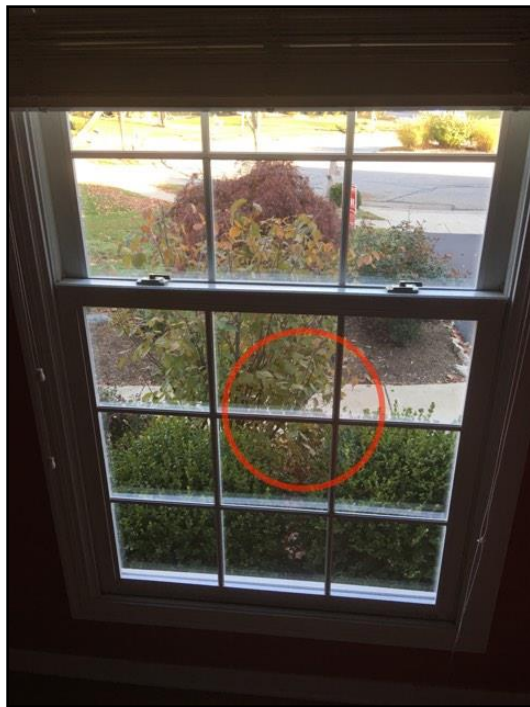
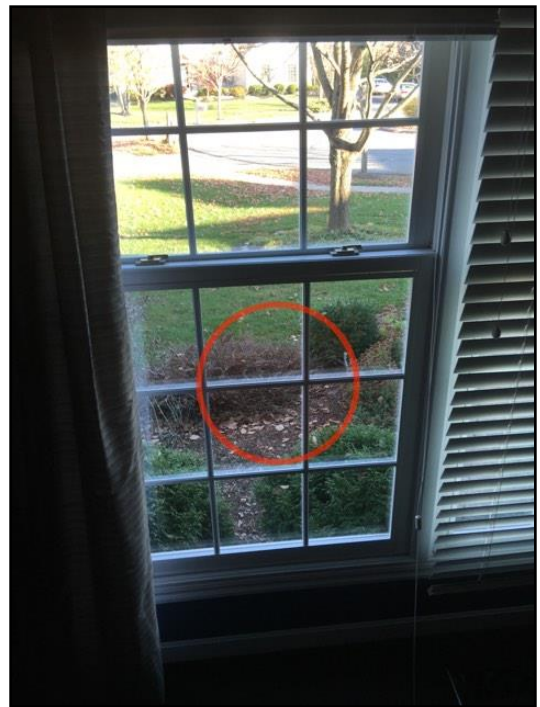
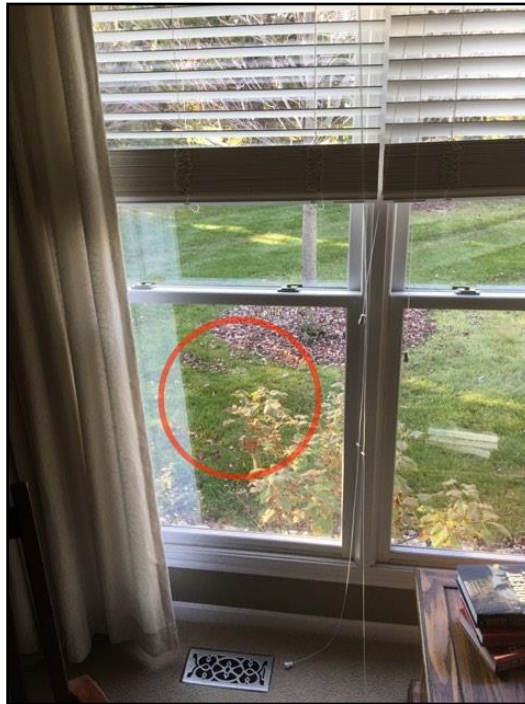
13. Condition: • [Won't stay open](#)

The spring or sash cord in the side of the window is not connected and allows the window to close partially when released. If both sides are broken the window can slam closed very quickly and harm anything beneath it. Correction of the spring or sash cord by a qualified person is recommended for safety of children and adults.

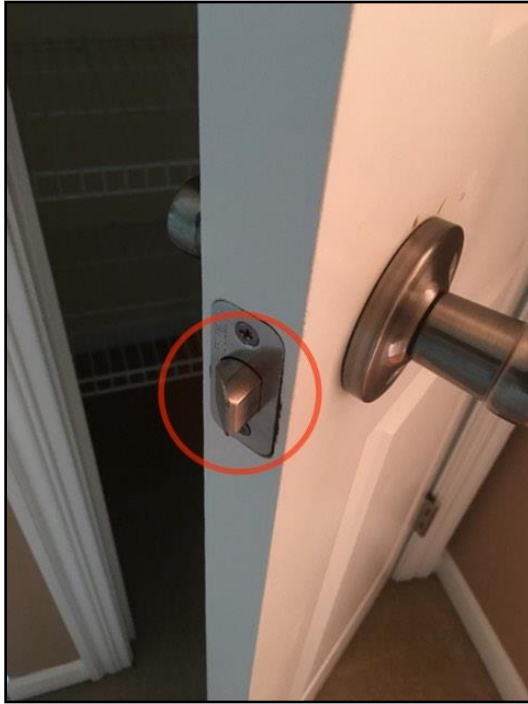
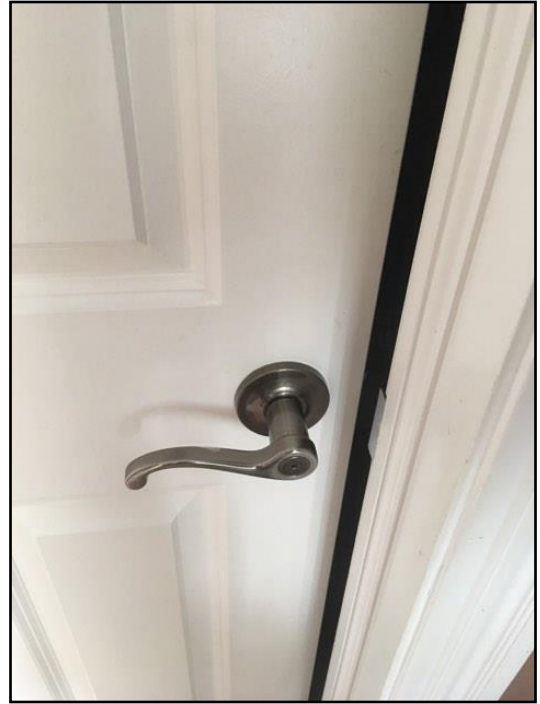
14. Condition: • Does not latch properly

The interior door doesn't latch properly, I recommend the door be repaired.
