Your Inspection Report

10717 Honeysuckle Way
Plain City, OH 43064

RE: Report No. 4534, v.2
10717 Honeysuckle Way
Plain City, OH
43064

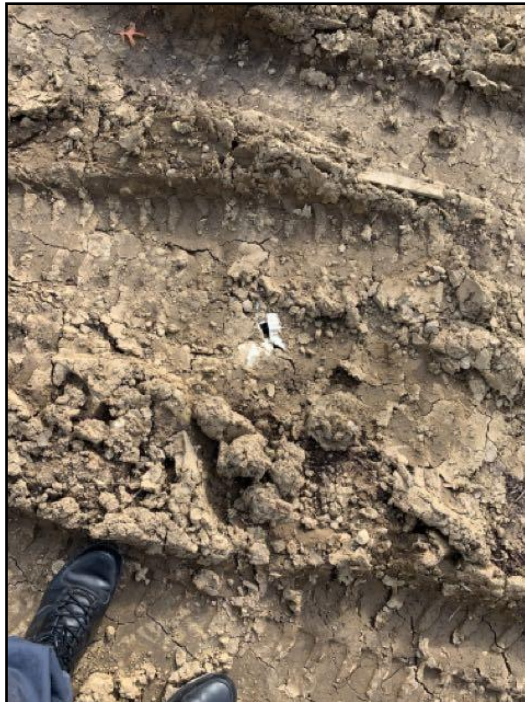
4. *Damage*

4. Condition: • Damage

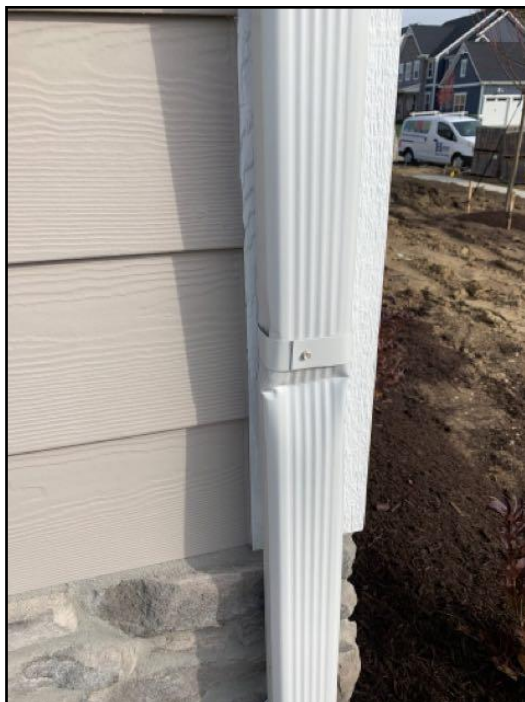
5. *Damage*

5. Condition: • Damage

Location: Rear left corner

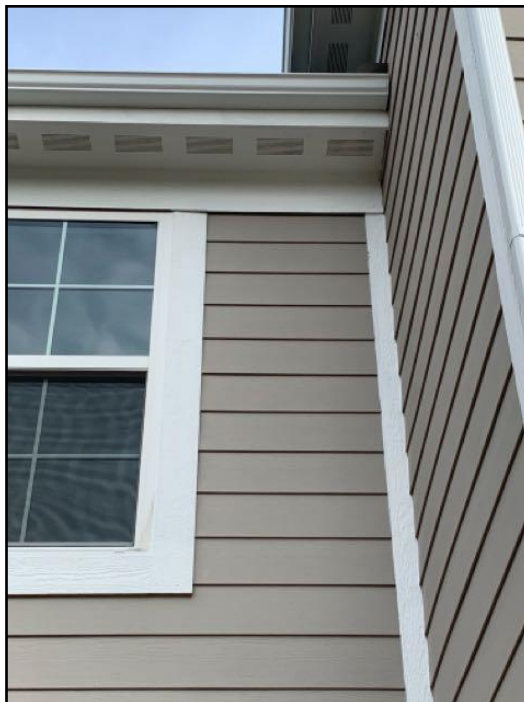
Location: Rear Exterior Upper Elevation Inside Corner

6. The exterior trim has cosmetic defects in...

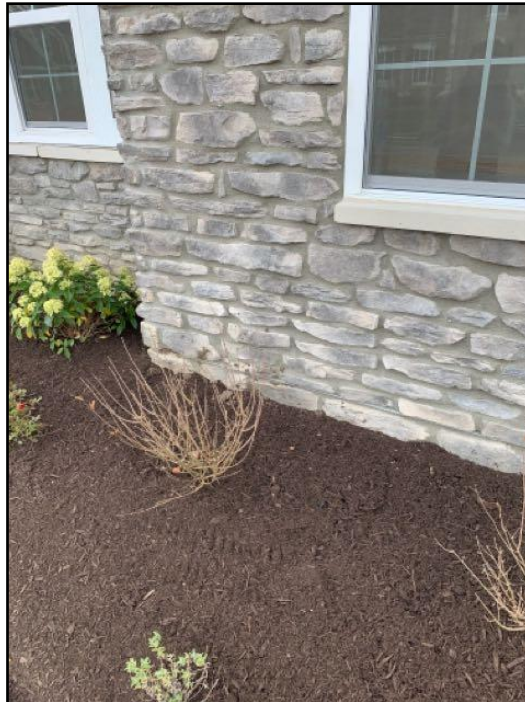
11. *Missing, ineffective weep holes or flashings*

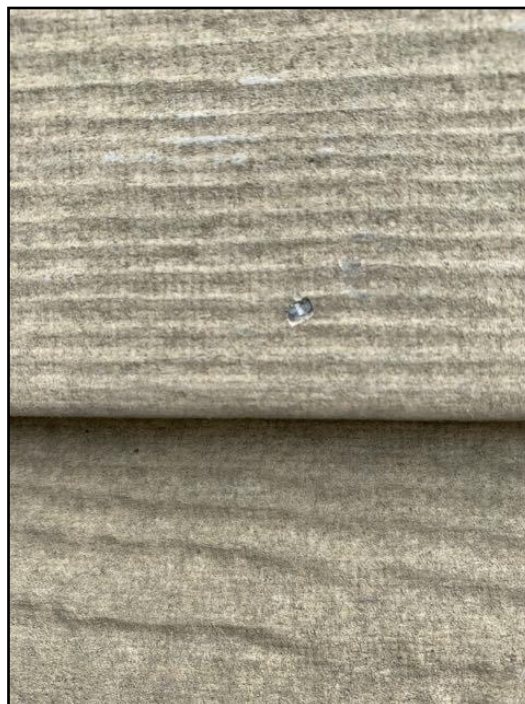
21. Nailing problems

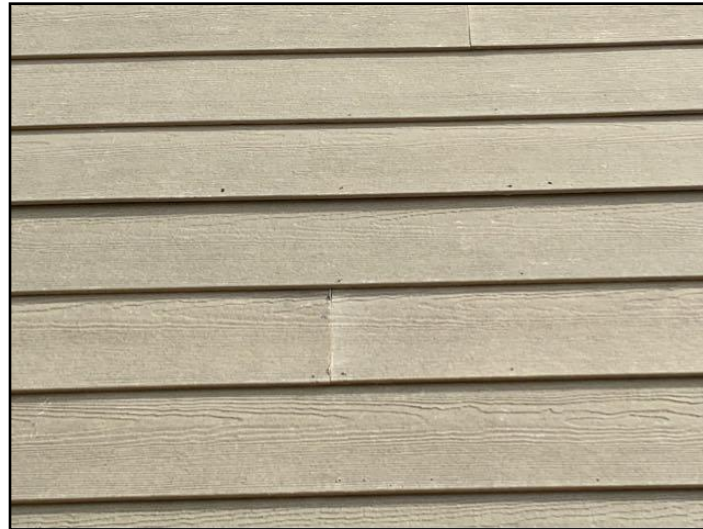
22. Nailing problems

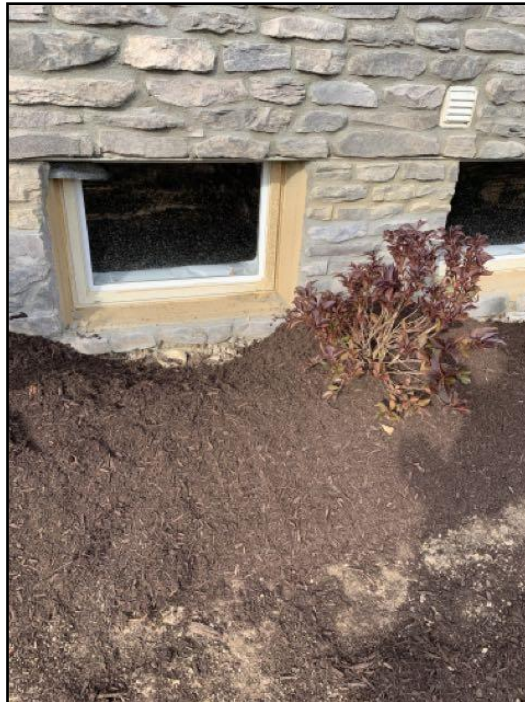
23. A window well is the area outside a...

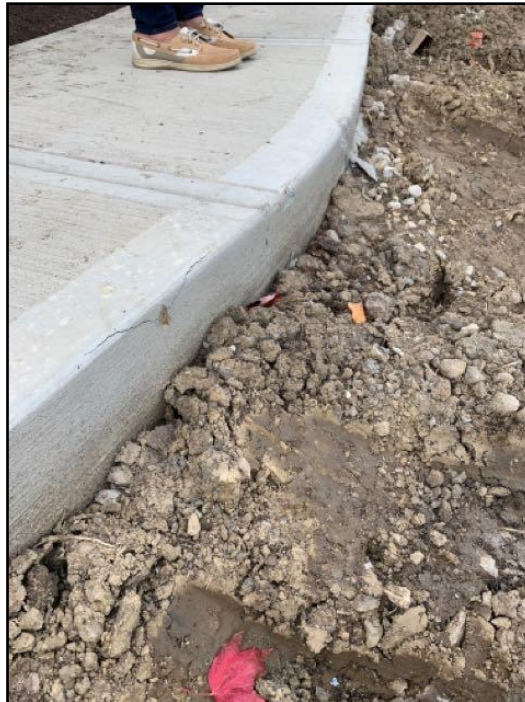
24. Cracked or damaged surfaces

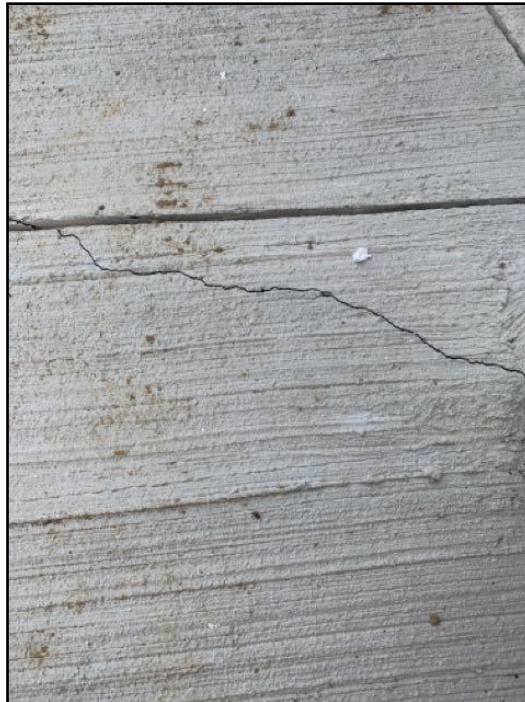
25. *Cracked or damaged surfaces*

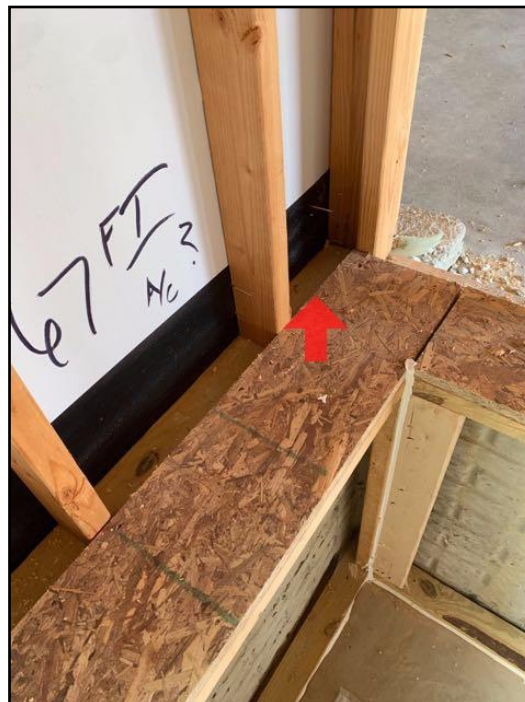
Location: Rec Room

29. Missing

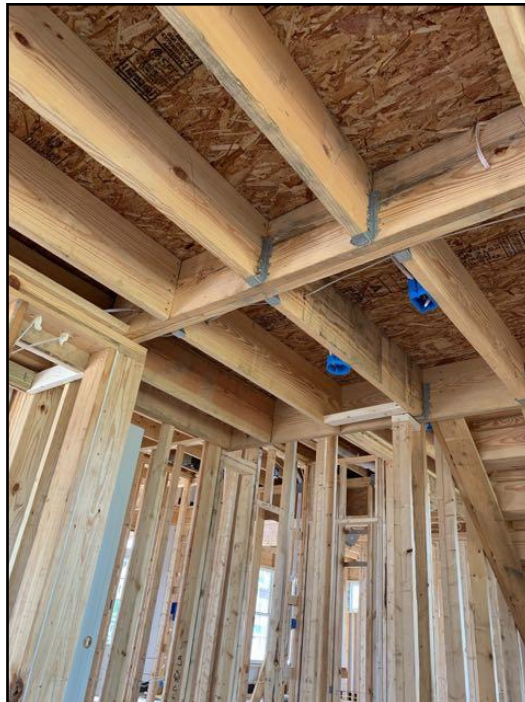
30. Missing

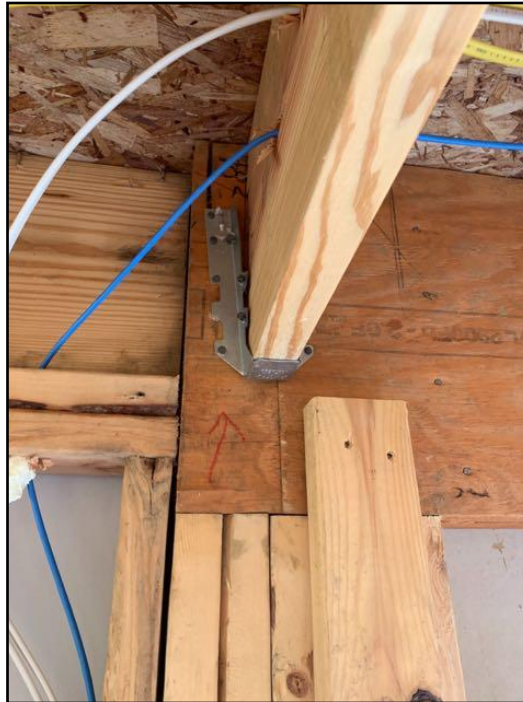
19. Condition: • Hangers and straps should be secured, each nail opening is required to have the proper fastener. I recommend the strap or hanger installation be reviewed and the necessary corrections made.

Location: Garage Joist Hunger

31. *Hangers and straps should be secured, each...*

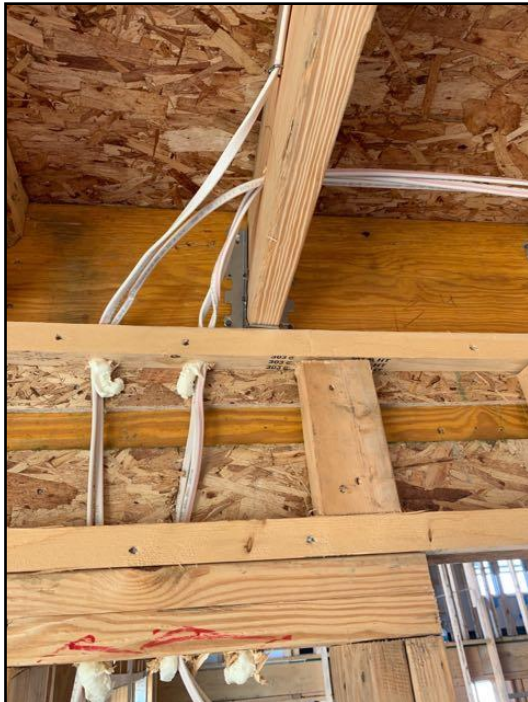
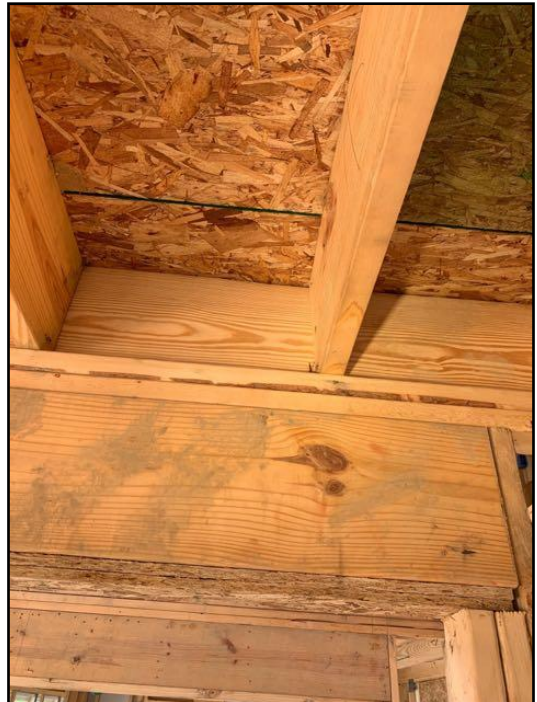
20. Condition: • The Joist is missed aligned. Building materials that are not square, plumb or level can cause structural issue when the structure begins to settle. I recommend correcting these issues to produce a quality building product.

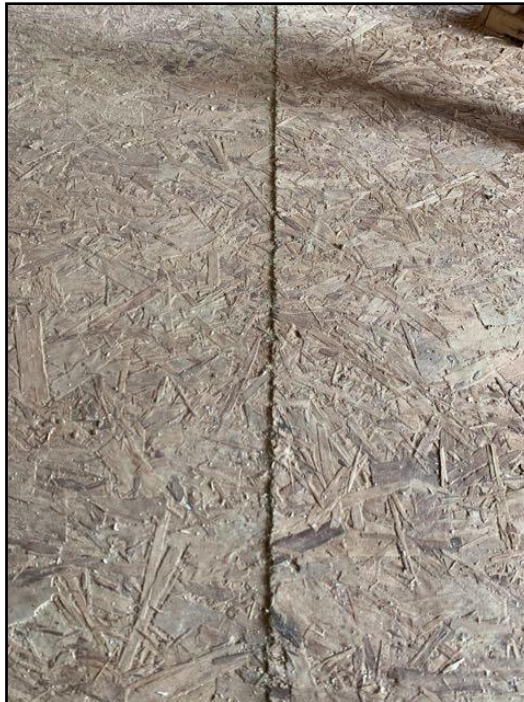
38. *The subfloor is the foundation for the wood...*

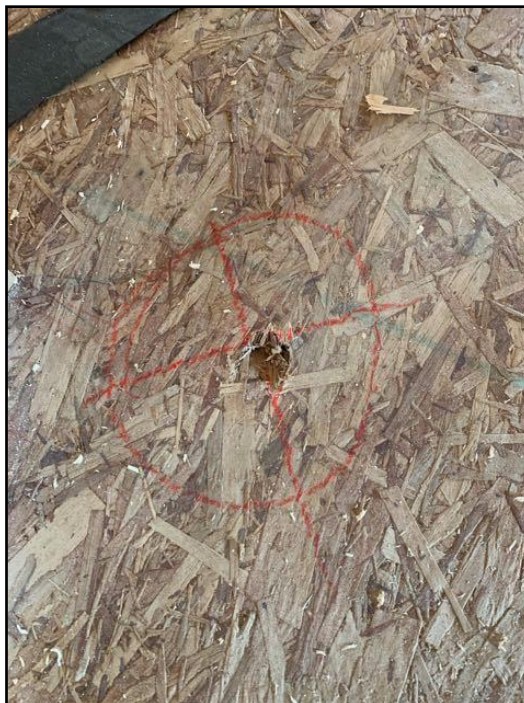
39.

24. Condition: • blank note

Location: Floor Various Locations

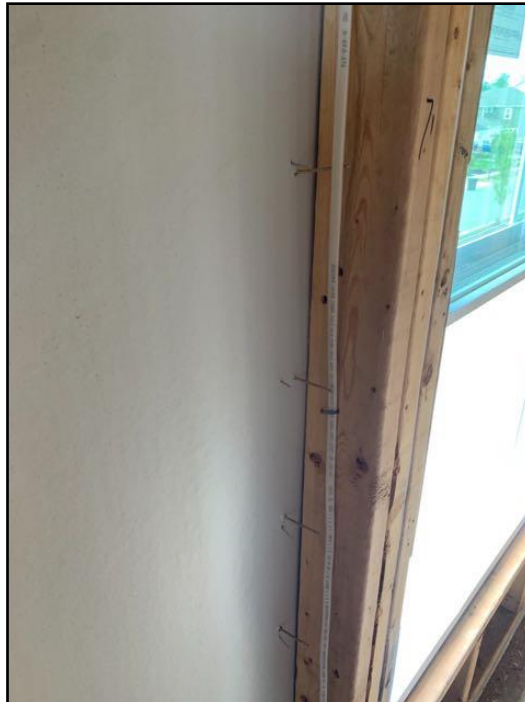
41. Poor nailing

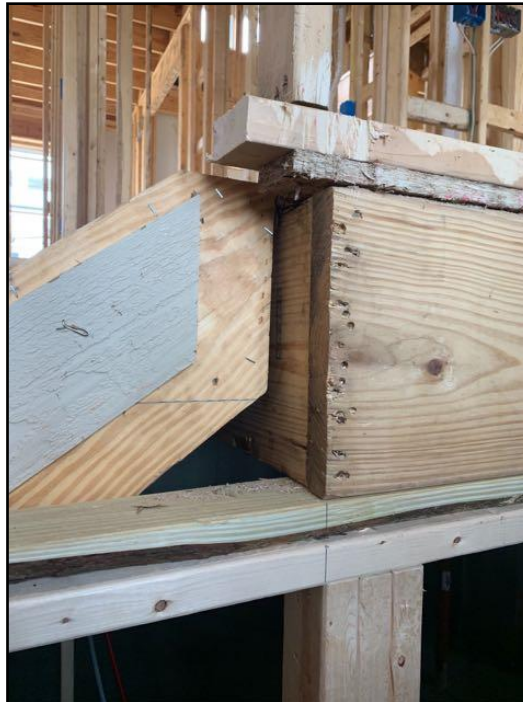
27. Condition: • Offset excessive

Location: Strairwell

42. *Offset excessive*

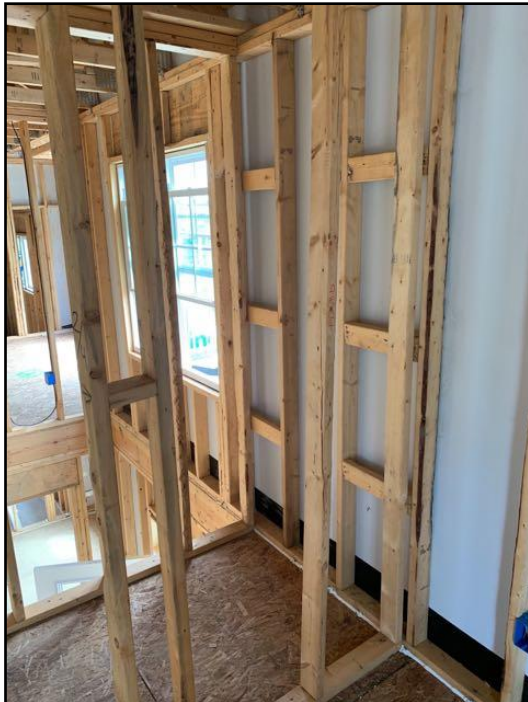
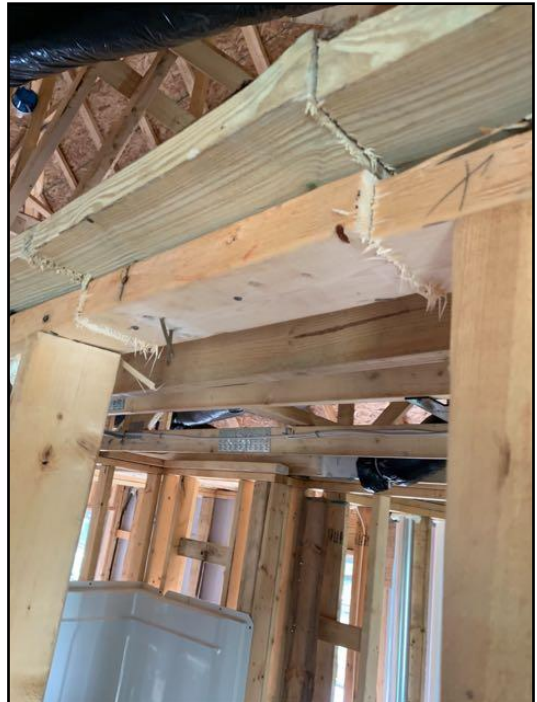
Location: Master Bedroom Tray Ceiling, Great Room, Study, Second Floor Evaluation Great Room, Bedroom 3, Bedroom 4

43. Mechanical damage

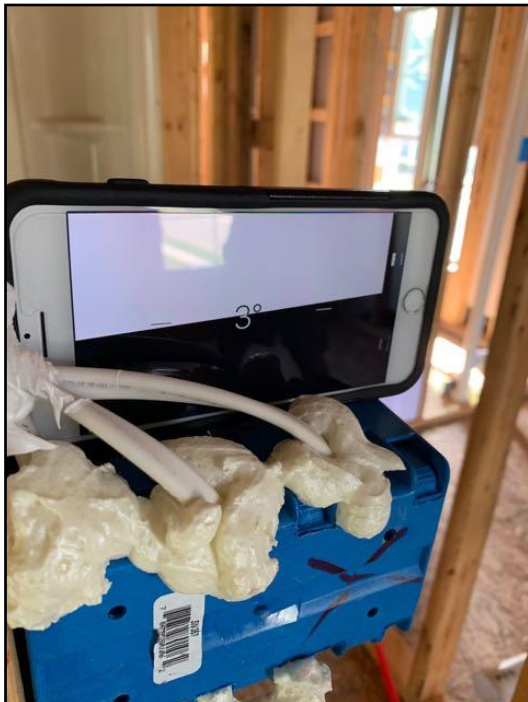
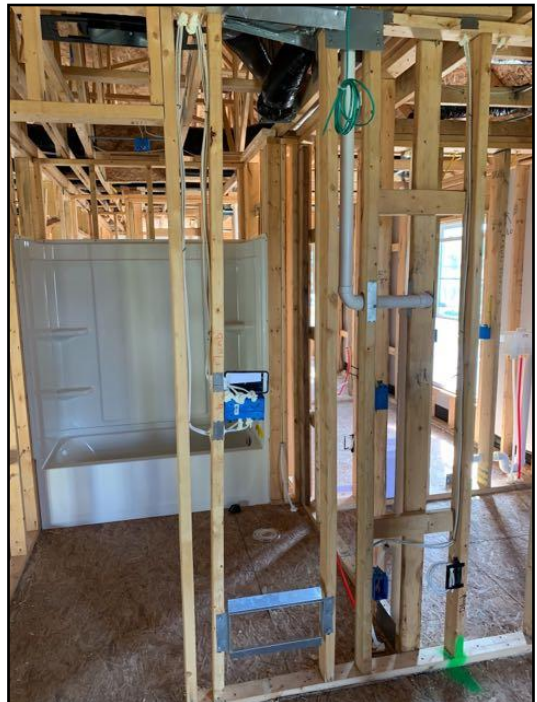
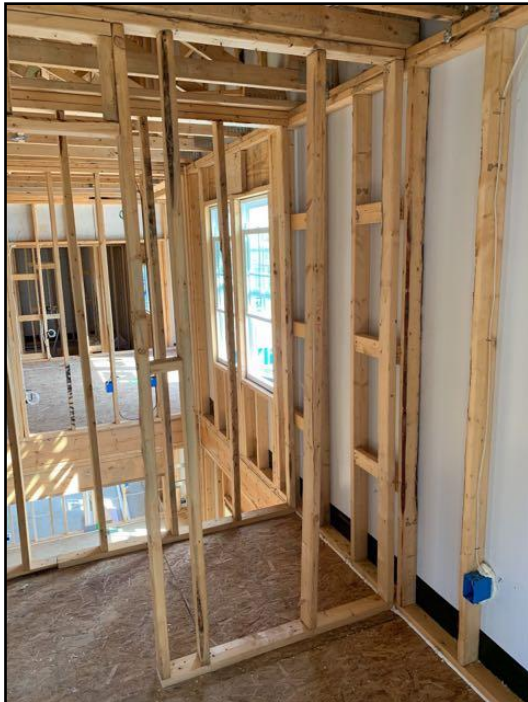
45. Leaning, bowing, buckling

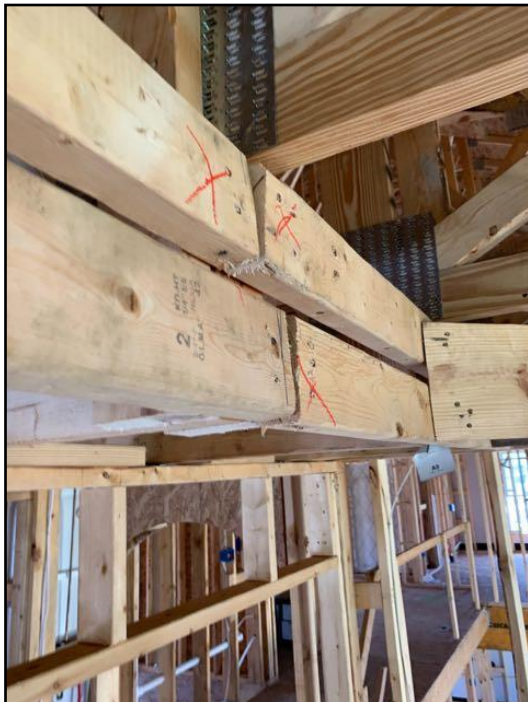
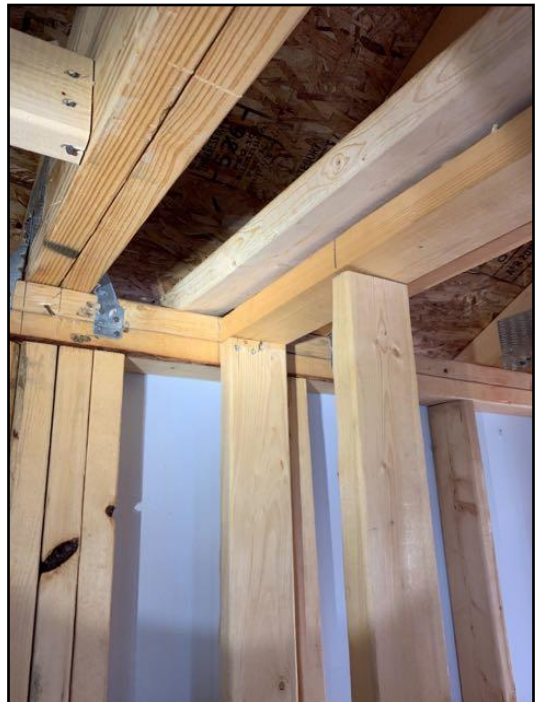
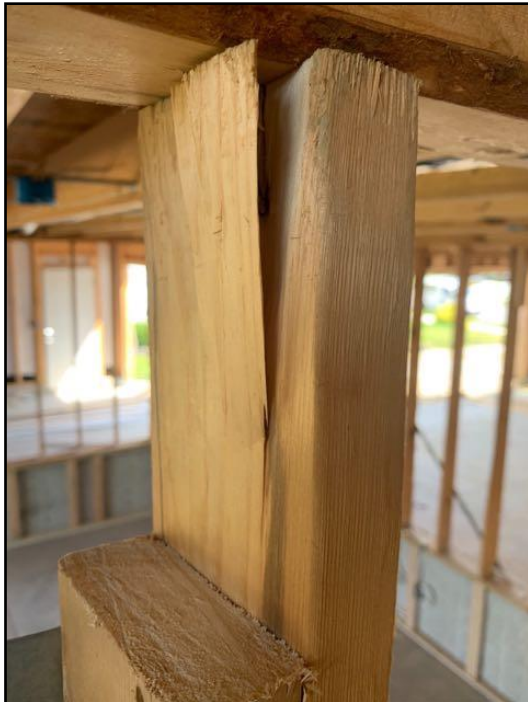
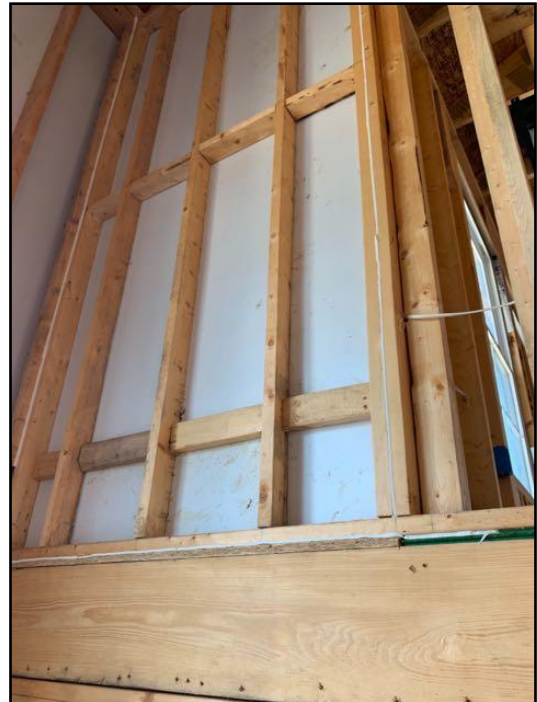
28. Condition: • The use of damaged or poor quality framing members can cause many undesirable implications. Some typical flaws that show up in your finishes our countertops and Cabinets not flush to the wall with large caulk lines, wavy baseboards, bulges and premature drywall flaws.

49. The use of damaged or poor quality framing...

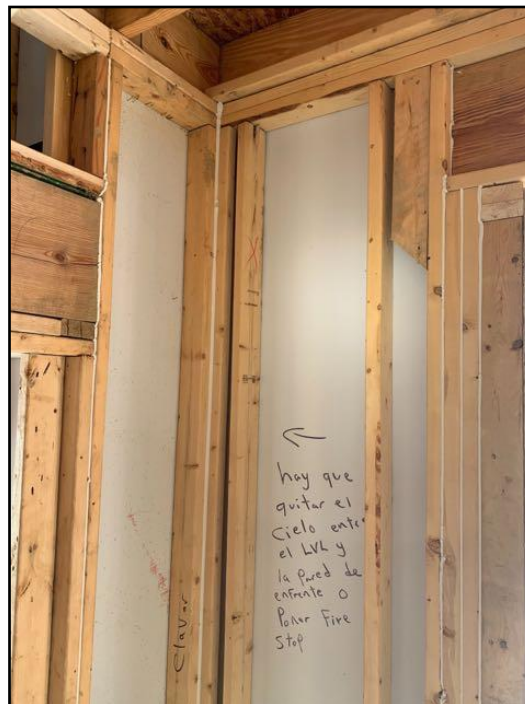
53. The use of damaged or poor quality framing...

Damaged framing members or poor quality installation should be improved in order to prevent issues during the installation of the final finishes.

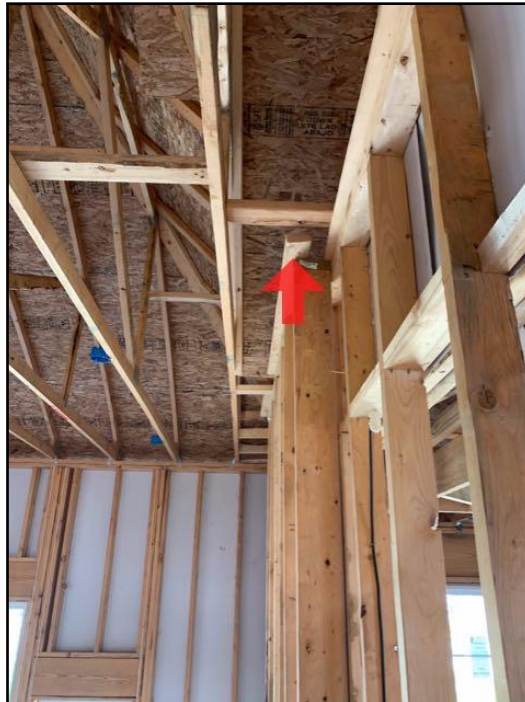
29. Condition: • Un-flush Studs within the framing system can cause problems for interior final finishes. I recommend the stud be flushed with neighboring framing members to prevent cosmetic defects.

Location: Nailer Above Fireplace

54. Un-flush Studs within the framing system ca...

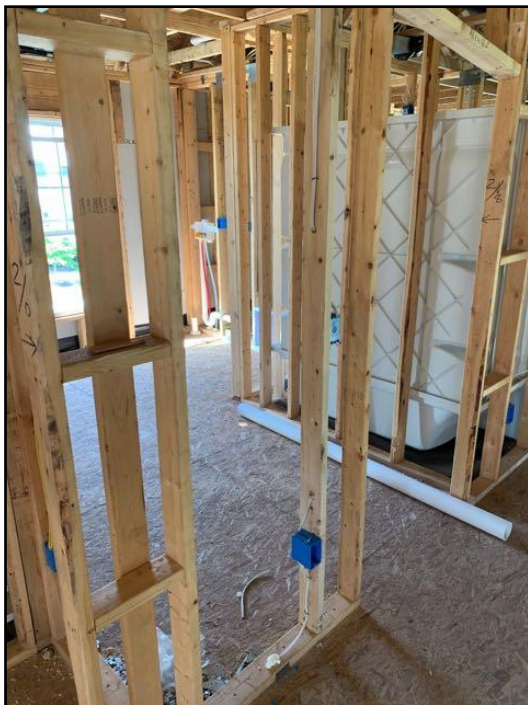
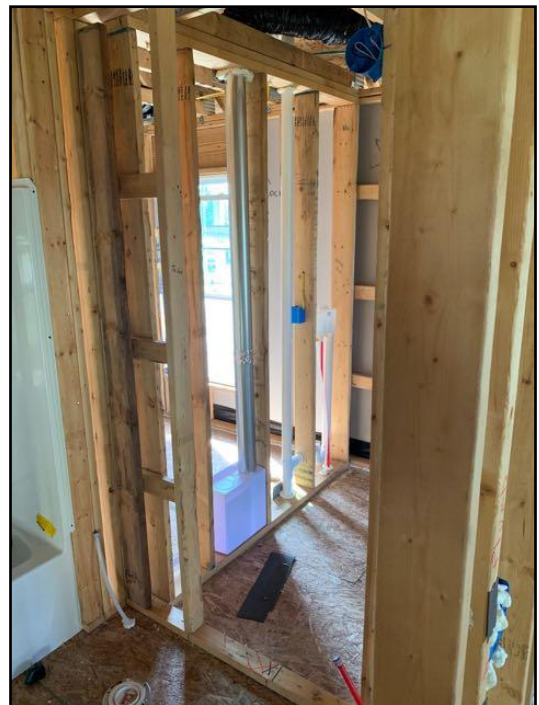
30. Condition: • Components of the partition missing at this location. I recommend consulting the builder to find a remedy

Location: Closet, Laundry Room

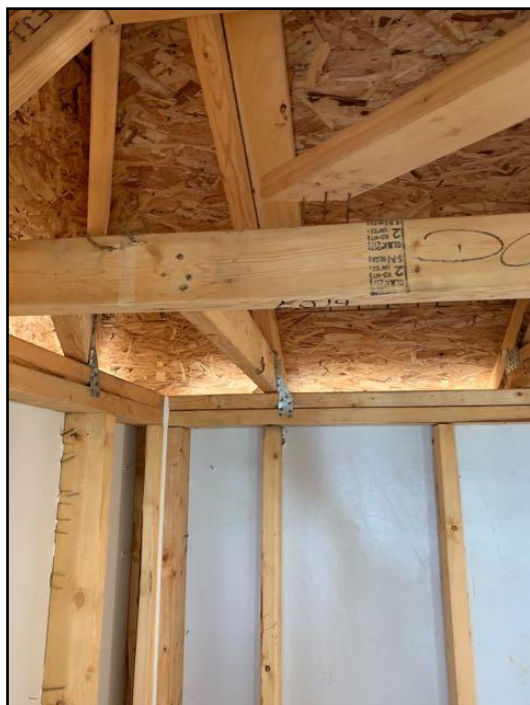
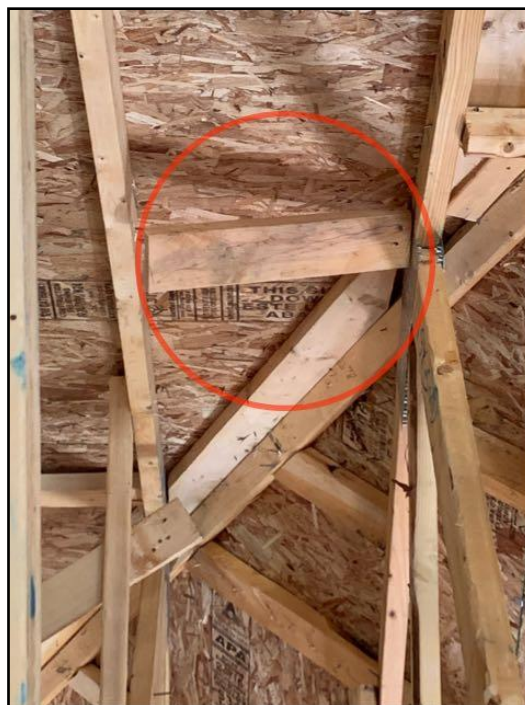
31. Condition: • Truss installation have both temporary and permanent bracing. Temporary bracing is needed to keep the trusses from falling over like dominoes during construction. Its the permanent bracing that were concerned about. Bracing can be either continuous lateral restraint (CLR) or individual web member reinforcement such as T-reinforcement. In older publications, CLR was called continuous lateral bracing (CLB).

Location: Closet One, Bedroom 4

57. Truss installation have both temporary and...

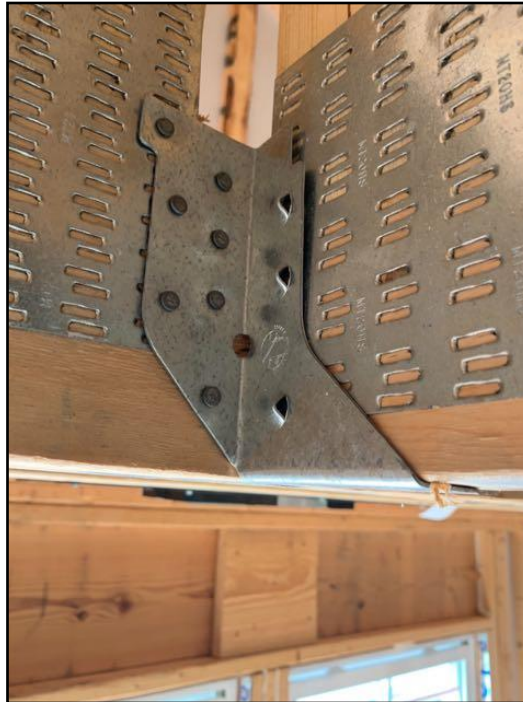
59.

32. Condition: • Hangers and straps should be secured, each nail opening is required to have the proper fastener. I recommend the strap or hanger installation be reviewed and the necessary corrections made.

Location: Bedroom 2

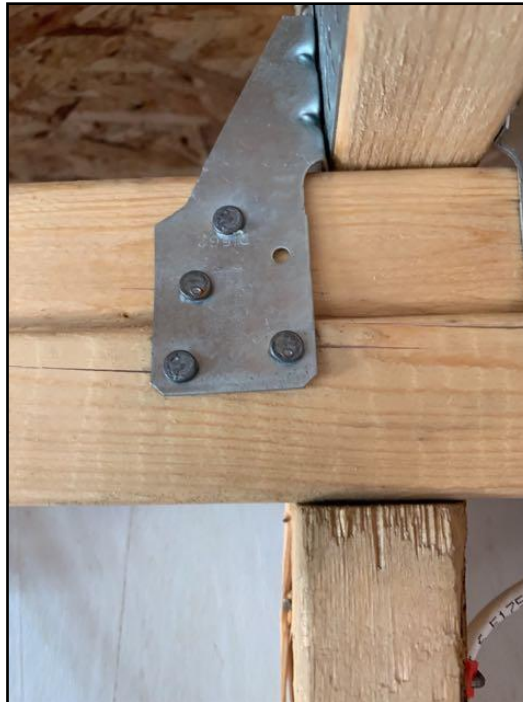
60.

33. Condition: • Hangers and straps should be secured, each nail opening is required to have the proper fastener. I recommend the strap or hanger installation be reviewed and the necessary corrections made.

Location: Various Locations Master Bedroom

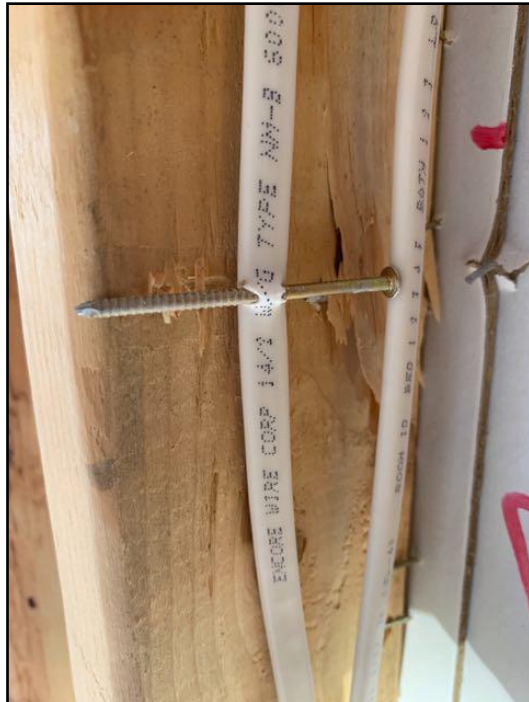
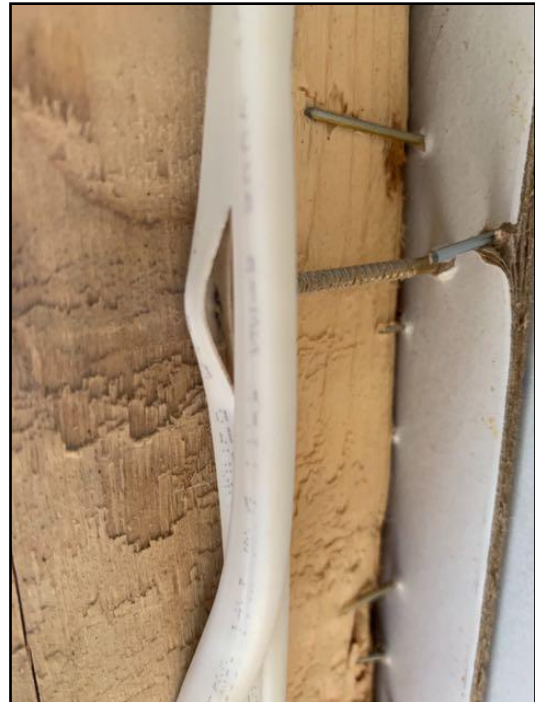
36. Condition: • Damage

The insulation is damaged leaving exposed non-insulated wiring. The wiring with damaged insulation could possibly cause arcing, I recommend this condition be improved to prevent safety risk.

Implication(s): Electric shock | Fire hazard

Location: Bedrooms 4, Bedroom 3

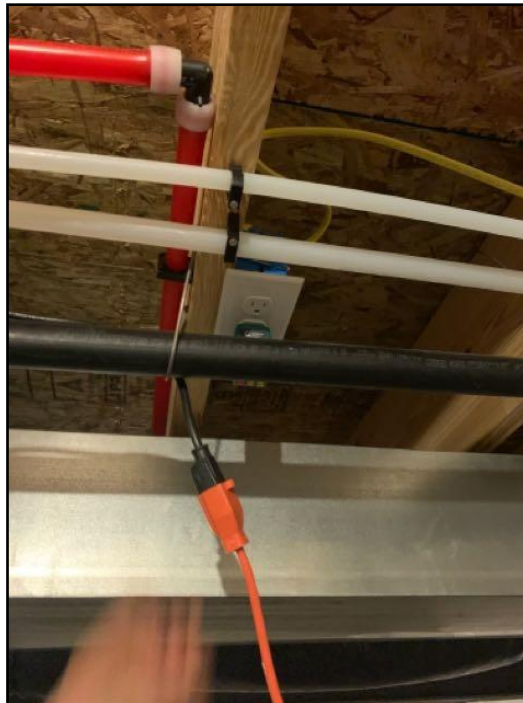
38. Condition: • Inoperative

The most common cause of inoperative circuits is a short or damaged fixture. I recommend contacting a qualified electrical contractor to troubleshoot these device to find a remedy.

Location: Basement Receptacles

69. Inoperative

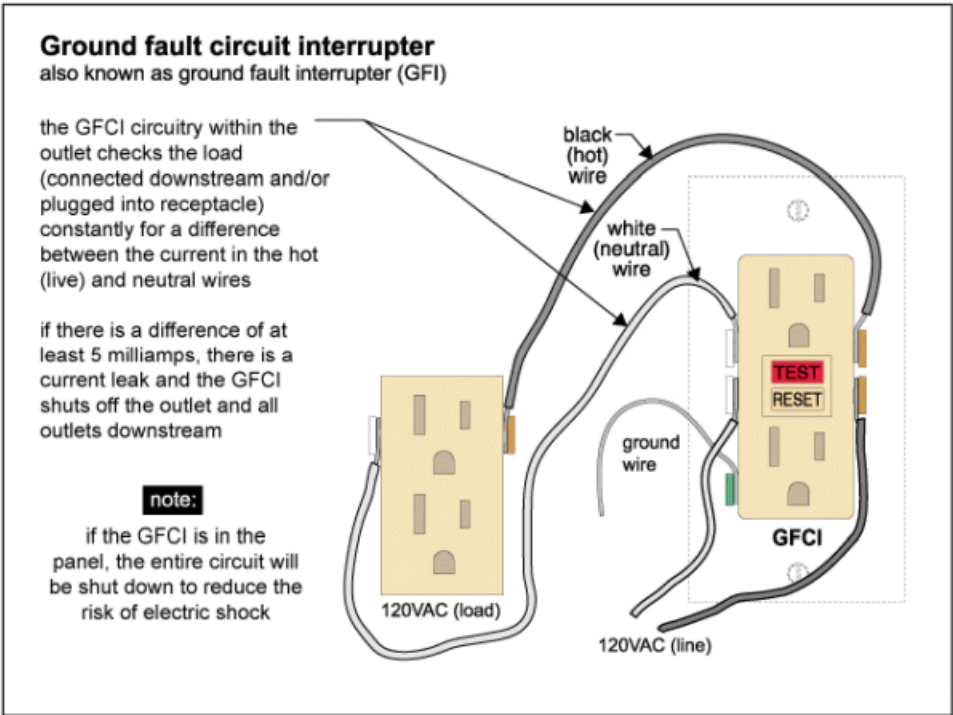
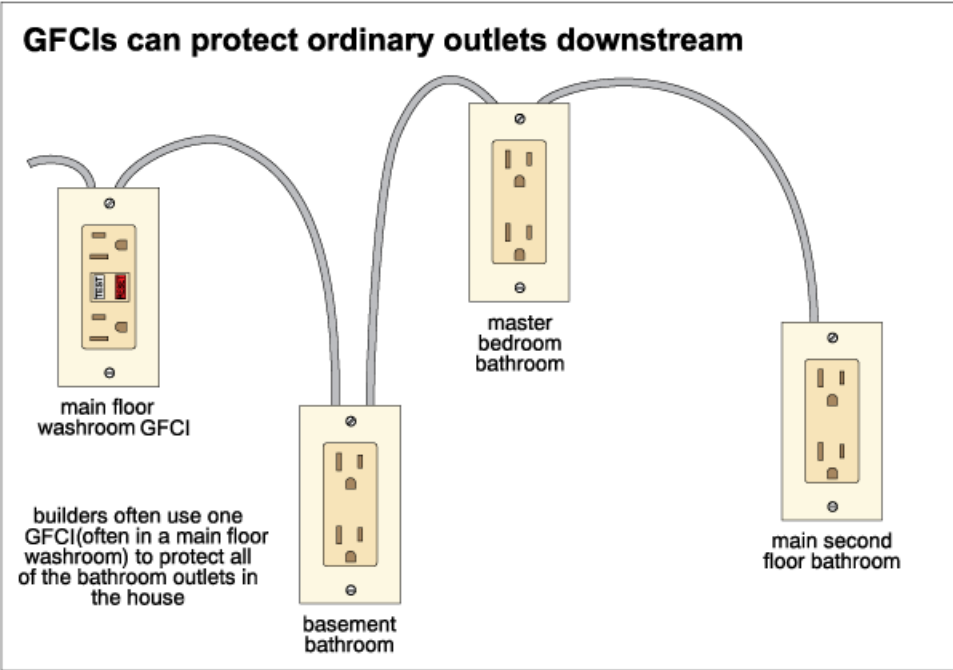
39. Condition: • [The Installation of ground fault circuit interrupter \(GFCI\) outlets is advisable in Bathrooms, Kitchens, Exterior, Basements, Garages Laundry Room.](#) A (GFCI) outlet offers protection from shock or electrocution. The Ground fault circuit interrupter (GFCI) is Inoperative or missing during this inspection. Exterior GFCI's shall be installed with weather proof housing. The receptacle should be repaired or replaced

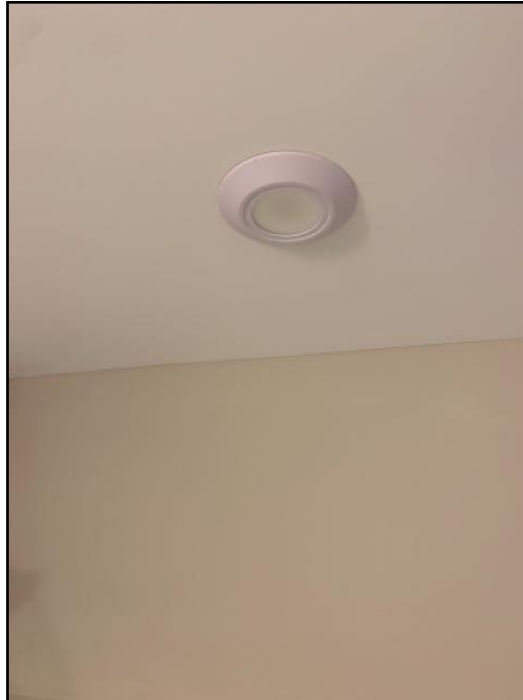
41. Condition: • Inoperative

The most common cause of inoperative circuits is a short or damaged fixture. I recommend contacting a qualified electrical contractor to troubleshoot these device to find a remedy.

Location: Second Floor Front Right bathroom

70. *Inoperative*

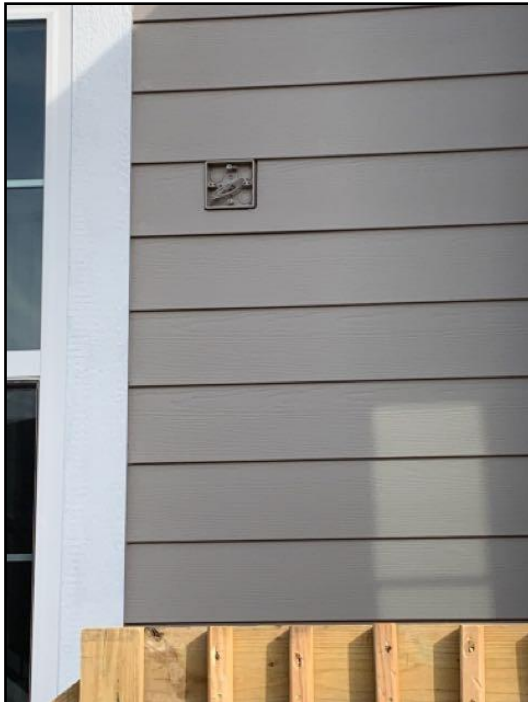
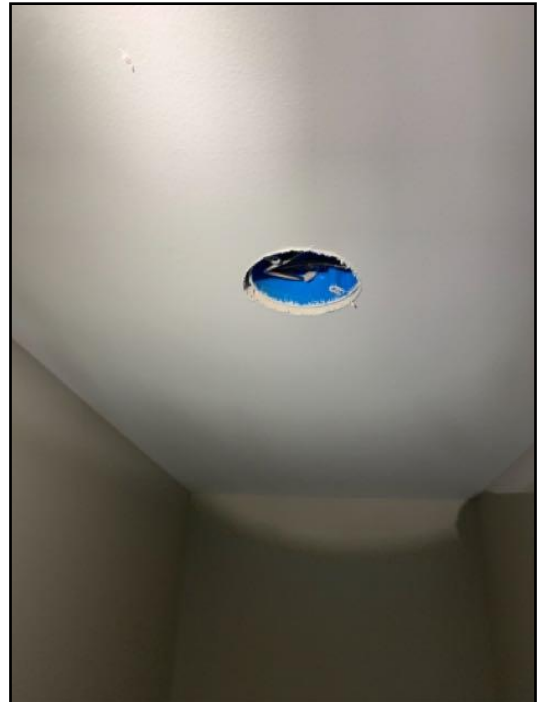
42. Condition: • Missing

The light fixture is missing at this location leaving wiring exposed to the occupants. I recommend this electrical hazard be remedied to improve safety.

71. Missing

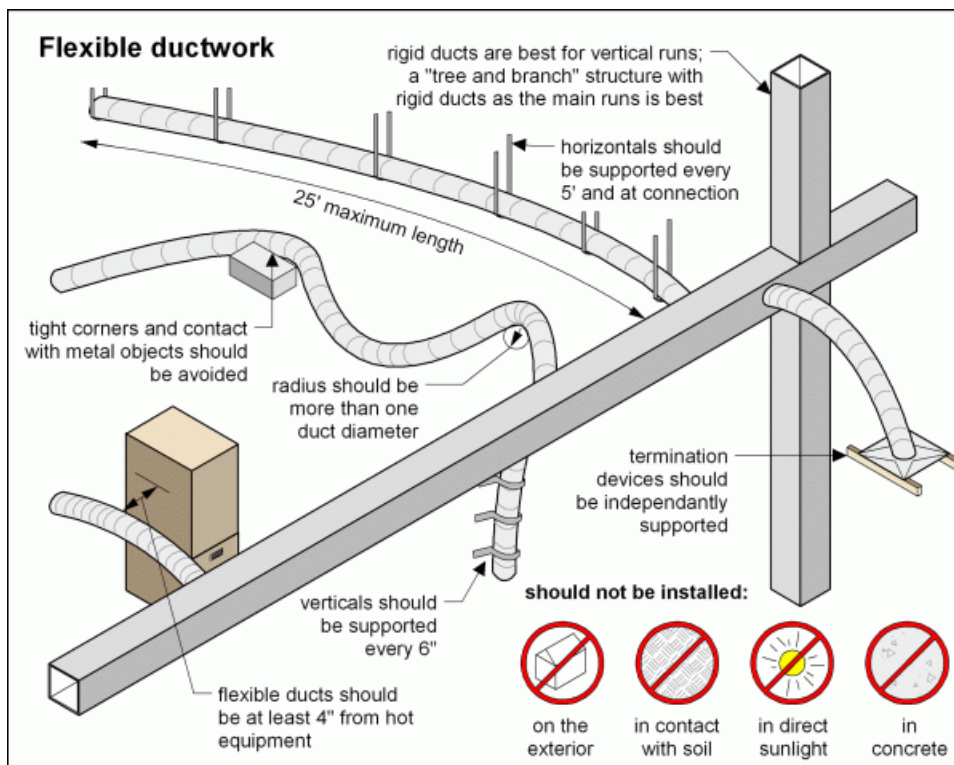
43. Condition: • The support strap appear to be missing, sagging or loose duct runs will cause reduced comfort and restrict airflow if not repaired. I recommend contacting a qualified HVAC contractor to make any and all repairs.

Location: Master bedroom

81. The support strap appear to be missing,...

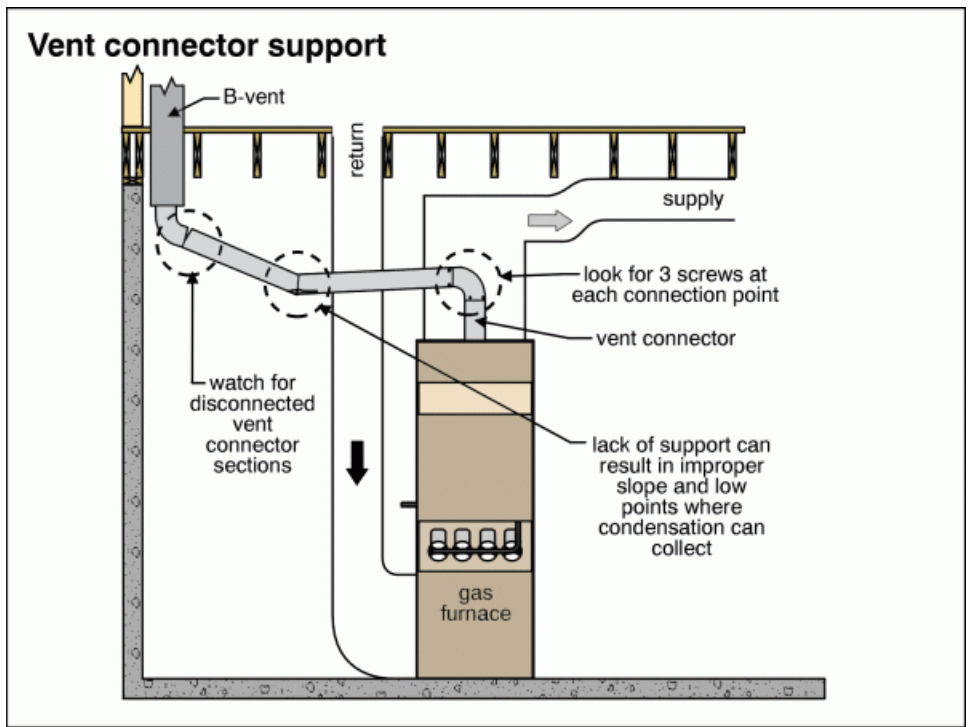
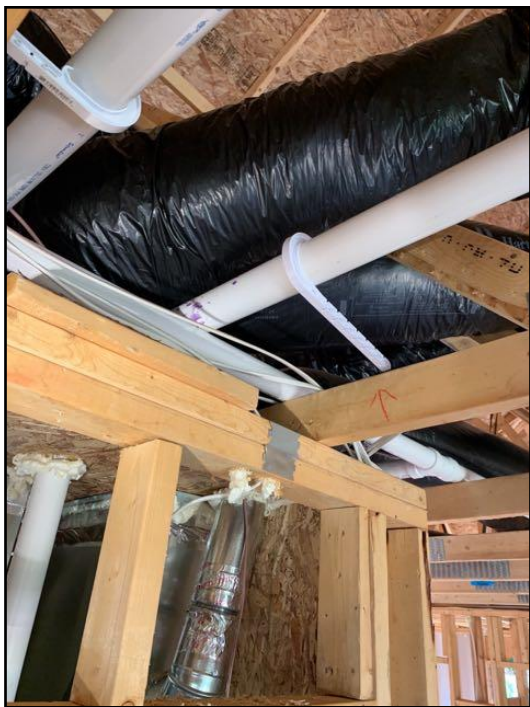
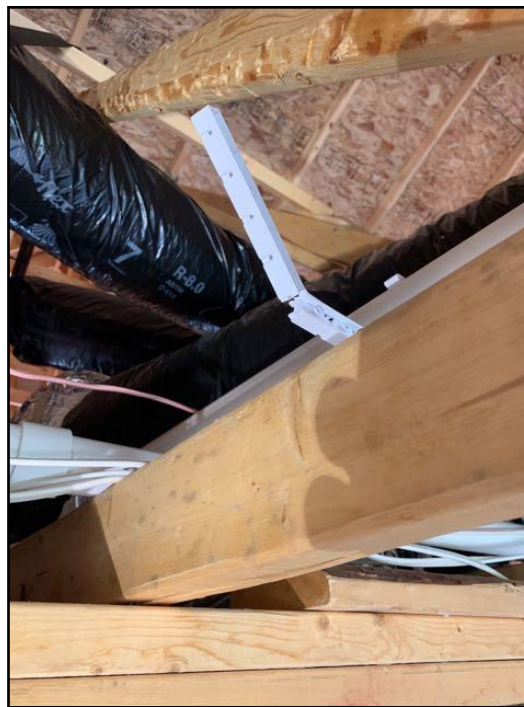
45. Condition: • Poor support

Improper flue connection and supports can allow combustible products to enter the structure. I recommend contacting the licensed HVAC contractor to make any and all repairs.

Implication(s): Hazardous combustion products entering home | Equipment not operating properly

Location: Furnace Flue

82. Poor support

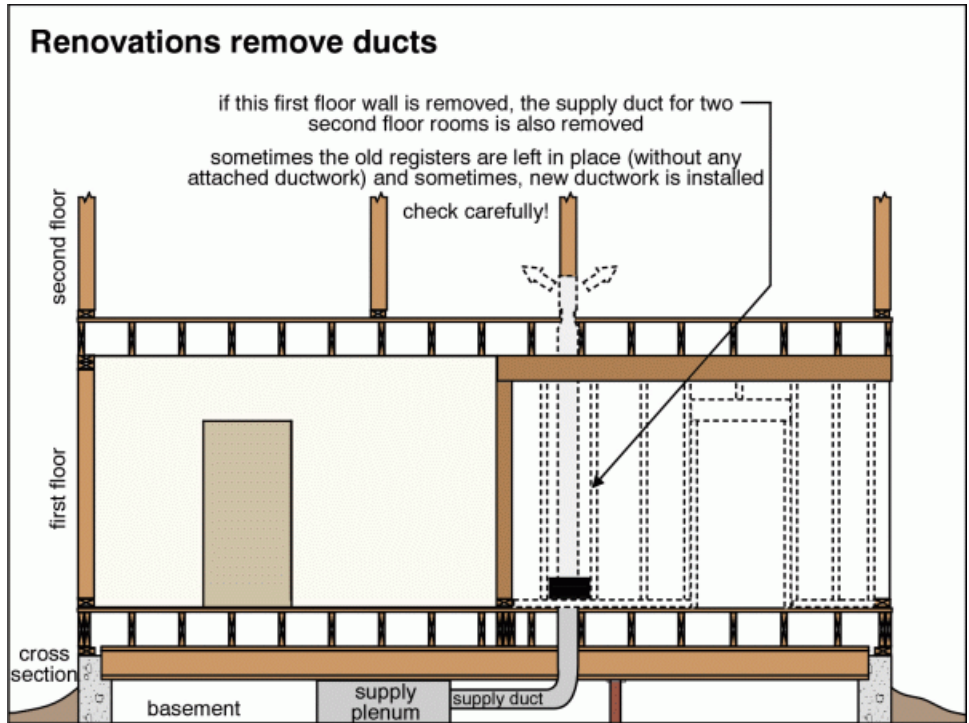
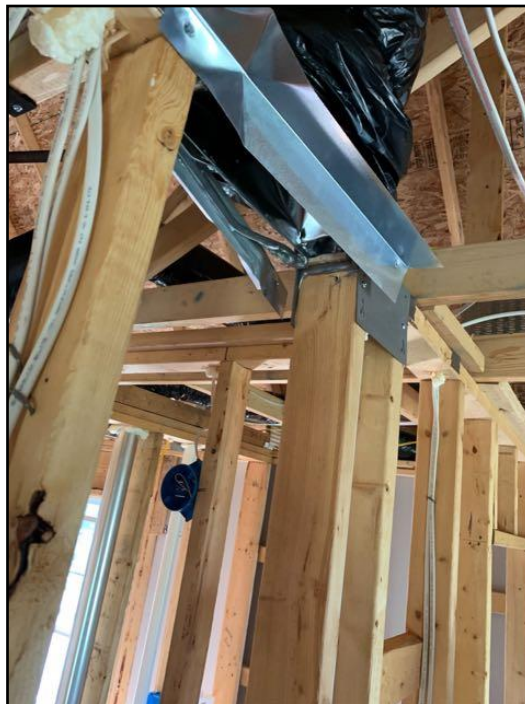
46. Condition: • Disconnected ducts

The ductwork is disconnected. I recommend contacting a qualified HVAC contractor to make any and all repairs.

Location: Bedrooms 4

84. Disconnected ducts

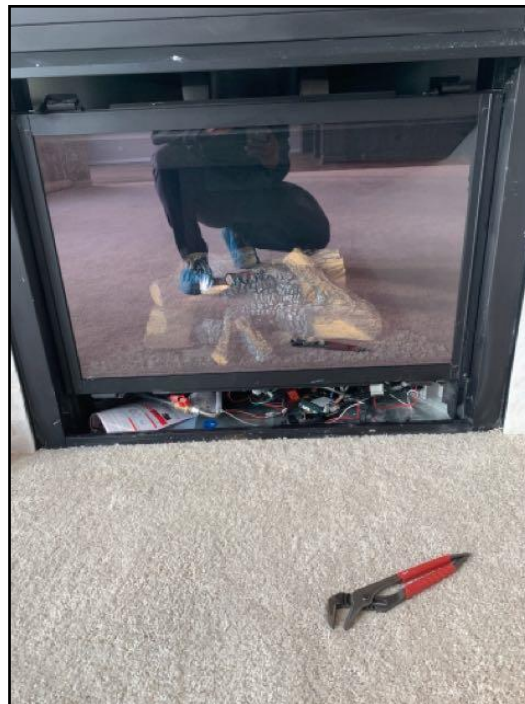
47. Condition: • Not functional

Location: First

85. Not functional

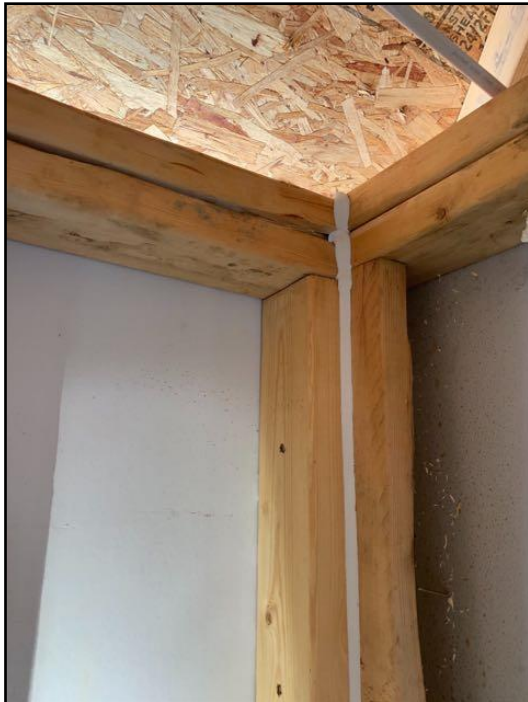
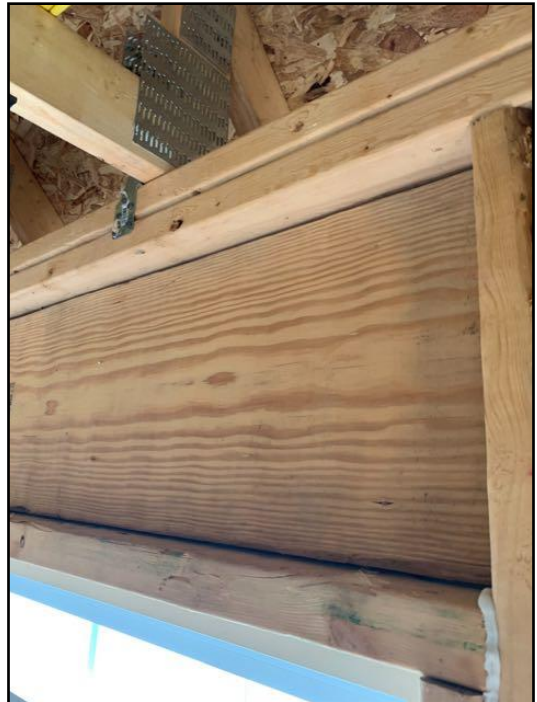
48. Condition: • The caulking sealing the void between the partition plates is incomplete. To improve heat and cooling cost in the structure a repair is recommended.

93. The caulking sealing the void between the...

94. The caulking sealing the void between the...

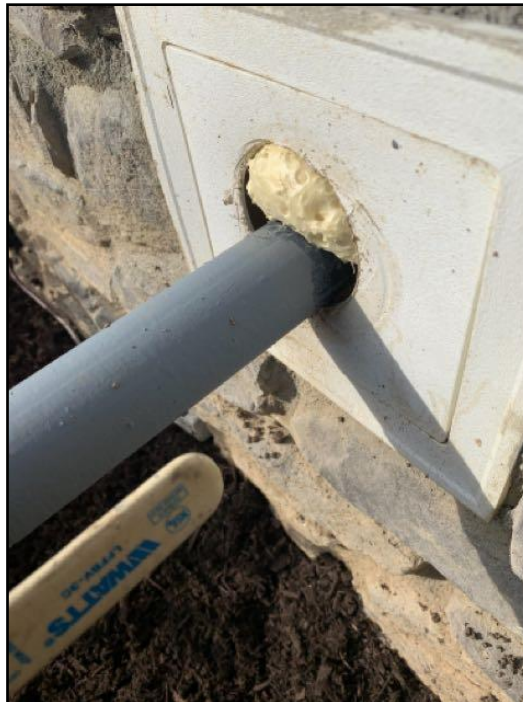
49. Condition: • All exterior penetrations into the structure should be weathertight. To avoid water damage or pest entry.

97. All exterior penetrations into the structur...
