Your Inspection Report

10717 Honeysuckle Way
Plain City, OH 43064

RE: Report No. 4534, v.2
10717 Honeysuckle Way
Plain City, OH
43064

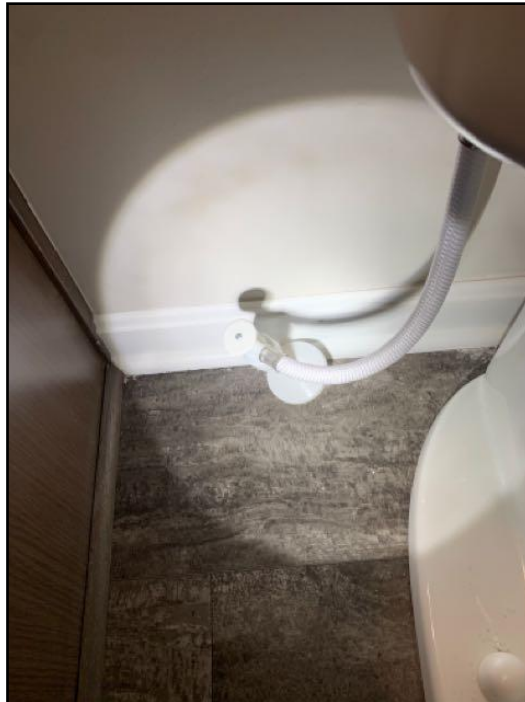
98.

50. Condition: • The toilet water line does not have the proper distance from the wall. The beauty ring is un-flush, which covers the penetration in the floor. I recommend consulting the builder to find remedy.

Location: Second Floor Front Front Bathroom

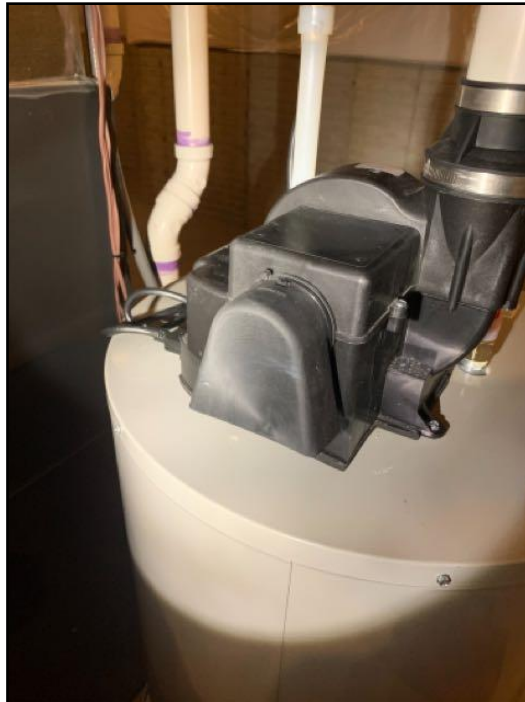
99.

51. Condition: • The power vent is required to be grounded, the grounding wires is currently not visible. The wiring diagram shows the ground inside the housing.

Location: Water Heater

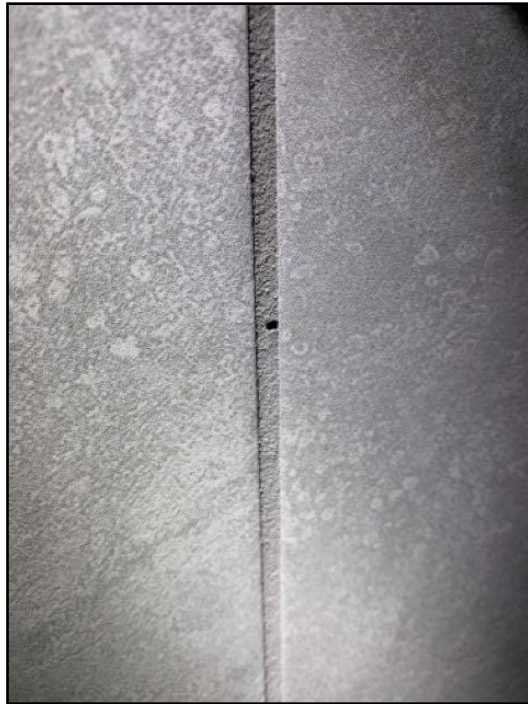
52. Condition: • Grout loose, missing or deteriorated

Loose or Missing grout may continue to worsen as water and solvents get underneath the tile causing grout to weaken and tiles to become loose. I recommend contacting a qualified professional to make any and all repairs as needed.

Implication(s): Chance of water damage to structure, finishes and contents

100. *Grout loose, missing or deteriorated*

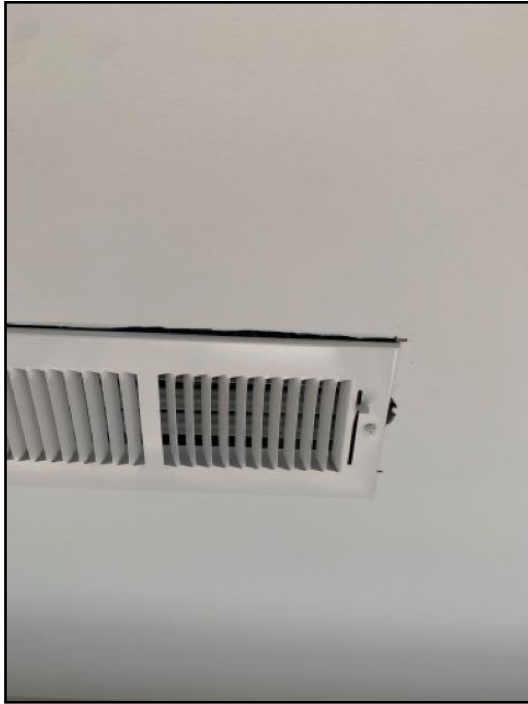
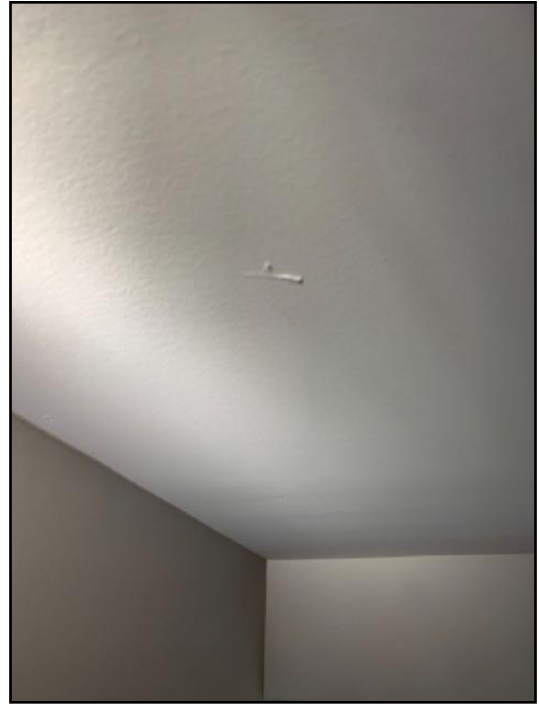
54. Condition: • Typical flaws

Drywall imperfections are common during the new construction punch out process multiple areas throughout the home were identified and discussed. The contractor should be willing to remedy these areas since they are below industry standards and are poor quality and craftsmanship. I recommend marking this area with tape and consulting the contractor for a remedy.

Location: Various Locations

103. Typical flaws

104. Typical flaws

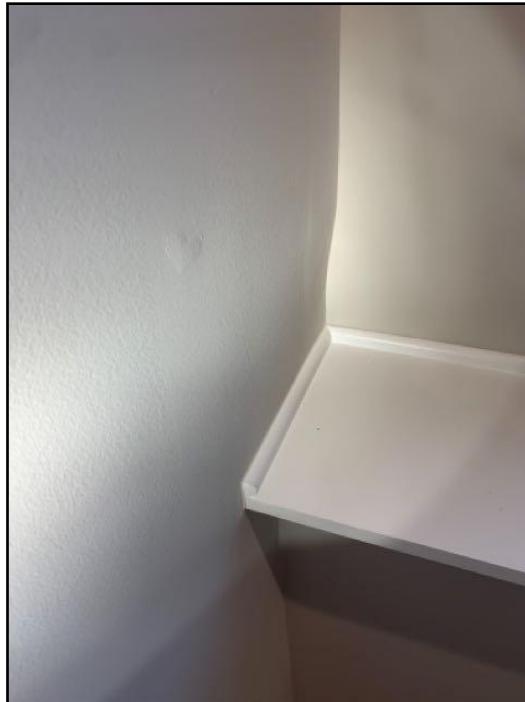
55. Condition: • Typical flaws

Drywall imperfections are common during the new construction punch out process multiple areas throughout the home were identified and discussed. The contractor should be willing to remedy these areas since they are below industry standards and are poor quality and craftsmanship. I recommend marking this area with tape and consulting the contractor for a remedy.

Location: Wreck room

105. Typical flaws

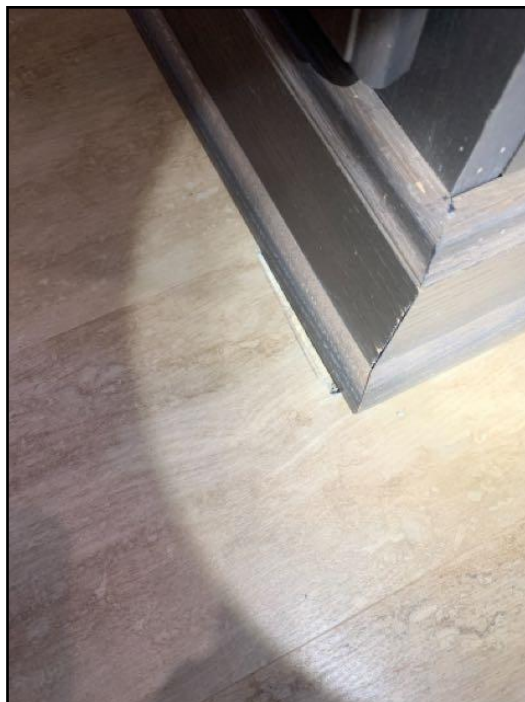
56. Condition: • The floor has cosmetic defects from poor installation practices. Your contractor will find a remedy to correct this matter.

Location: Kitchen Floors

106. The floor has cosmetic defects from poor...

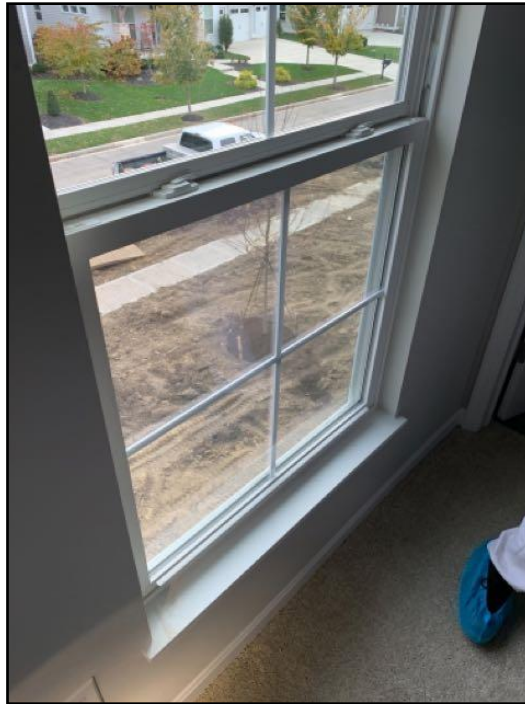
57. Condition: • Loose fit

The sash is loose. I recommend contacting a qualified contractor for further evaluation.

Implication(s): Chance of damage to finishes and structure

Location: Bedroom 3

107. Loose fit

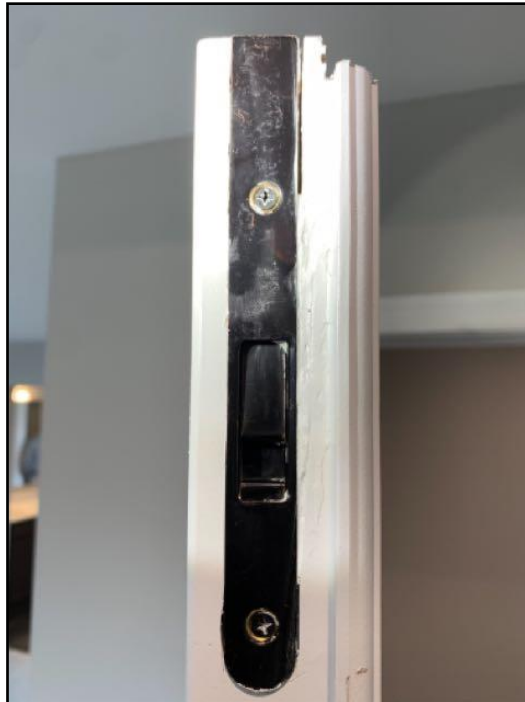
58. Condition: • Damage

The door is damaged, I recommended that the door be repaired by a qualified contractor.

Location: Master bedroom

108. Damage

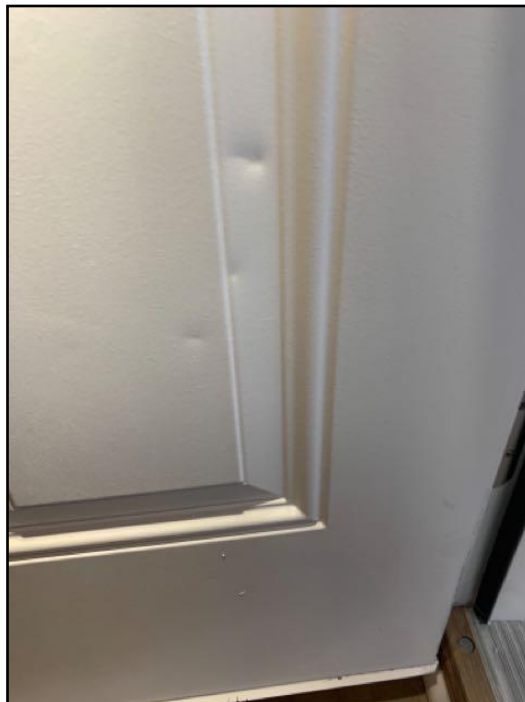
Location: Garage service door

115. The door slab has cosmetic defects in the...

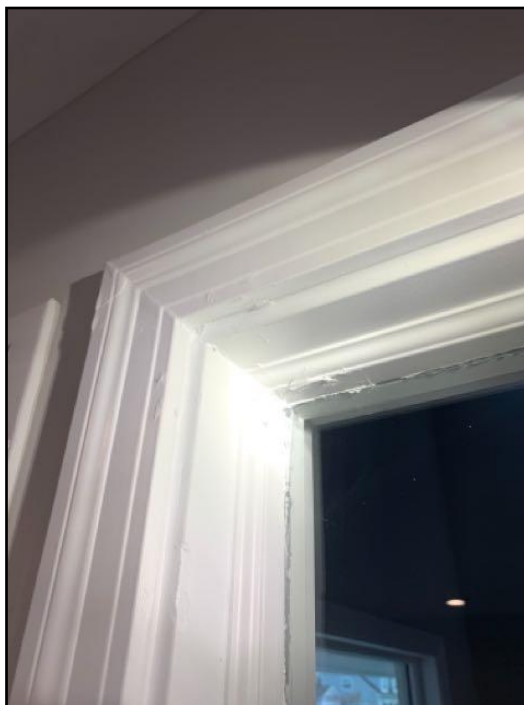
Location: Office

116. *Low-quality paint work was observed trash i...*

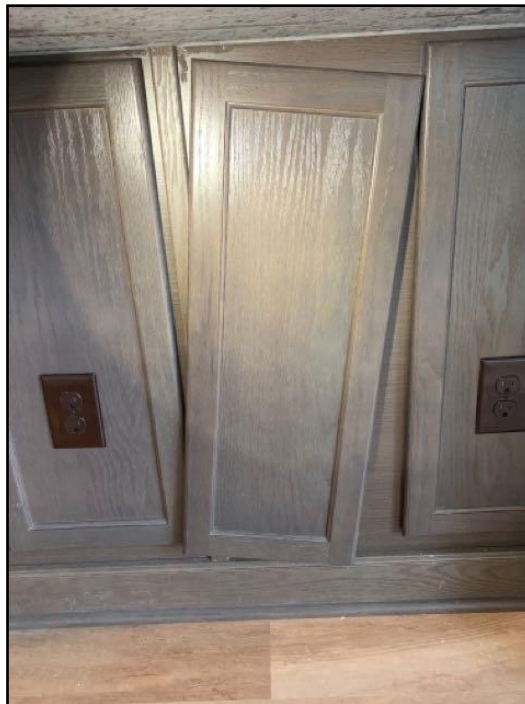
Location: Kitchen island

117. Pieces missing or loose

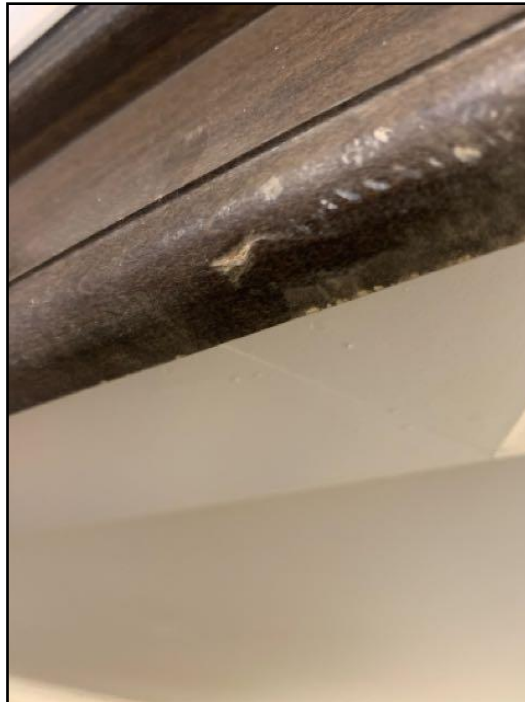
121. *The finish has imperfection, unfilled voids...*
