FINAL ASBESTOS REPORT

SCIOTO VALLEY CTC 951 VERN RIFFE DRIVE
LUCASVILLE, OHIO 45648

ASBESTOS MATERIAL SURVEY

AT Scioto County CTC Taylor Building

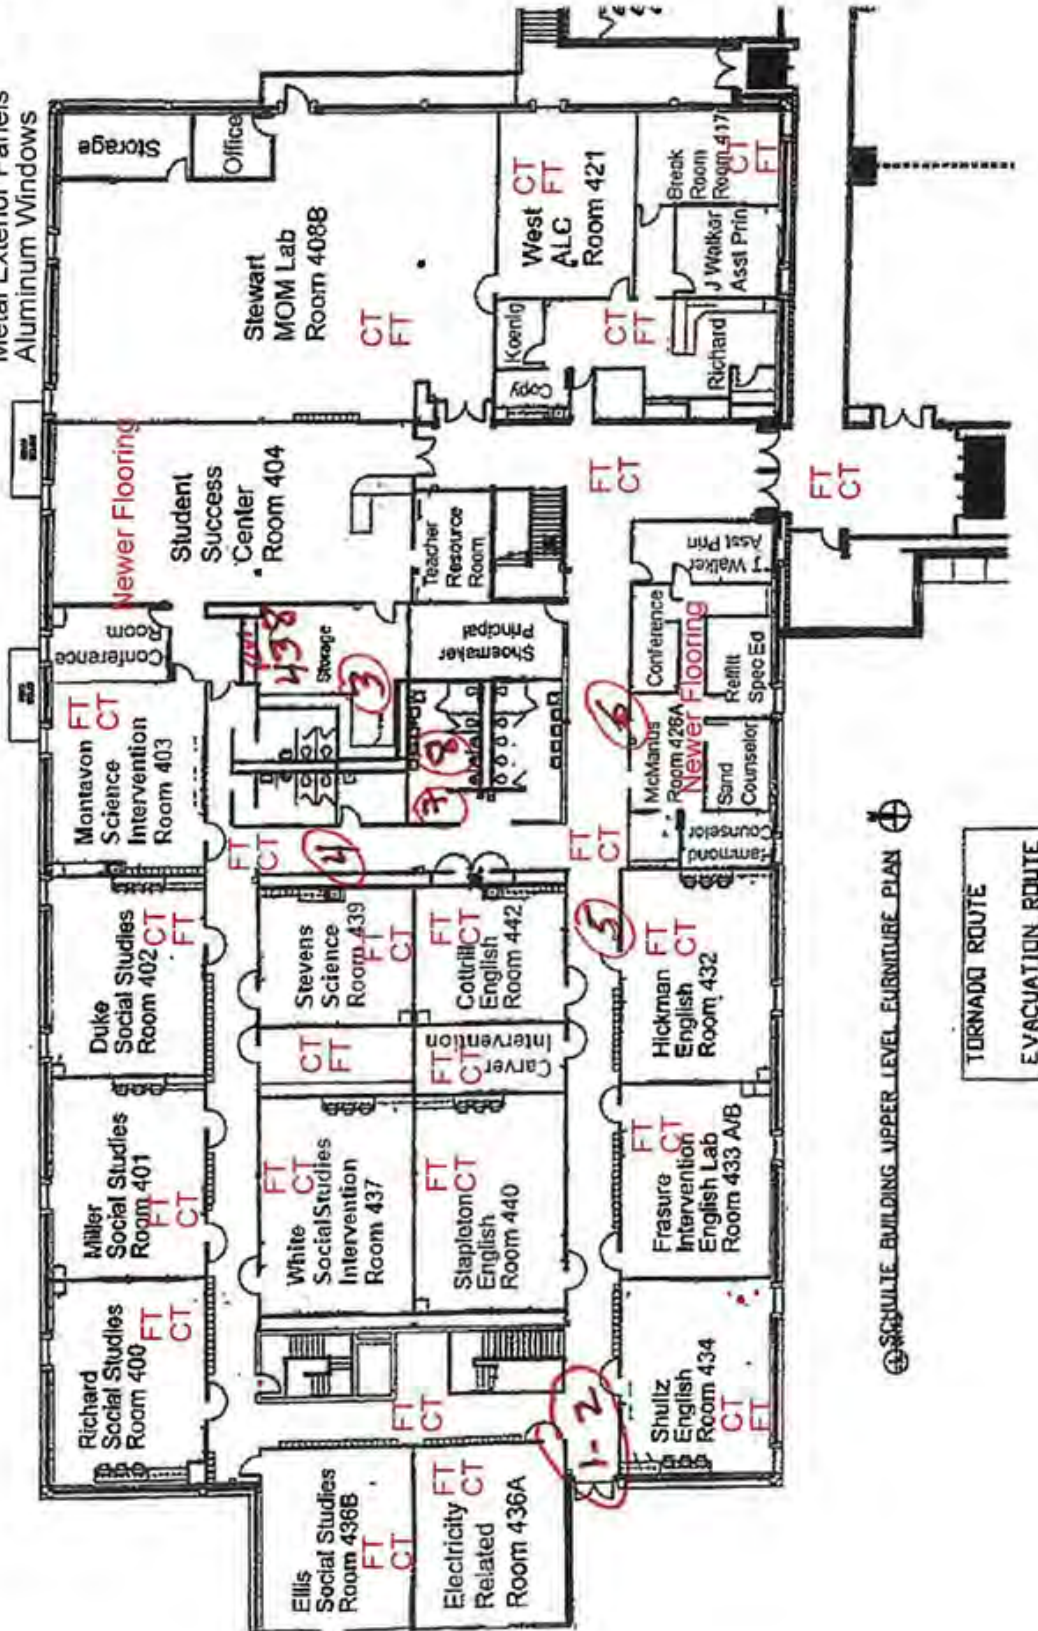
Built in 1971, Remodel in 2007-2008

(CT) Ceiling Tiles - Throughout
 (FT) Floor Tiles - Throughout
 Metal Exterior Panels
 Aluminum Windows

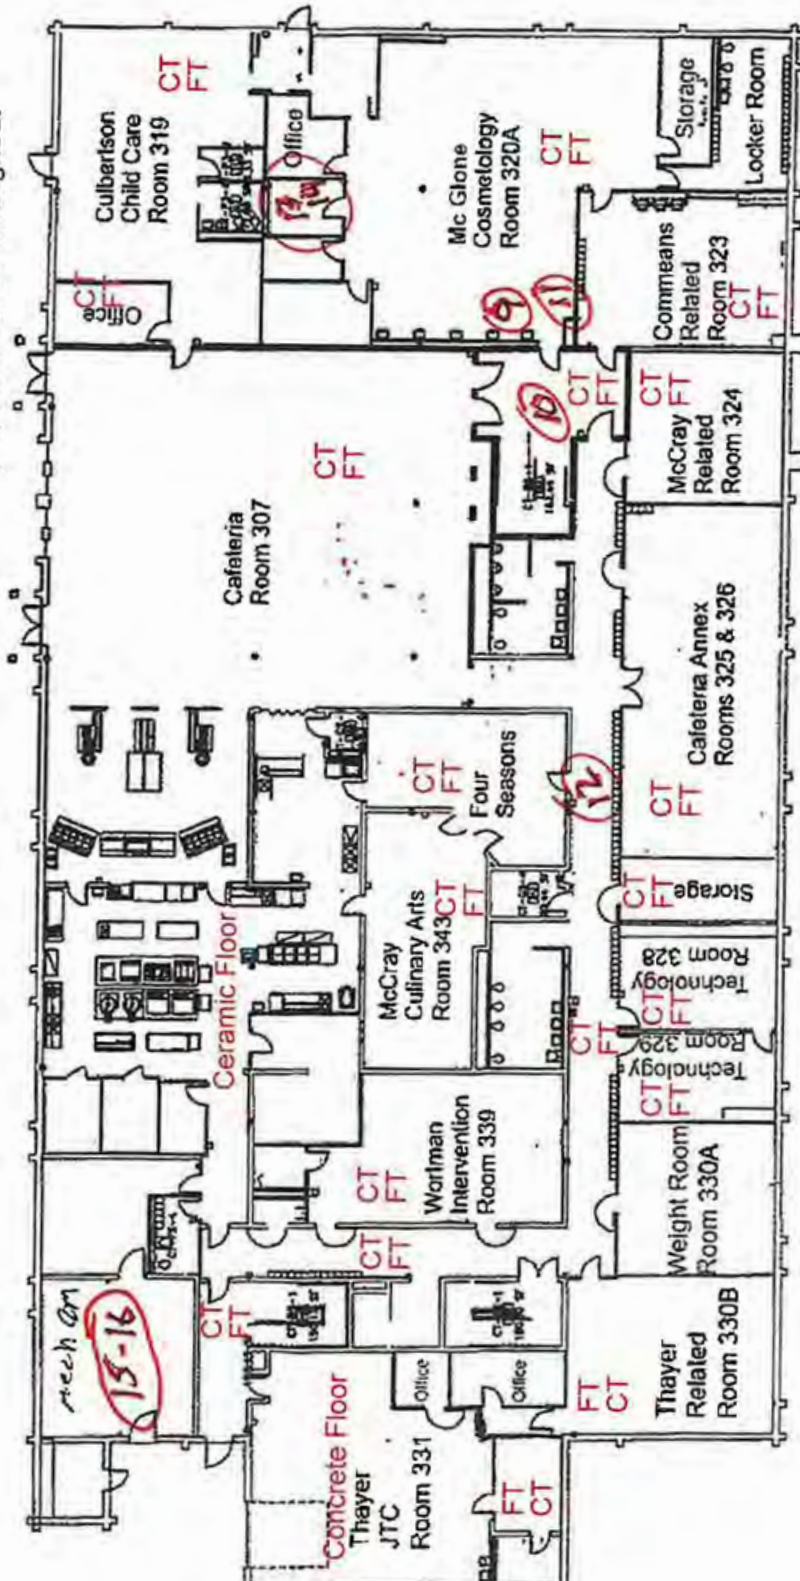
⊕ SCHULTE BUILDING LOWER LEVEL FURNITURE PLAN

Built in 1971, Remodel in 2007-2008

(CT) Ceiling Tiles - Throughout
 (FT) Floor Tiles - Throughout
