Your Inspection Report

6865 Bryne Court
Dublin, OH 43017

Thursday, November 17, 2016

Master Inspector James Jones

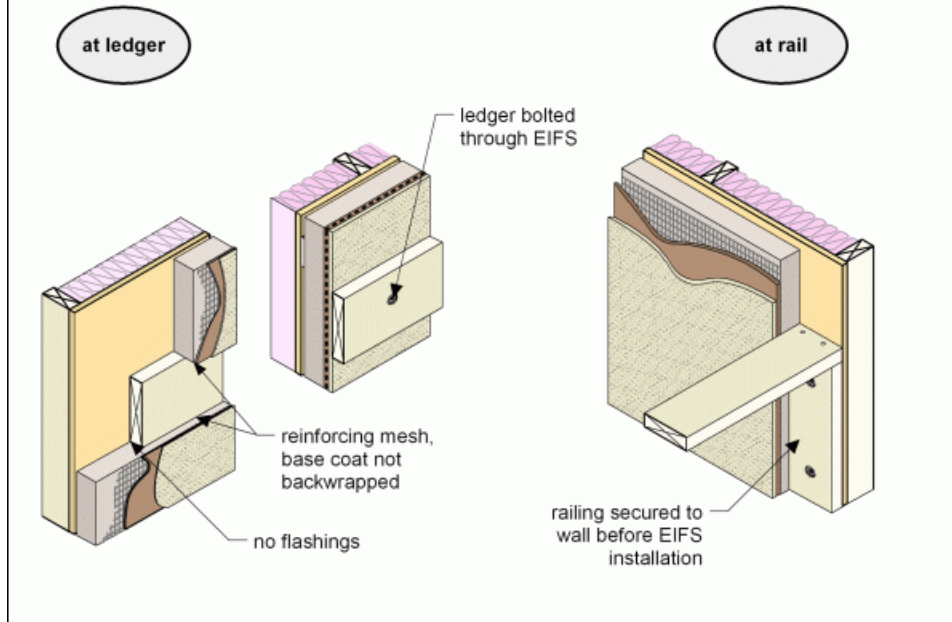
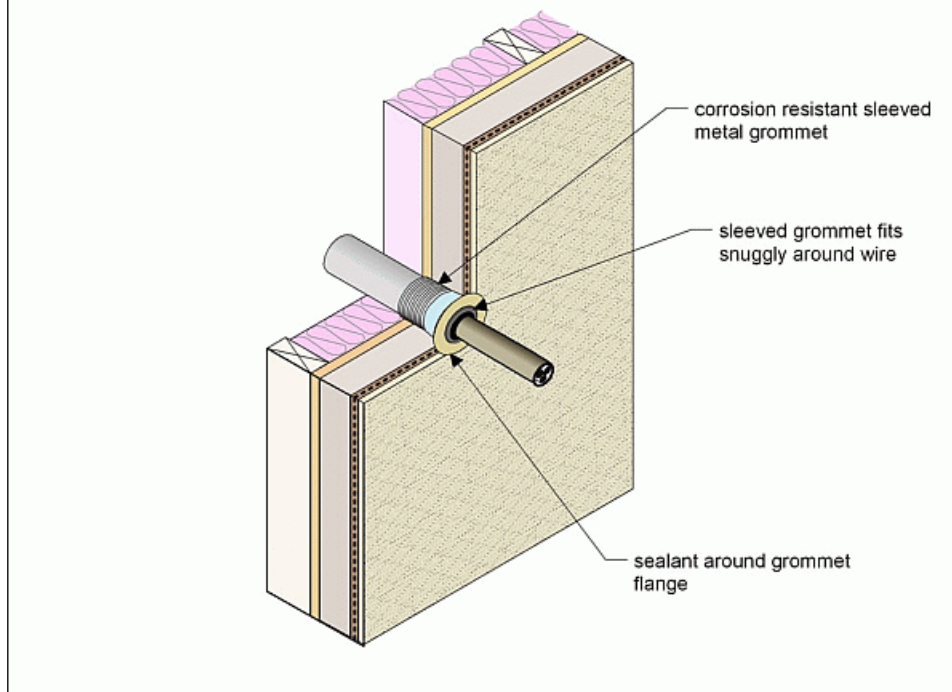
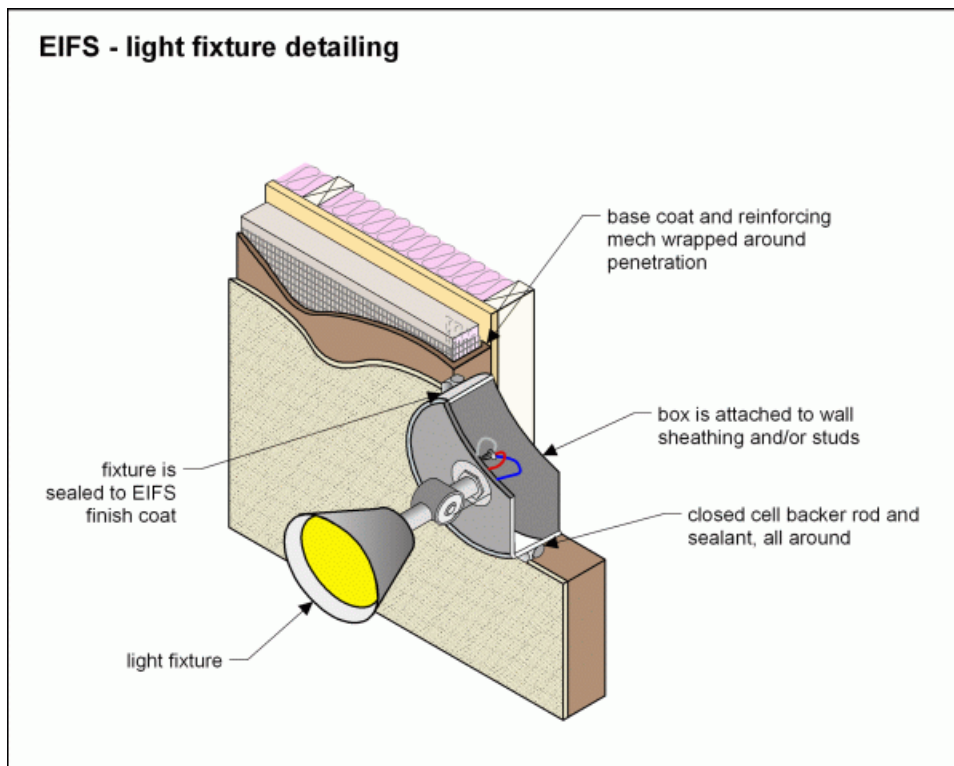
The stucco appears to have absorbed water in this area for an extended period of time. When there is stucco surface staining it's usually a sign it's retaining water from failure of flashing, caulking or the lack of maintenance of the stucco surface and trim. I recommend contacting a qualified contractor to repair the problem to prevent water damage to the structure.

Implication(s): Chance of water damage to contents, finishes and/or structure | Material deterioration

Task: Repair

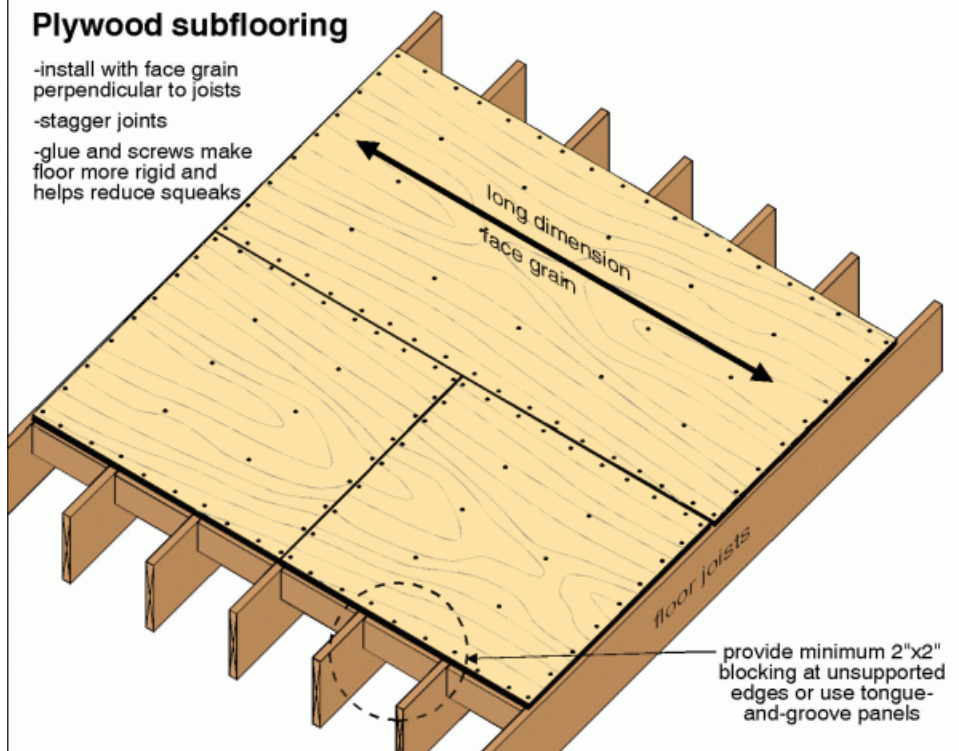
Moisture has caused damage to the structure. I recommend a qualified contractor be consulted and any and all repairs made as necessary.

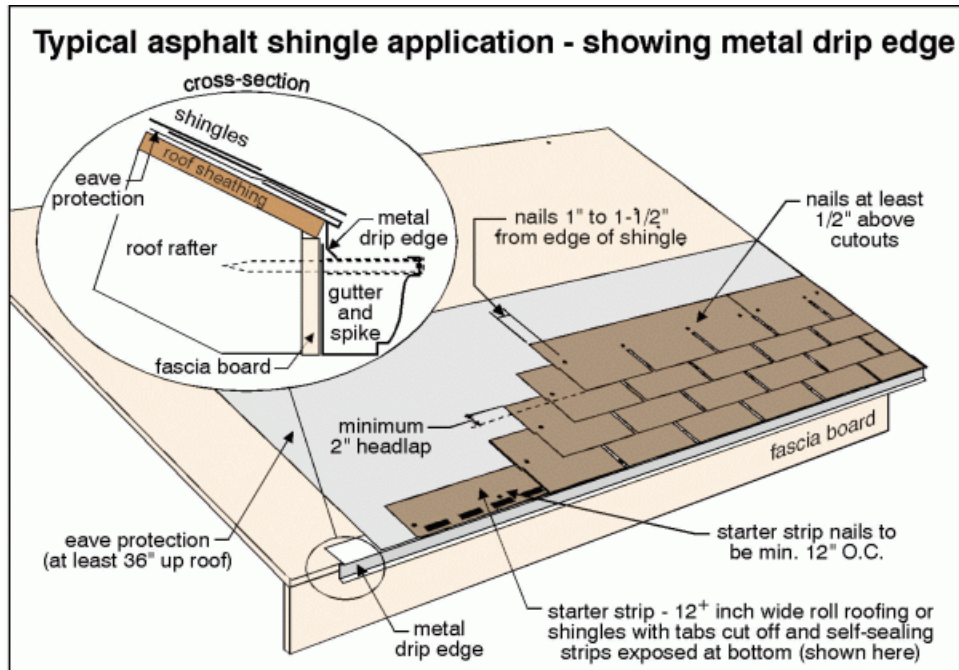
1. Condition: • Ice and Water shield is a critical component to any new roofing system especially in cold weather climates. Many local building codes require Ice and Water shield and The National Building Code states Ice and water shield must start at the roof eave edge and extend 2 ft inside heated wall space of a structure. As the name implies the product is to protect your roof deck in cold and wet situations. When Ice forms and rain or ice melts it can get inside most vulnerable areas where we need to keep it out.

5. Ice and Water shield is a critical componen...

Task: Improve when remodeling

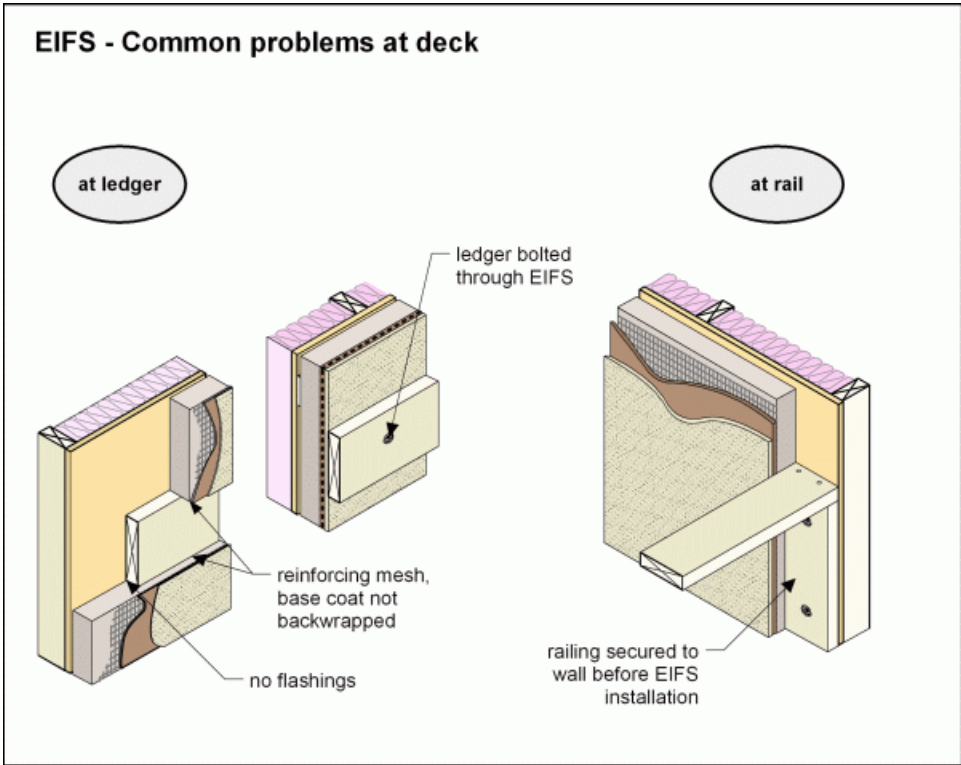
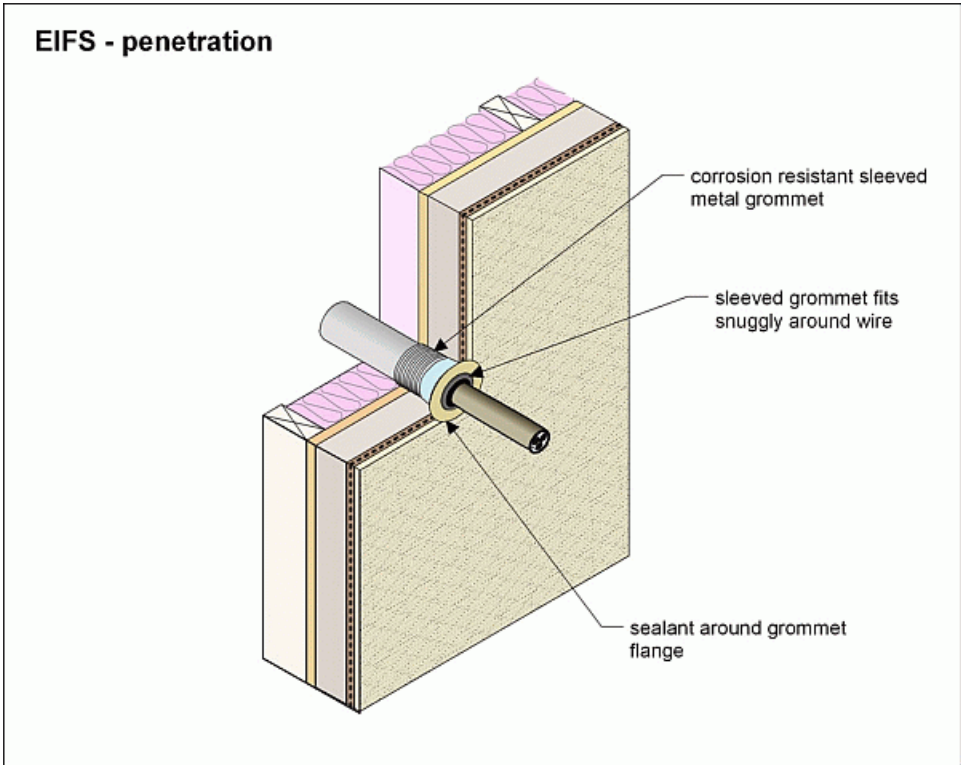
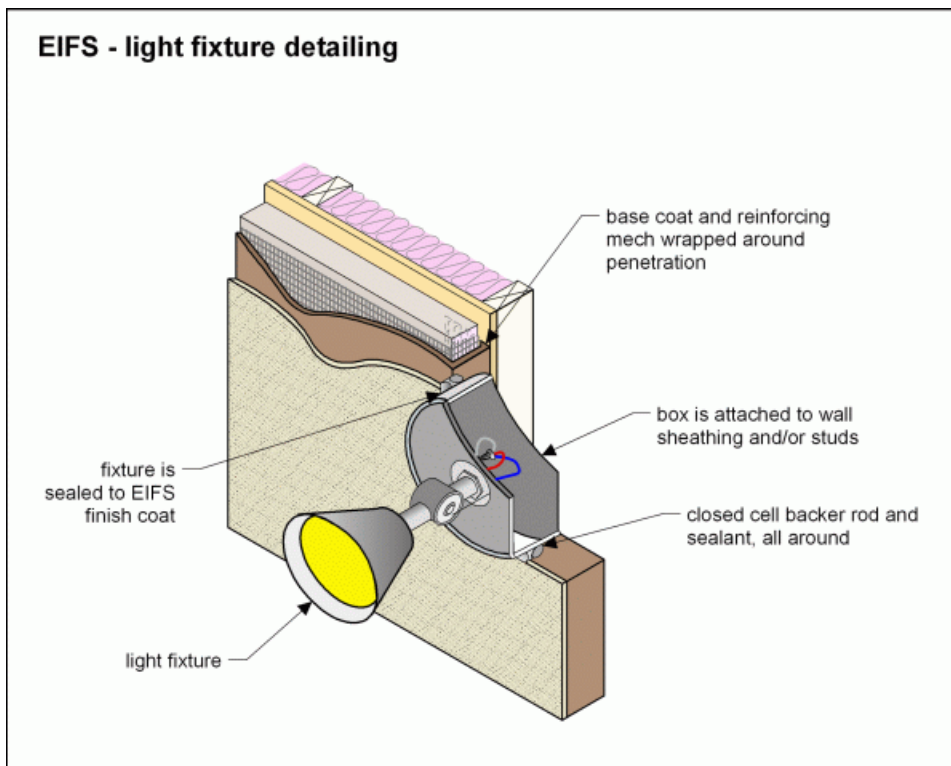
The stucco appears to have absorbed water in this area for an extended period of time. When there is stucco surface staining it's usually a sign it's retaining water from failure of flashing, caulking or the lack of maintenance of the stucco surface and trim. I recommend contacting a qualified contractor to repair the problem to prevent water damage to the structure.

Implication(s): Chance of water damage to contents, finishes and/or structure | Material deterioration

Task: Repair

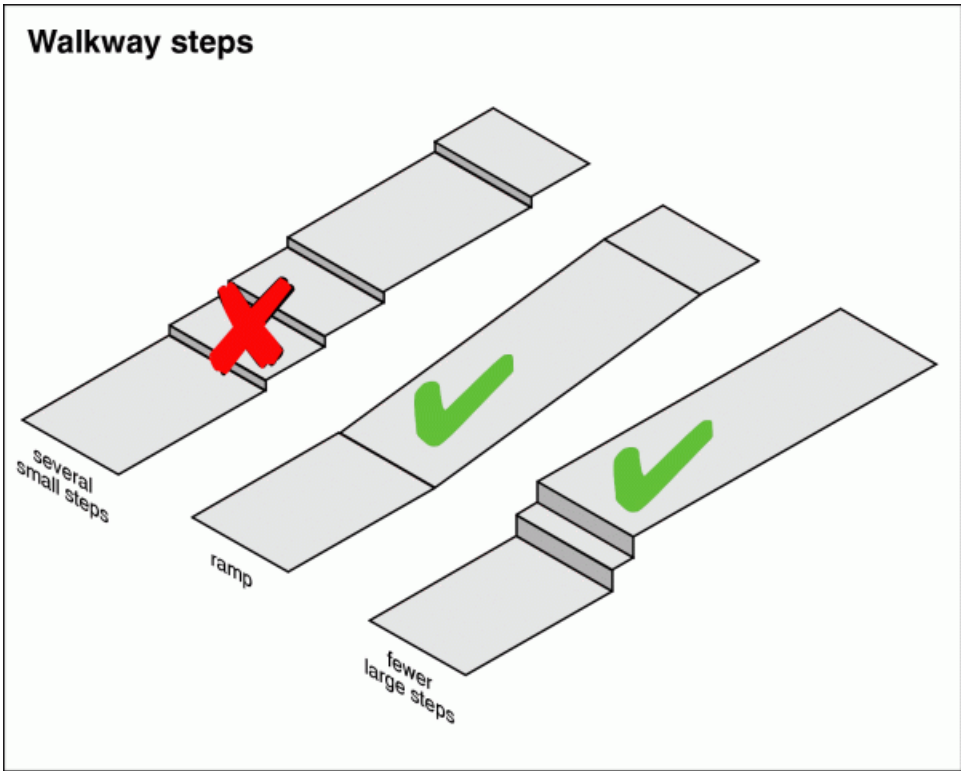
9. Uneven (trip hazard)

The concrete slab is heaving or settlement causing the slab to drop. Some common causes are the base has failed or washed out, I recommend contacting a qualified contractor to make any and all repairs.

Task: Repair

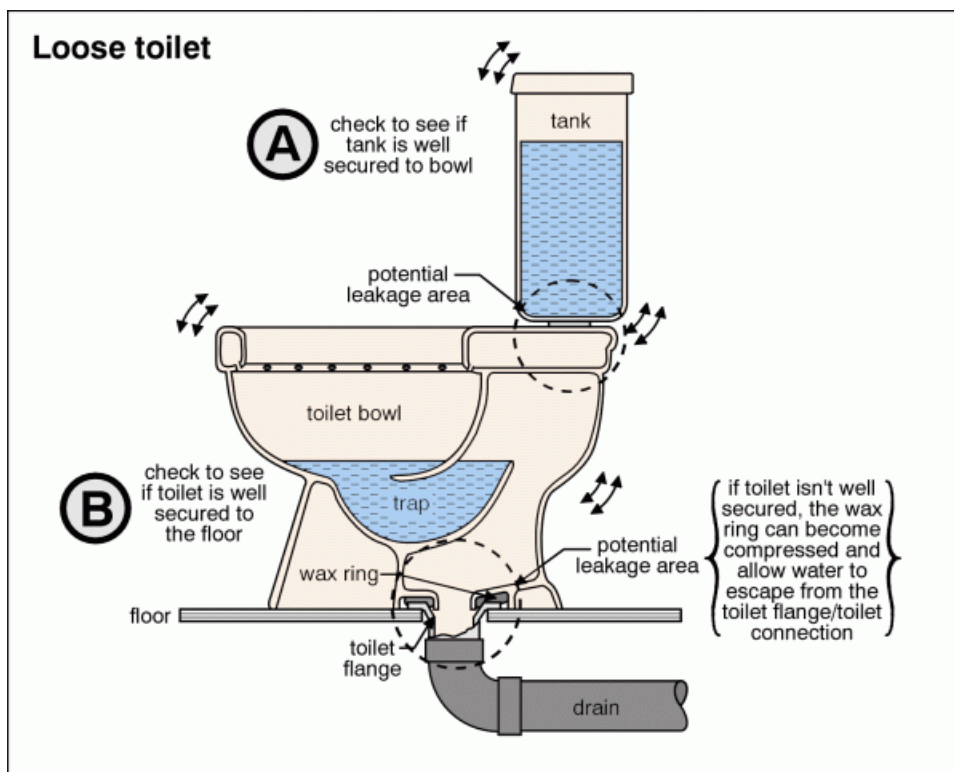
24. Loose

The loose toilet needs reset there were no water stains found. If this problem is left unattended it could cause damage to the structure. I recommend a qualified professional make repairs as necessary.

Implication(s): Chance of water damage to contents, finishes and/or structure | Sewage entering the building

Task: Repair

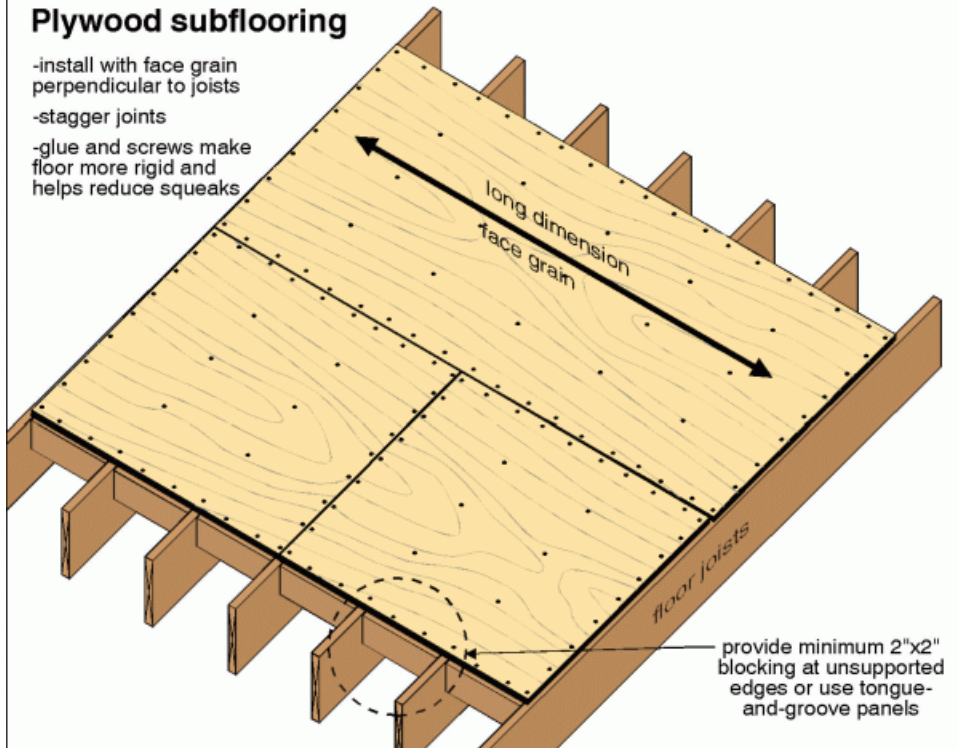
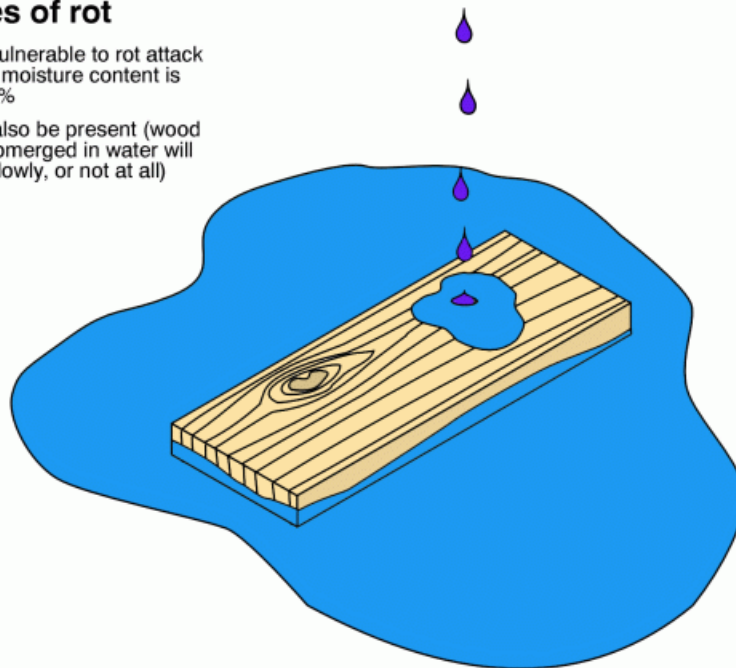
25. Rot

Moisture has caused damage to the structure. I recommend a qualified contractor be consulted and any and all repairs made as necessary.

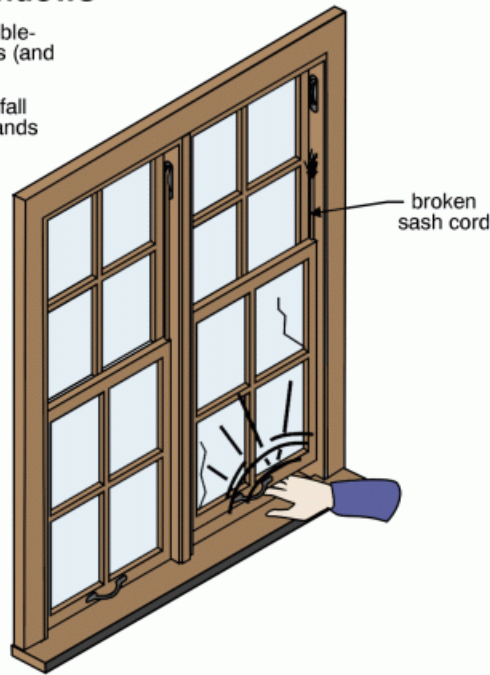
29. Won't stay open
